Fuel Spill and Fire Rapid Environmental Emergency Assessment Mukuru-Sinai slum, Nairobi Kenya October 2011

JOINT
UNEP / OCHA
ENVIRONMENT UNIT

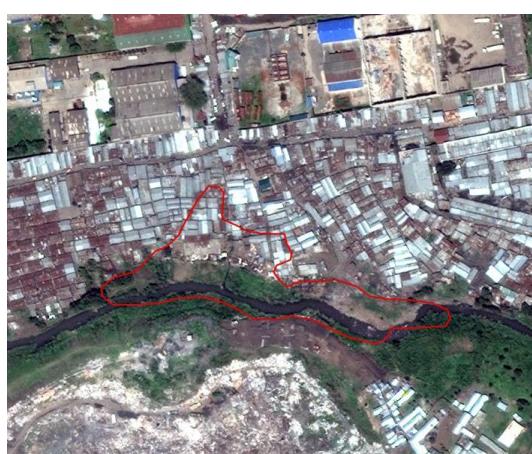
Undamaged zone before the explosion: 20 November 2010

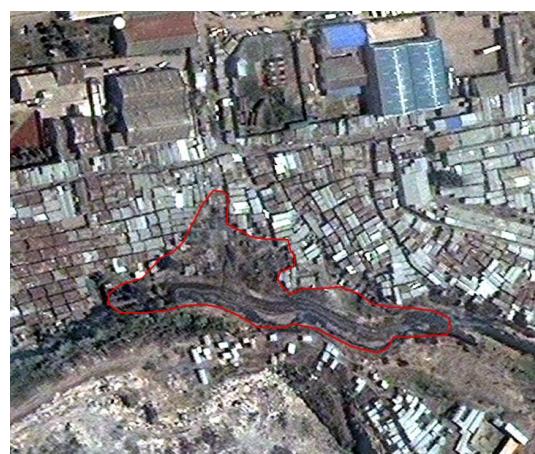
Damaged zone after the explosion: 22 September 2011

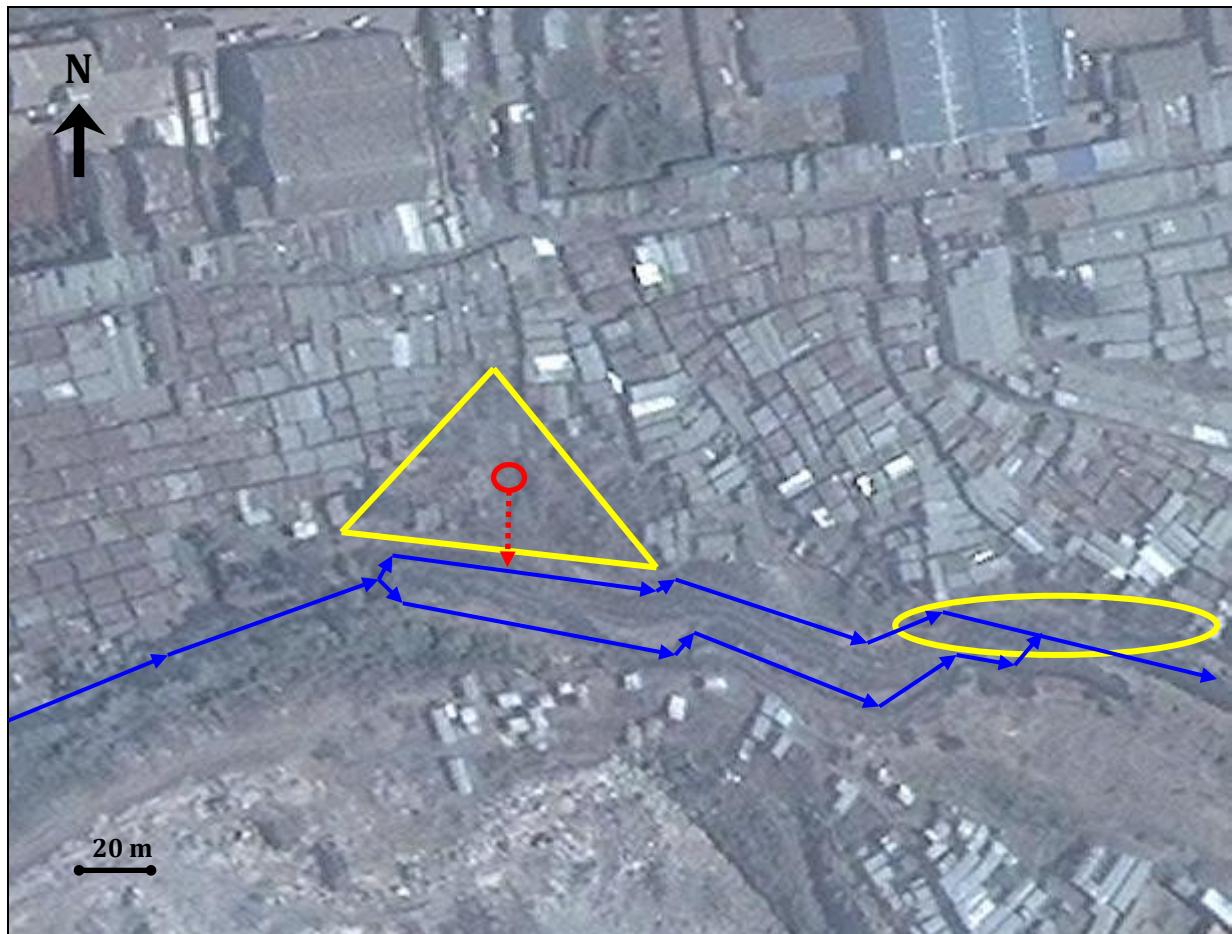
The primary affected site is centred on the outlet of a storm water drainage system situated approximately 15 meters from the Ngong River (marked red in the picture below).

The outlet runs into an open gutter which flows into the Ngong River.

The site visit also allowed the identification of a second area affected by the fire, further downstream of the Ngong River. The primary and secondary site have been visualised on the satellite imagery below. The distance between the two sites is approximately 80 meters.

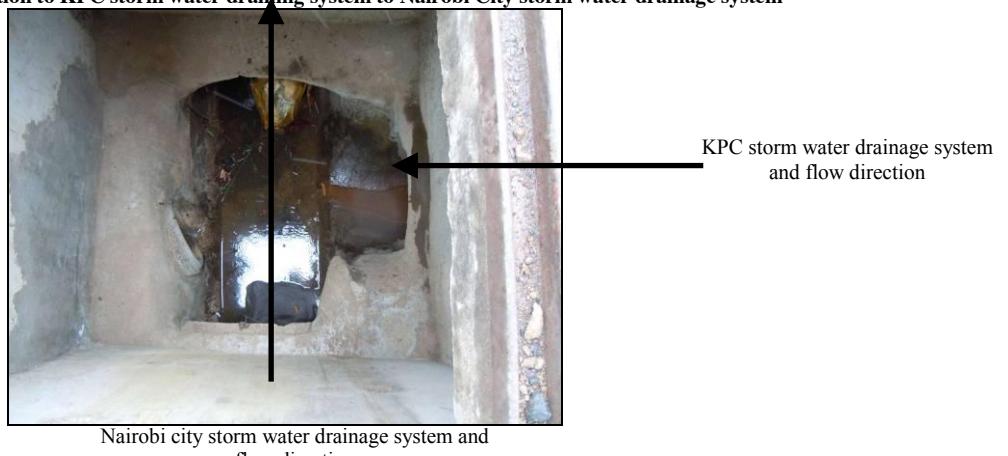
Notably, the KPC underground storm water drainage system, composed of a concrete culvert network, is connected, outside the deposit facility, to the underground storm water draining system of the City of Nairobi.

Photography of connection to KPC storm water draining system to Nairobi City storm water drainage system

Nairobi city storm water drainage system and flow direction

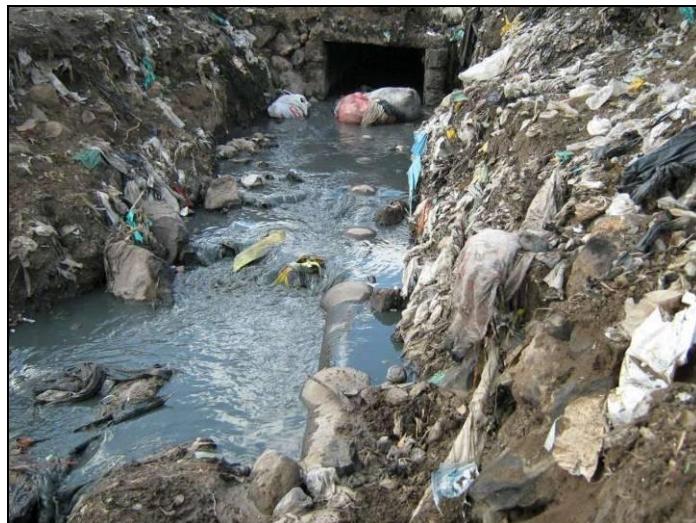
View of the outlet of the storm water drainage network in the slum

At the open outlet of the city's storm water drainage system, extremely flammable vapors formed on the surface of the hydrocarbon spill and created an explosive atmosphere in the slum and the surrounding dwellings. The flammable vapor cloud was dispersed following the flow direction of the petrol spill in the Ngong River.

In these conditions, any spark caused by metal contact, a discarded cigarette, or an open fire in a dwelling could have caused the ignition of petrol fumes present in the atmosphere. The ignition could have taken place at different places due to the dispersion of the vapor cloud from the ditch to the river, as well as the movement of burned people and animals.

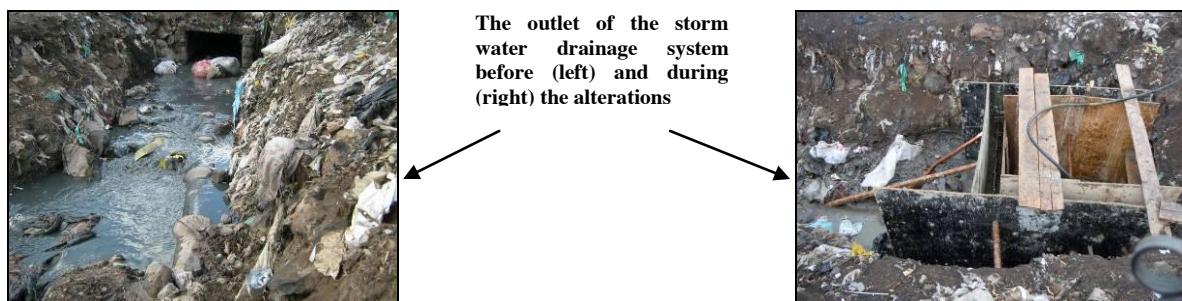
During the second field visit on 13 October, construction works were observed on the outlet of the storm water drainage system, connecting it to the municipal waste water system (GPS waypoint N°111 and see pictures below).

Although the exact reasons for this construction work could not be verified on-site, it should be noted that if this is intended to avoid the collection of potential hydrocarbon releases in the storm water drainage system by the slum inhabitants, there will be limitations to achieving this, because:

- In case of newly released inflammatory products in the storm water drainage system, the hydrocarbon spill would be dispersed in the waste water network, releasing flammable vapors in the inspection hole (especially in the manhole identified by GPS waypoint N°111) and the explosive conditions in the slum would still be present;

- The municipal waste water network runs into one of the waste water treatment plants of Nairobi. However, as waste water treatment plants of the city are exclusively equipped for the treatment of domestic effluents, the risk of the treatment facility malfunctioning due to the existence of possible industrial releases could be realized;

- Due to the small diameter of the two connected networks (storm water draining system in Ø 800 mm and the municipal waste water network in Ø 300 mm) high hydraulic pressures could destroy the current construction works under way, causing a possible leak at the connection point and further risks of pollution.

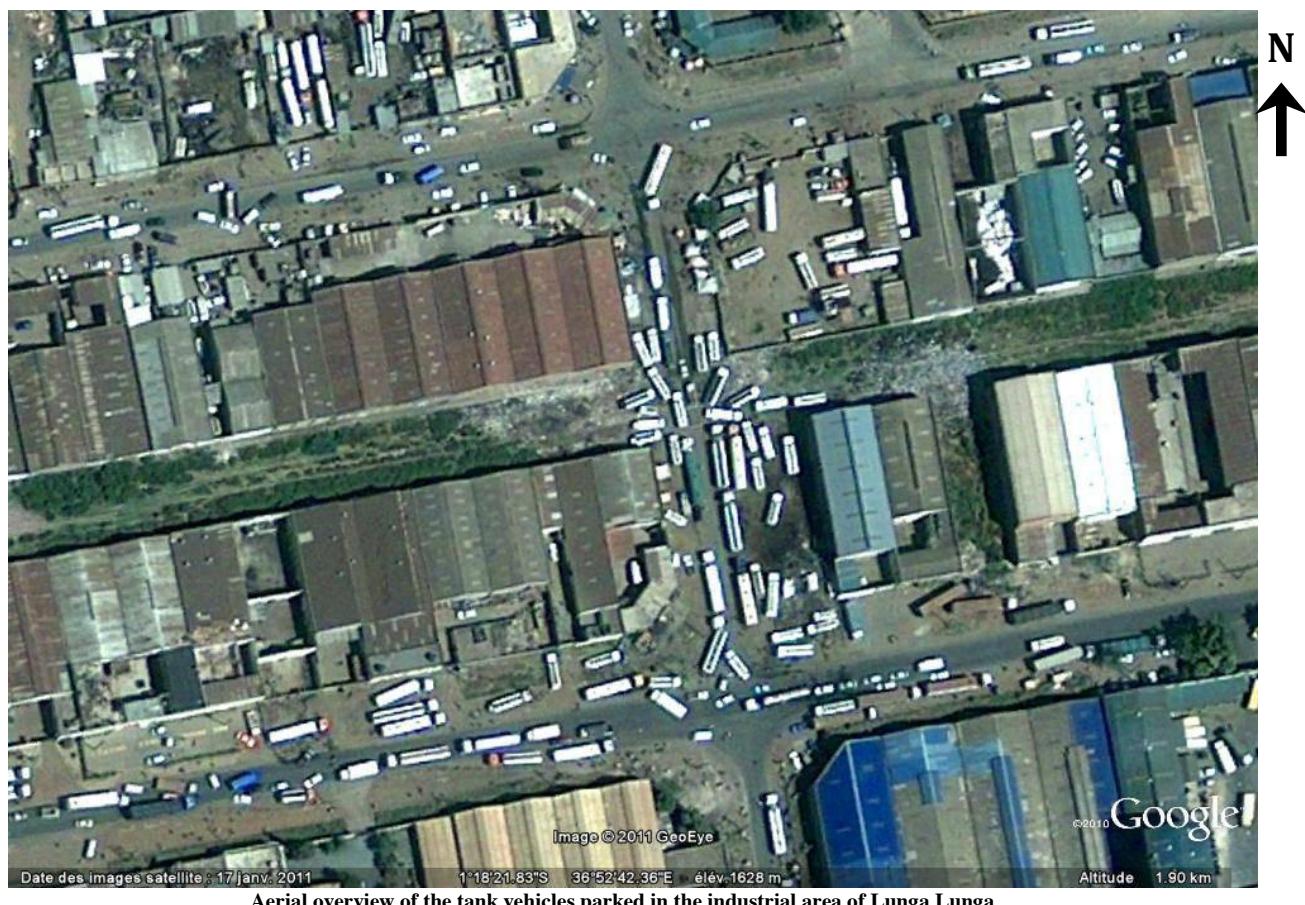
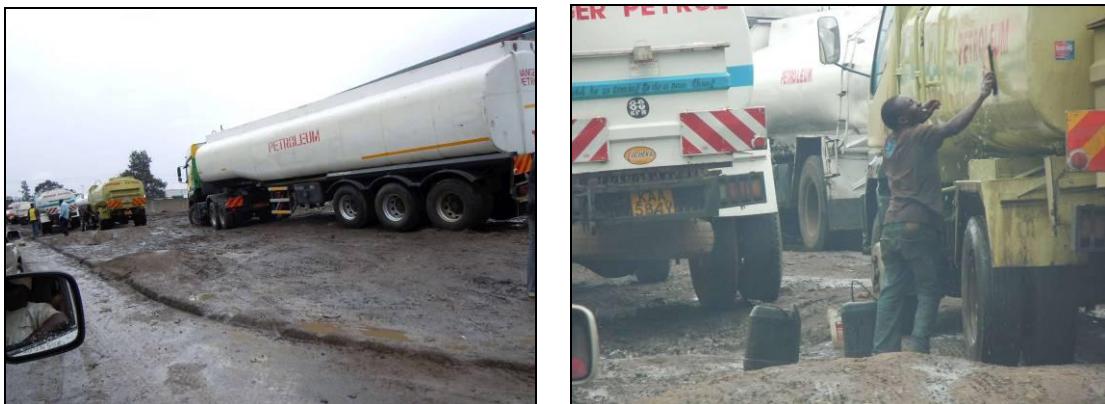
One of the most obvious potential sources of pollution of the storm water drainage system, which could cause a similar type of accident with grave human and environmental consequences, was observed at a loading bay and parking for tank vehicles. Tank vehicles, which can contain up to 30,000 liters of petrol, are parked on the sidewalk, without any specific precautions. The parking areas are not equipped in case of accidental leak nor is there any regard or enforcement of basic safety regulations such as a ban on smoking or the use of potential heat sources. As no retention basins exist to contain a potential leak, or the polluted water from simple washing of the trucks, any spilled petrol will penetrate the soil or, if in large enough quantities, flow into the storm water drainage system.

Overview of parking and washing of tank vehicles
