UNDAC landslide advisory visit to Serbia June 2014

Open Report IR/14/043

H J Reeves

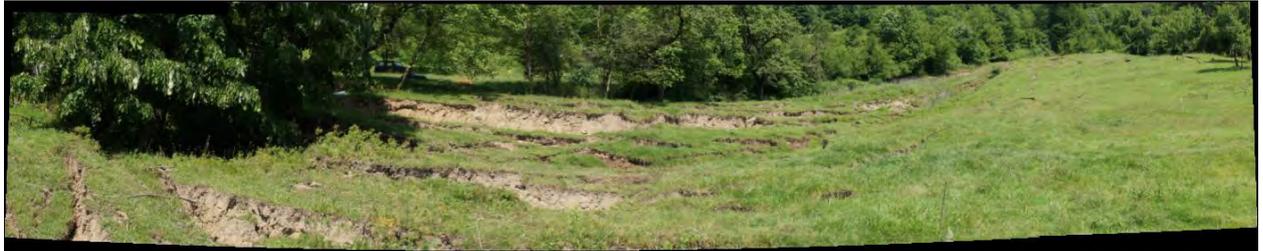
Figure 4.1 - Scarp features seen in the middle of the landslide mass at Mali Zvornik showing typical features for multiple rotational slides.

this streamline the meta-sedimentary rocks (schist and phyllites) are heavily weathered to a clay soil and have a number of large continuous scarp features (cracks in soil), with vertical displacements of between 1.0 – 5.0 m and apertures of 0.1 – 0.5 m (Figures 4.1-4.3). Slope angles in the middle of the landslide's meta-sedimentary rocks are 10-15° (Figure 4.2) and at the top of the landslide are 20-25° (Figure 4.3).

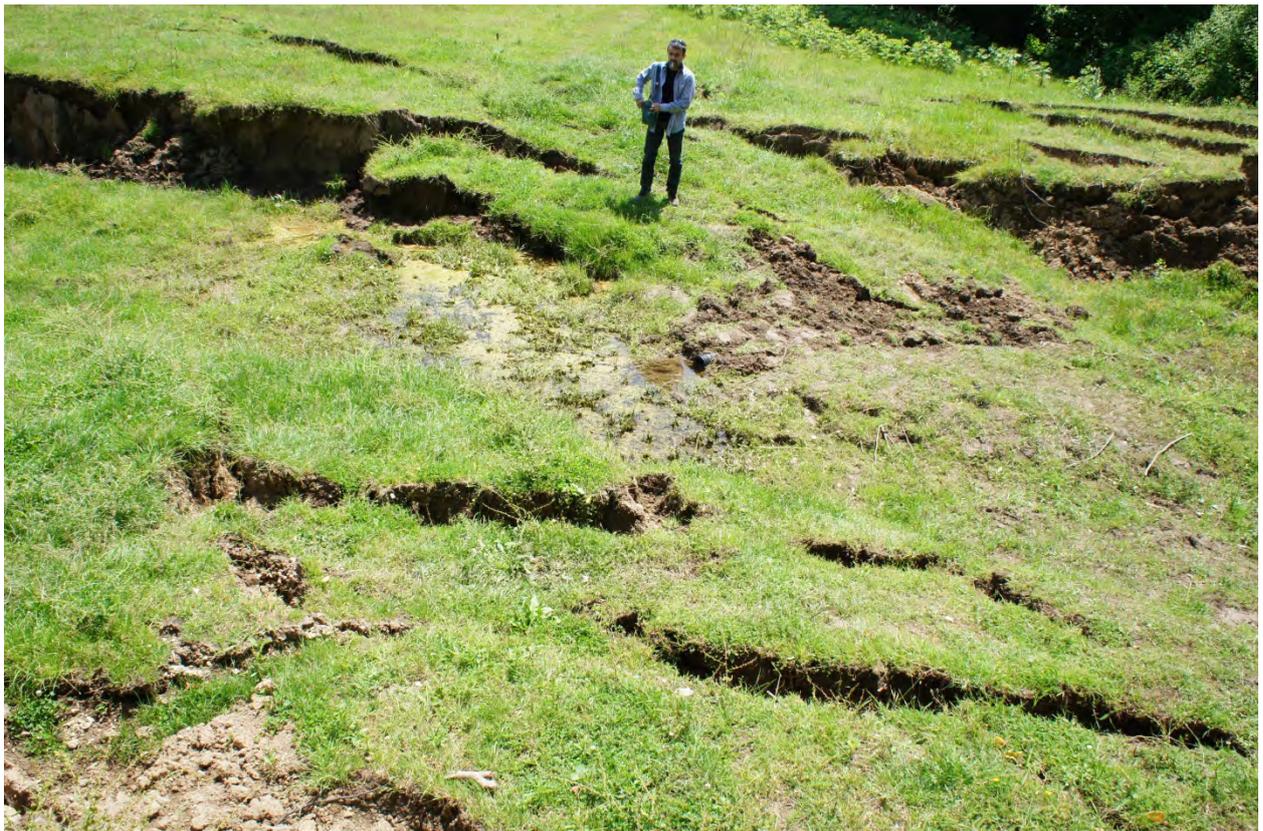
Figure 4.2 - Scarp features seen in the middle of the landslide mass at Mali Zvornik showing the typical features for multiple rotational slides with small pools of water observed.

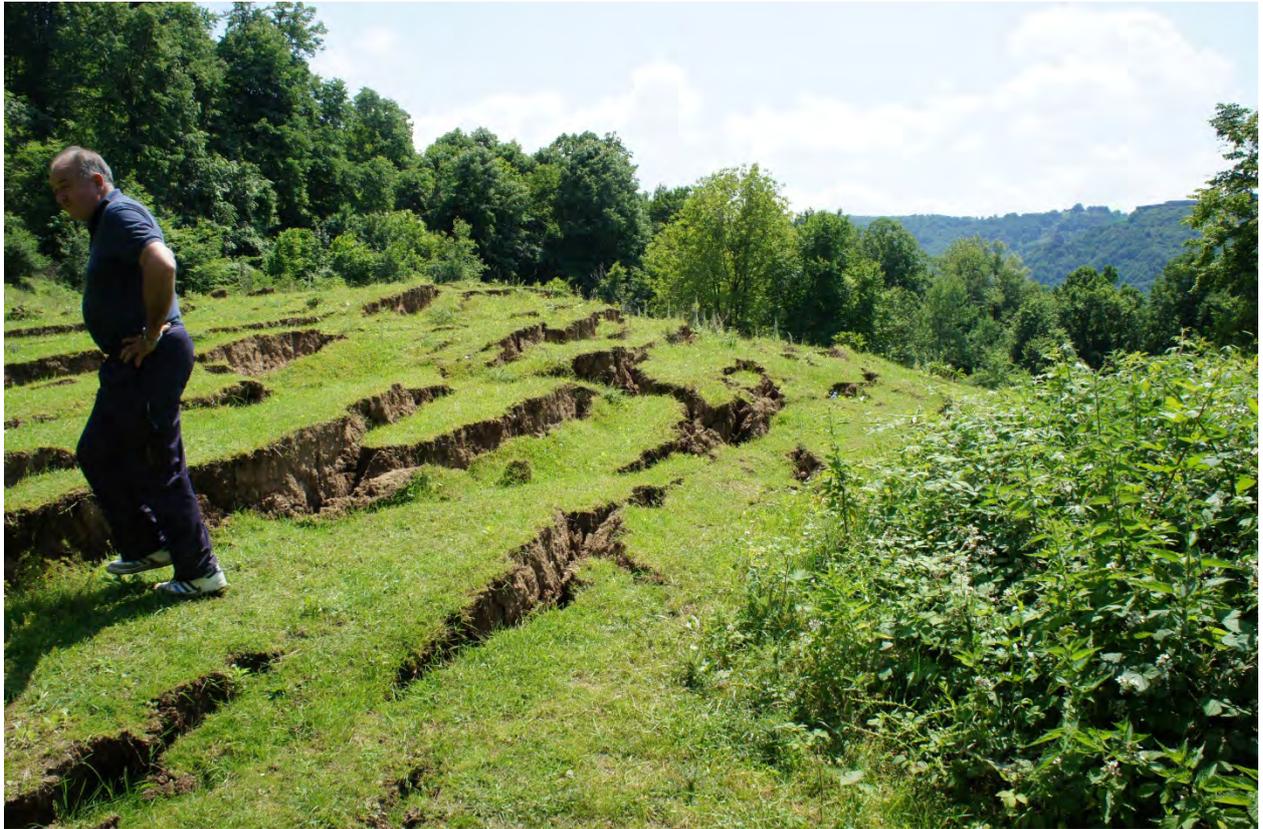
Figure 4.3 - Scarp features seen at the top of the Mali Zvornik landslide mass showing typical features for multiple rotational slides.

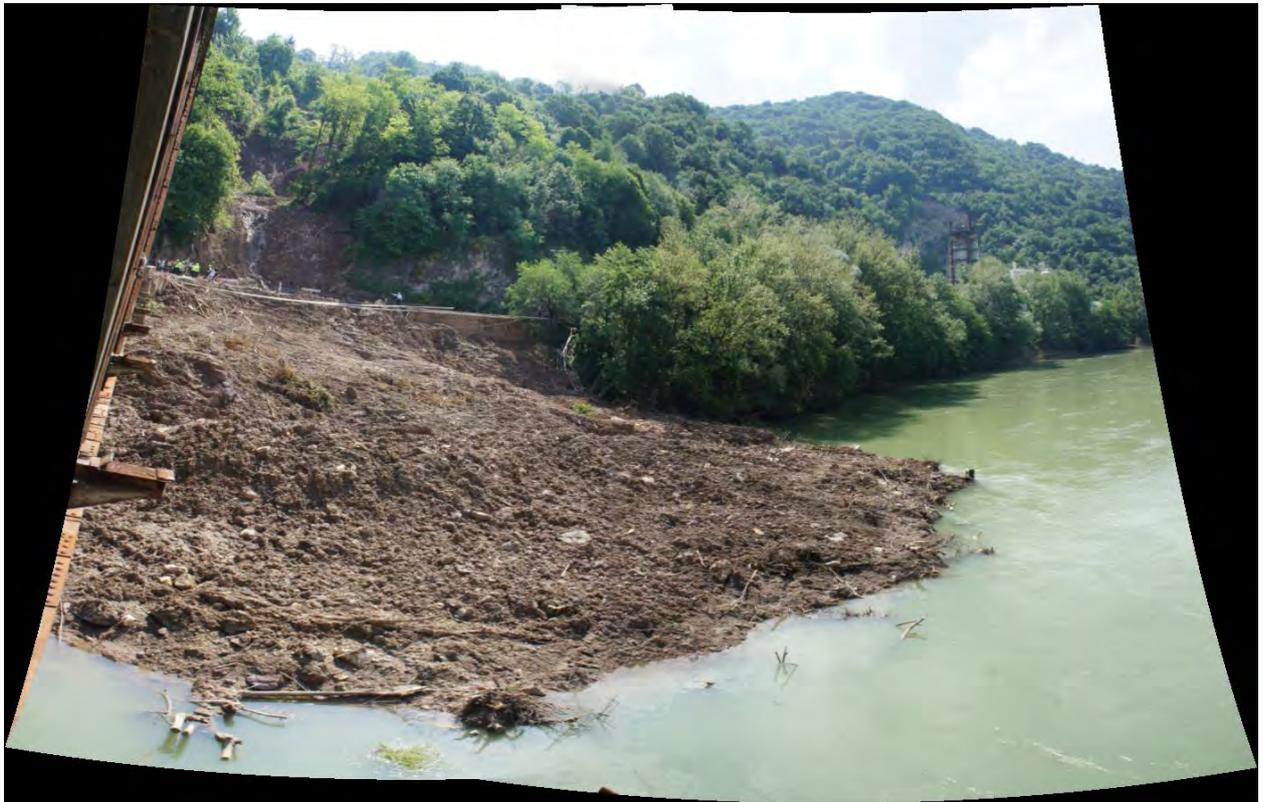
Figure 4.4 - View from pedestrian bridge looking west to the debris flow at the toe of the Mali Zvornik landslide.

At the bottom of the slope there is a band of strong limestone that is approximately 10m high with a slope angle of $\sim 45^\circ$. The landslide debris flow (mixture of rock, soil, trees in a clayey matrix) came down and over the limestone band, flowing down a pre-existing stream line. Above

landslide. Additionally, it would be recommended to monitor the volume and flow rates of water that is currently being diverted away from the landslide through the temporary diversion.

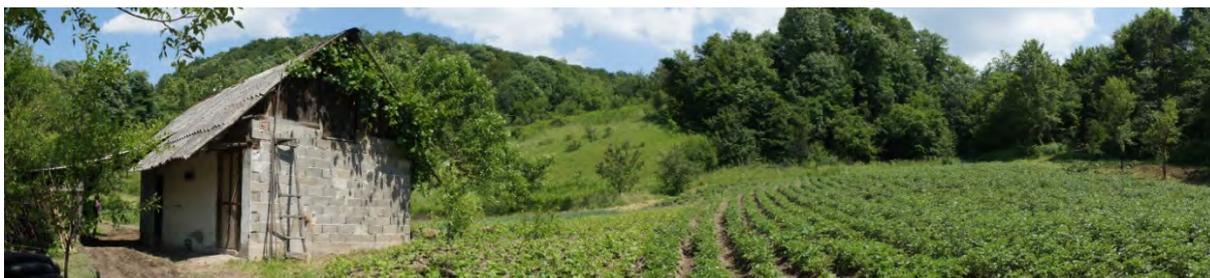
The Mali Zvornik landslide covered and damaged the road at the bottom of the landslide, as well as severing the utilities services at the side of the road, by the Drina River (Figure 4.4). At the top of the slope small agricultural buildings had been damaged by the landslide moving. There is also evidence of there having been sustained damage from the movement of the landslide for a number of years (Figure 4.5). The agricultural practices, of growing vegetables, at the top of the slope and the associated watering and storage of water have also contributed to enhancing the movement of the landslide (Figure 4.5).

Figure 4.5 - Top of the Mali Zvornik landslide showing evidence of damage to buildings and agricultural use of land.

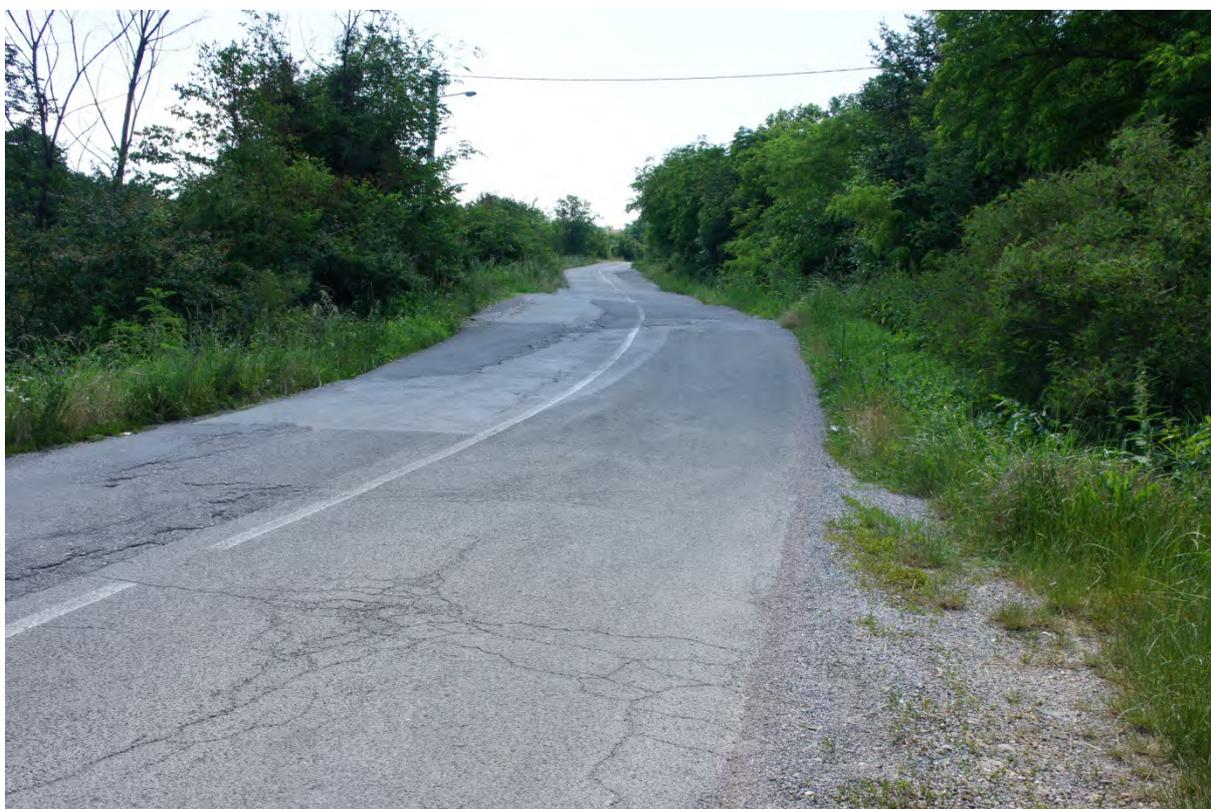
At Umka and Duboko large slow moving rotational landslides were observed in the weathered Neogene Miocene laminated soft marls and clayey marls. A number of continuous scarp features (cracks in soil), with vertical displacements of between 0.2 – 5.0 m were observed (Figures 4.6).

Figure 4.6 - A view of the slow moving rotational landslide observed at Duboko. Damage to road from the slow moving landslide can be observed.

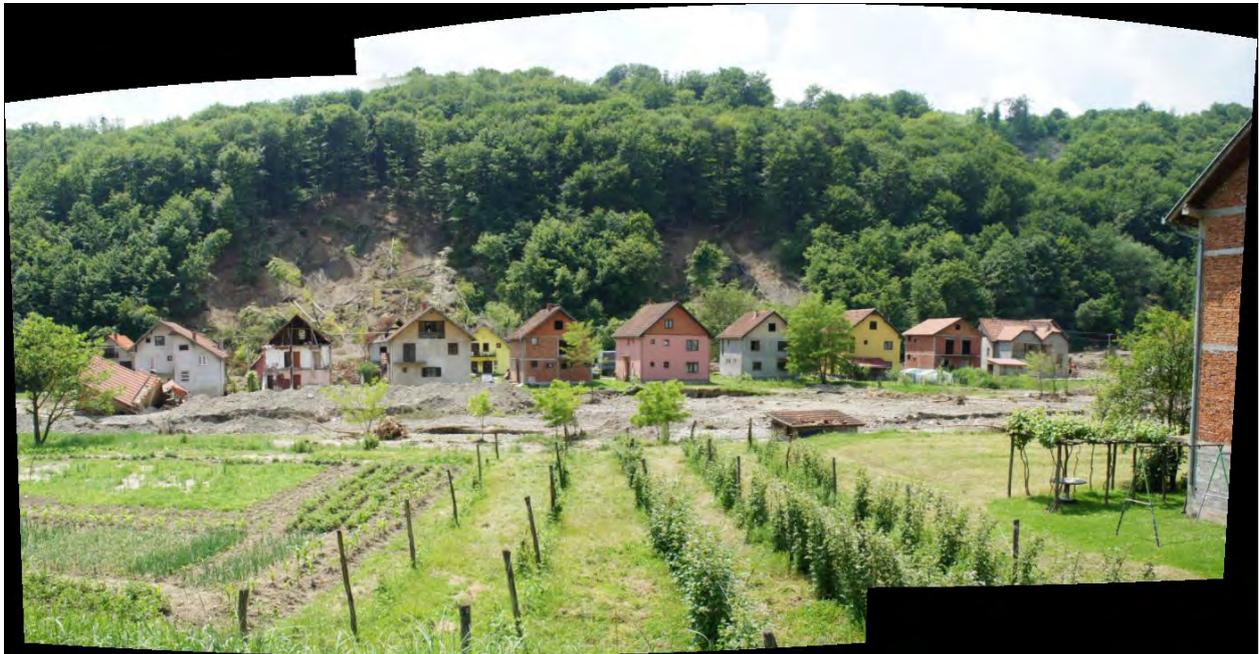
Figure 4.7 - Debris slides seen in the Cadjavica valley that have damaged houses.

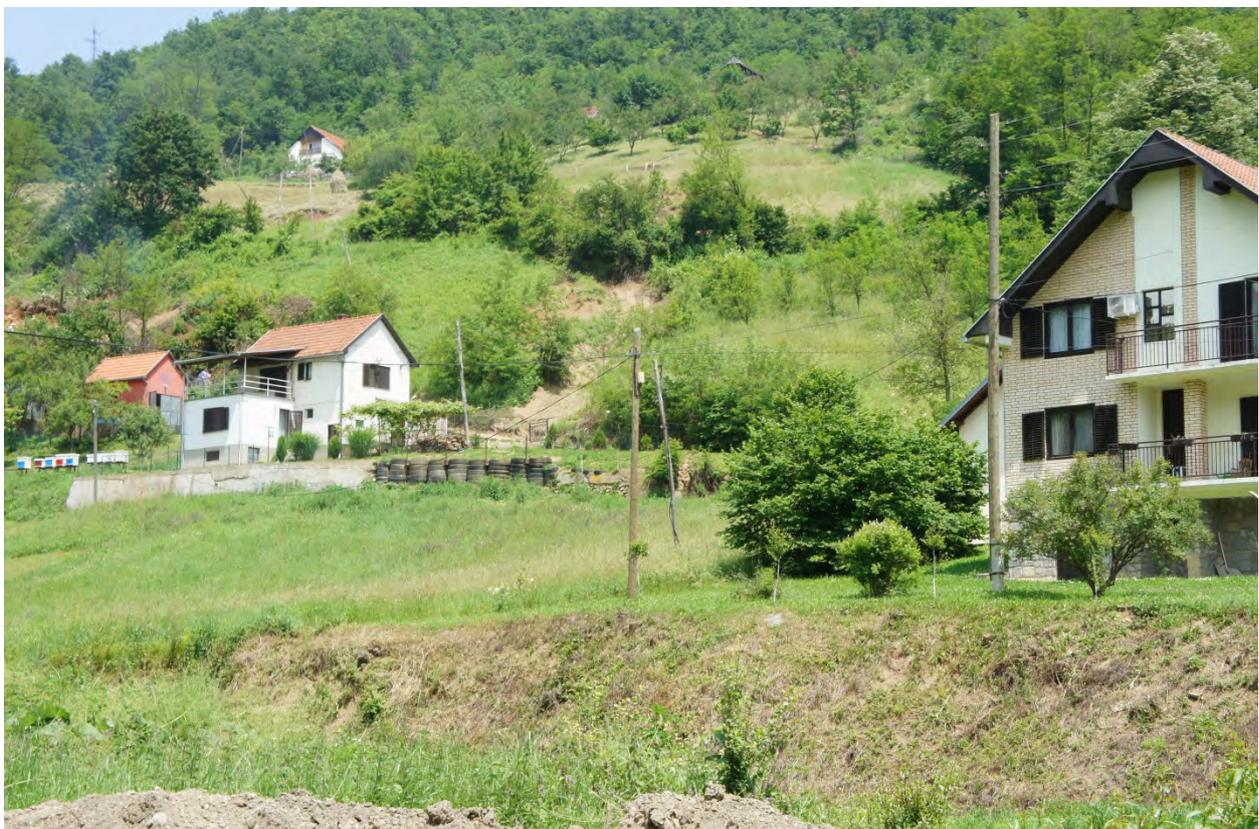
Figure 4.8 - Debris slides seen in the Ogradjenica valley that have damaged agricultural land.

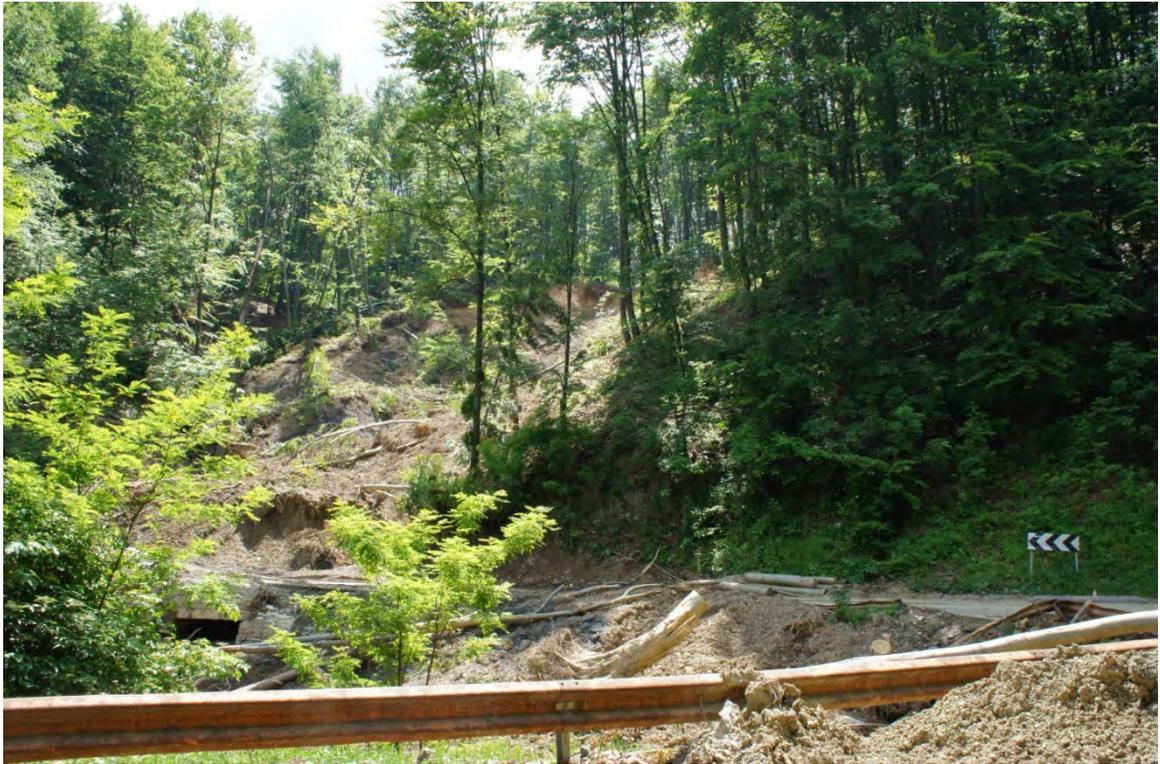
Figure 4.9 - Debris flow seen in the valley above the Antimony Mine Waste Tailings Dam where damage to the road and road infrastructure was observed.

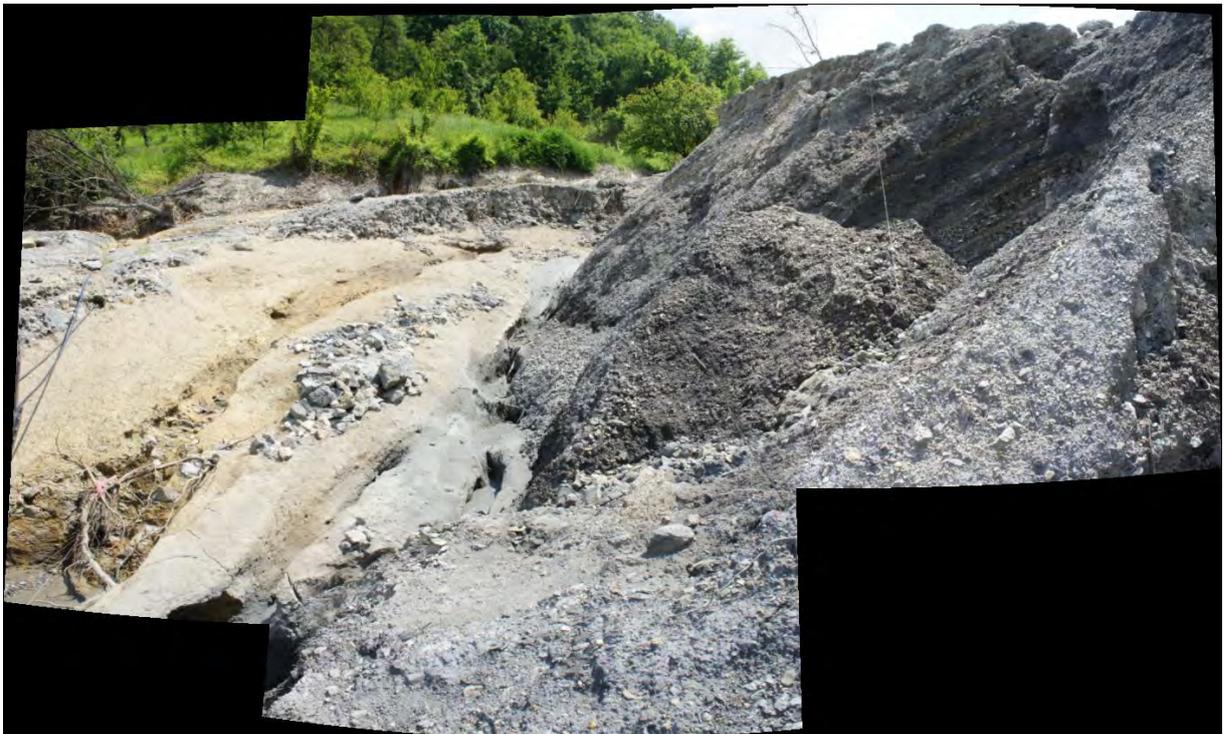
In addition, to observing the landslide sites in the valleys around Krupanj, the Stolice Antimony Mine Waste Tailings Dam was visited. The embankment of this dam was observed to have been breached and water from the mine waste is discharging into the river below the site.

Figure 4.10 - Stolice Antimony Mine Waste Tailings Dam showing breached embankment and discharge of mine waste water.

At the Stolice Antimony Mine Waste Tailings site, due to the nature of the mined mineral Antimony (<http://en.wikipedia.org/wiki/Antimony>), potentially harmful fluids to human health, are discharging into the river. This site needs to be investigated with a full hazard and risk assessment by experts in the field of Mine Waste/Tailings Engineering and Mine Water Geochemistry as a matter of urgency. The representatives from the local municipality said that the dam had been inspected and water had been sent away for testing and that they were waiting for results. It is also recommended that until this is done, as a precaution, local people are evacuated from the local vicinity.

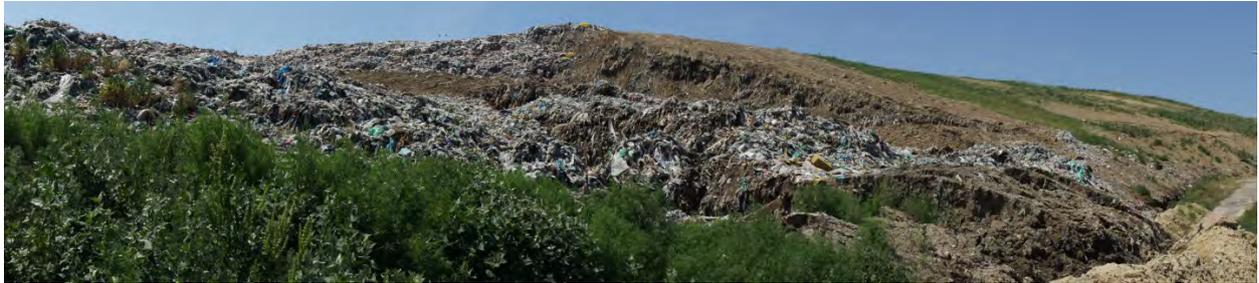
At Vinca a complex landslide (Figure 2, Appendix 1) was encountered that had a multiple rotation slide mode (Figure 2, Appendix 1 & Figure 4.11) at the top of the complex with debris flow (Figure 2, Appendix 1 & Figure 4.12) at the bottom of the landslide (toe) in the Belgrade Municipal Waste site.

Figure 4.11 - Scarp features seen in the middle of the landslide mass at the Belgrade Municipal Waste site showing typical features for multiple rotational slide.

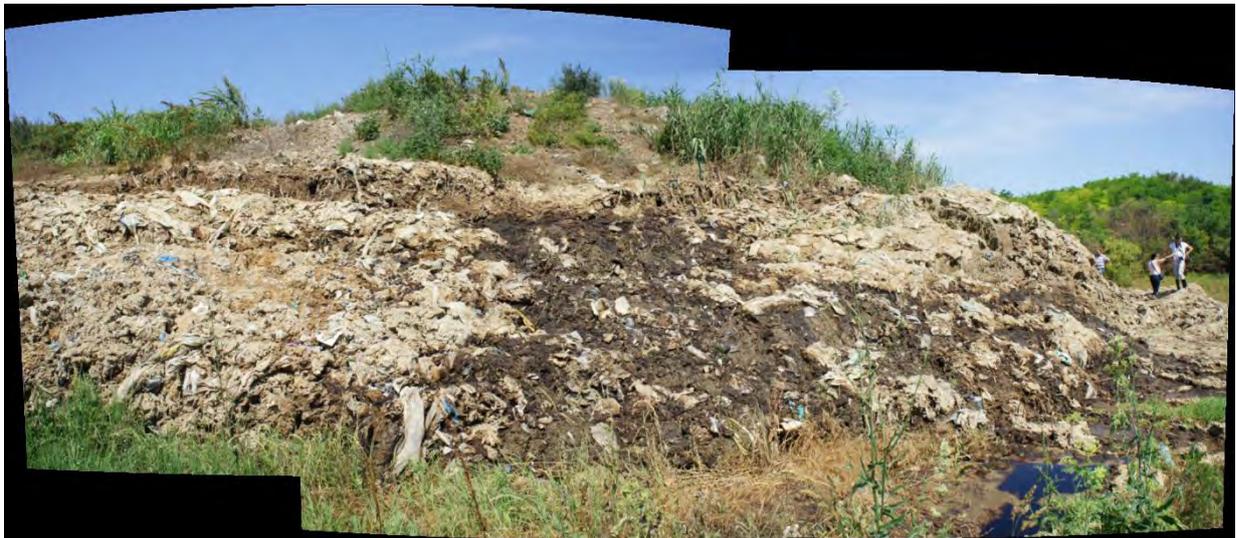
Figure 4.12 - View looking south-east back over the debris flow at the toe of the Vinca Municipal Waste site landslide.

Survey should accurately map both the geomorphological, hydrological, hydrogeological, geochemical and anthropogenic features of the landslide, ideally using a differential GPS system &/or detailed surveyed points, interpretation of orthophotographs and satellite imagery. This dataset can then be used as a baseline to monitor movement on the landslide, which will help to understand the on-going movement of the landslide. Additionally, it would be recommended to monitor the geochemistry, as well as the volume and flow rates of leachate that is currently seeping out of the landslide.

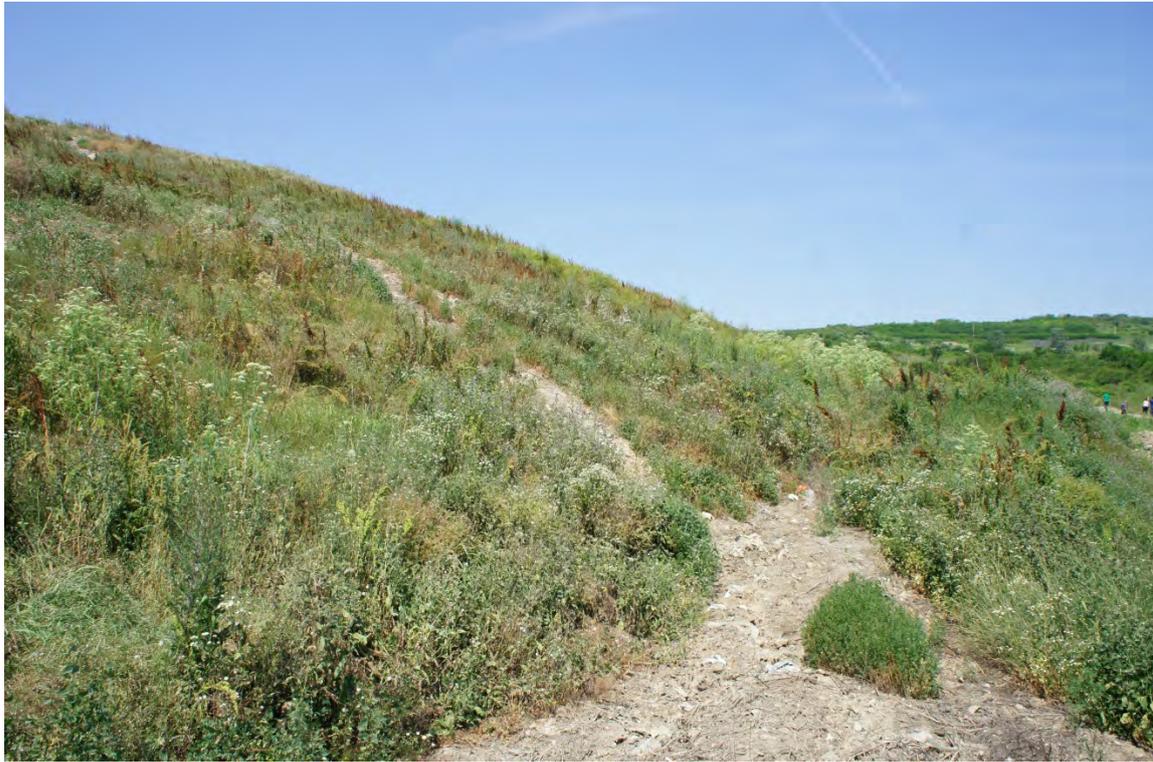
Slope angles around the edge of the Belgrade Municipal waste site range from 25 - 30° (Figure 4.14).

Figure 4.13 - View looking south of the slope around the edge of the Belgrade Municipal Waste Site.

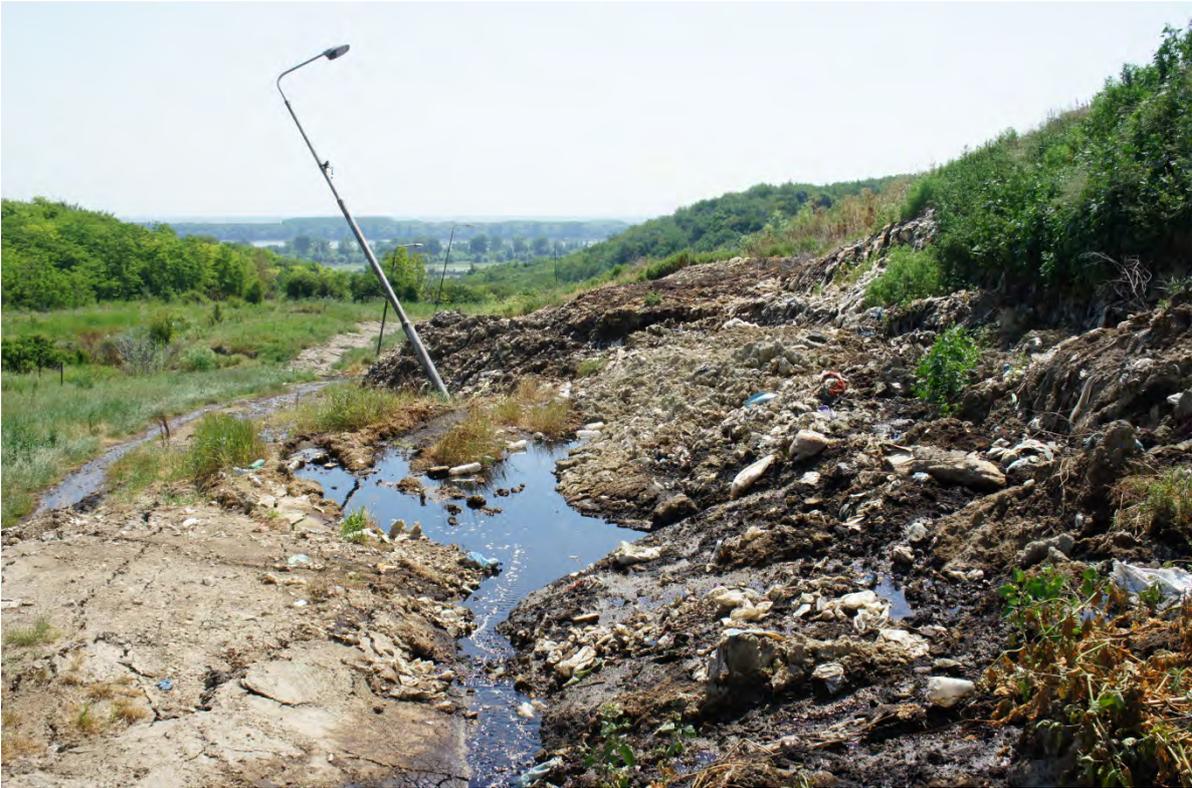
The Belgrade Municipal Waste site landslide has damaged the perimeter road and the utilities around the waste site (Figure 4.15). Leachate was observed to be seeping out all over the site, but particularly towards the toe of the landslide (Figure 4.15).

Figure 4.14 - View looking north of the damage to the infrastructure and road around the edge of the Belgrade Municipal Waste Site.

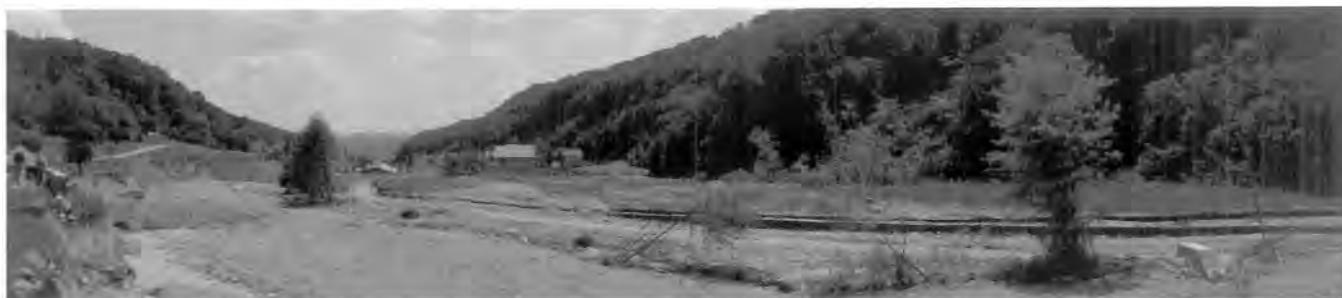
Поплављена долина реке Чађевице

Констатовано је да су реке се делом вратиле у своја речна корита, али су алувијалне равни и даље у водозасићеном стању и део вода покушава да формира нове токове. Јасно су уочљиви делови формираних мањих каскада висине 20-30цм низ које се слива вода.

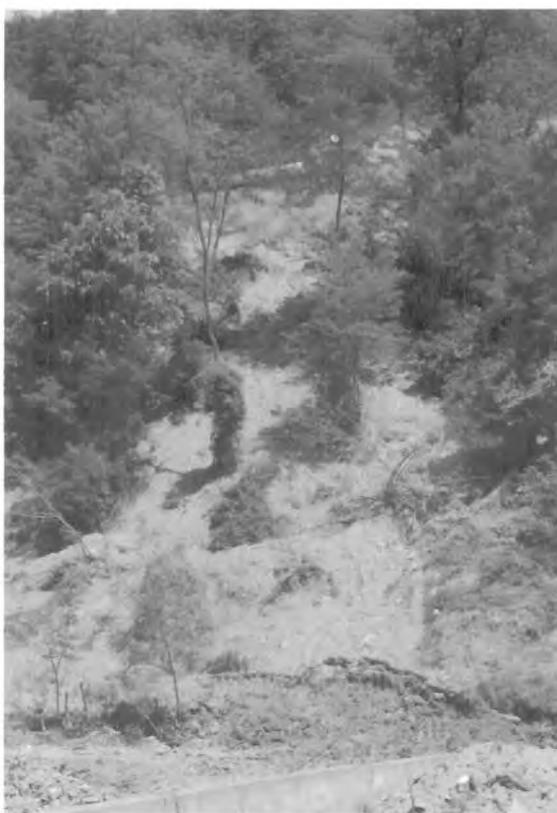
У исто време формирана су бројна тецишта у распадини стена на падинама, те су постојећи објекти на више локација били двојакo угрожени. Према речима представника из општине од 27 мостова који су били у општини Крупањ 21 мост је оштећен у већој или мањој мери.

Тециште формирано у распадини шкриљаца

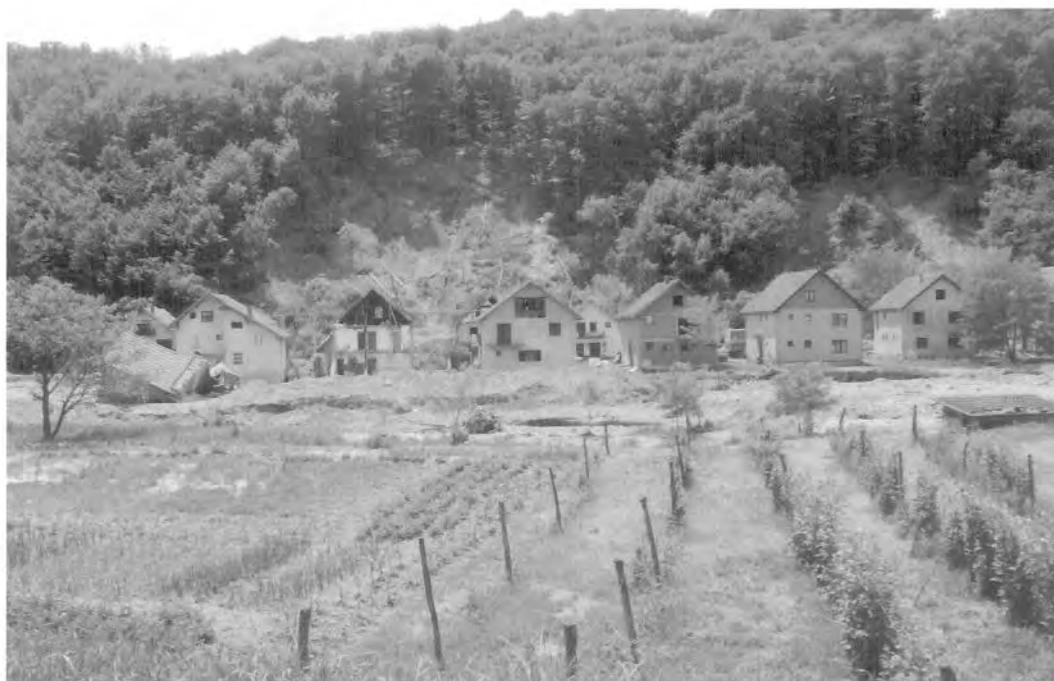
Угрожени објекти у долини реке Чађевица

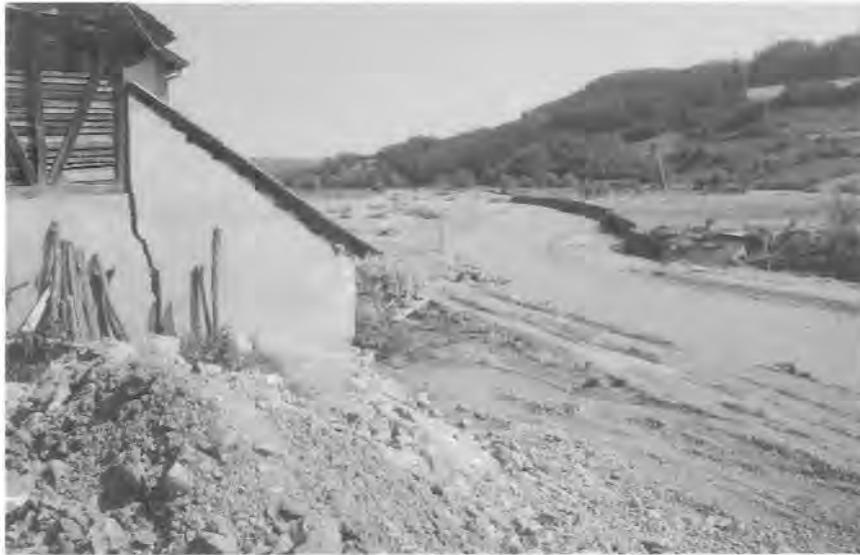
Долина Ликодре –објект у насељу Липеновић

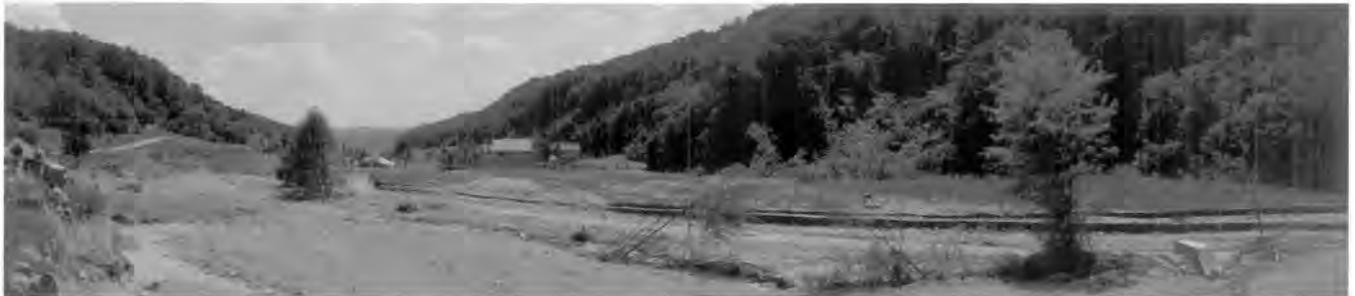
Flooded river valley of the River Cadjavica

It is considered that the rivers are mainly back to their river bed, but the alluvial plains are still in the saturated state and part of water is trying to form a new stream. It can be clearly seen that part of cascades, are formed from which water flows (height from 20 to 30 cm).

- In the river valleys removal of the flood material is proposed.
- After the water level settles the river beds need to be cleaned. It is necessary for river beds to stay mobile in the future.
- Estate parts of the terrain needs to be protected with the proper embankment with the clay core, thus the further influence of the surface waters will not be able to damage them again. In order to prevent buildings from the higher level of ground waters, extensive drainage procedures need to be predicted.
- Parts of the terrain which are dedicated for construction, within the alluvial plains, need to be elevated with embankment above the recent flood maximum.

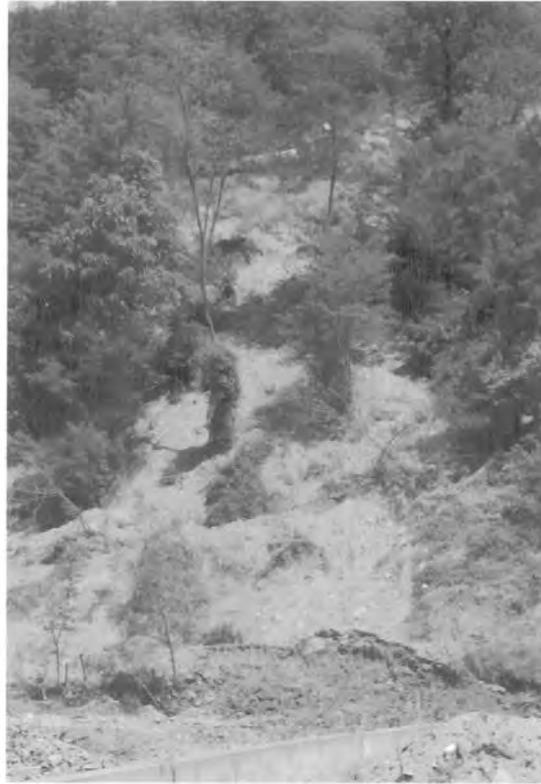
At the same time the numbers of debris flows in the weathered rock on the slope are formed, therefore buildings on many locations had been doubly endangered. As the mayor of municipality said that from the 27 bridges which municipality of Krupanj had, 21 is damaged more or less.

Debris flow in the weathered shales

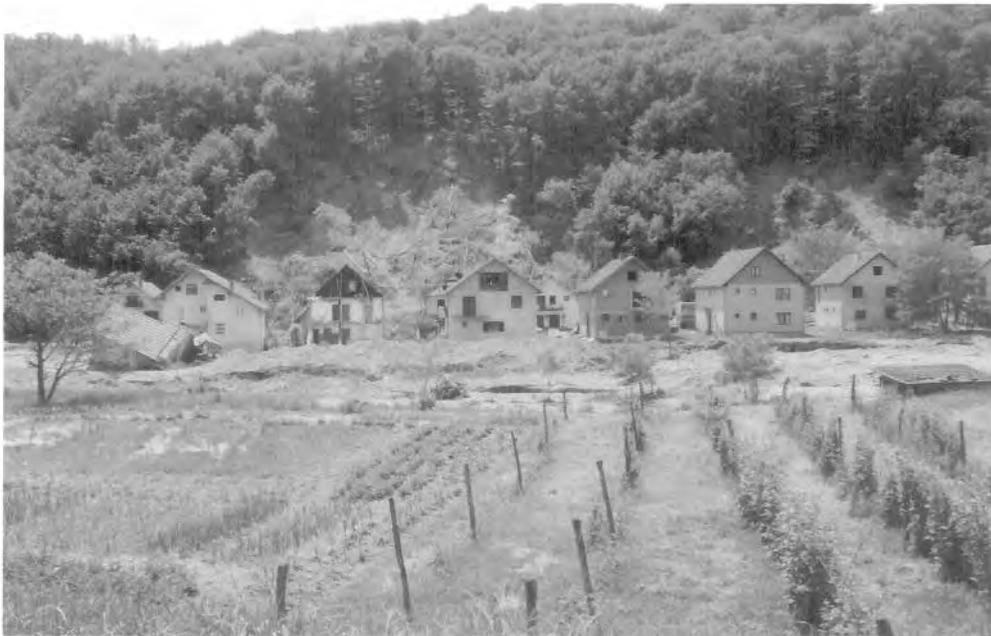
Destroyed buildings in the valley of River Cadjavica

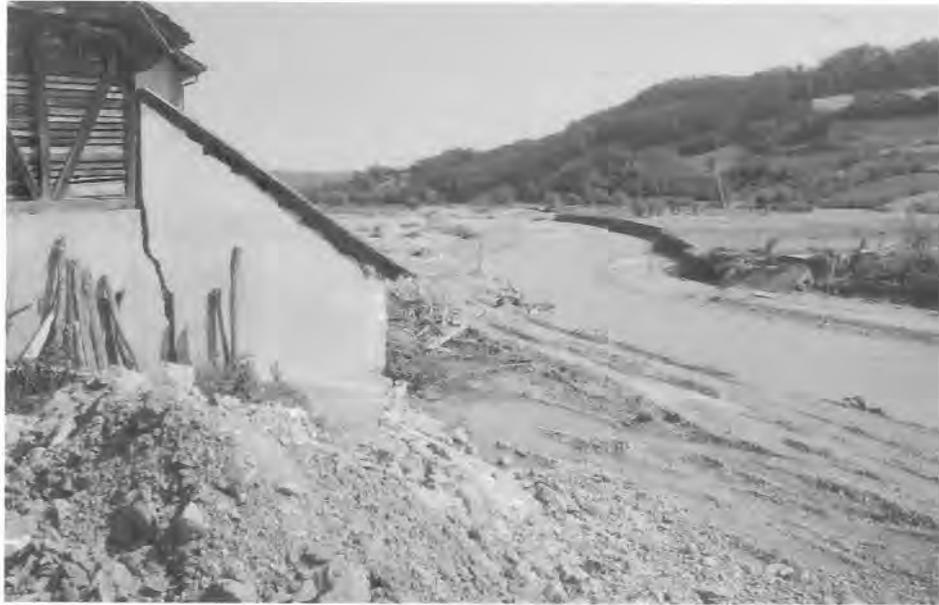
Valley of river Likodra – damaged house in Lipenovic
