Technical Scoping Mission

Kalush Area, Ukraine

March 2010

**A Joint United Nations – European Commission
Environmental Emergency Response Mission**

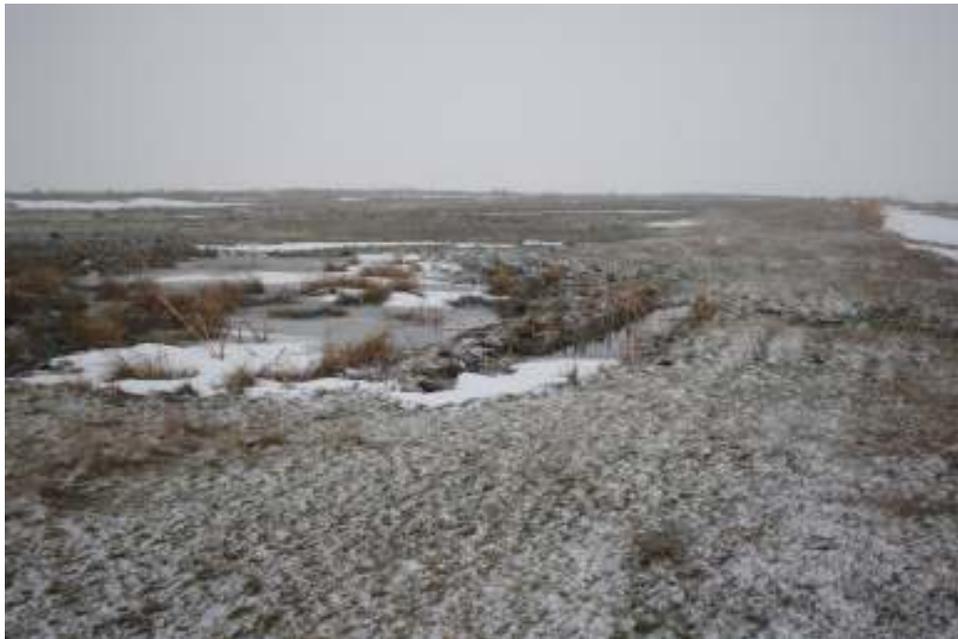
Tailings Dam No. 1 was no longer in use when the mining facilities were closed. However, no final and proper decommissioning has taken place. A limited soil cover is in place and a good grass cover established, as seen in Figure 3. According to the decommissioning plan, 600,000 m³ of fill is required to establish a fully functioning cover for the dam.

Figure 3: Grass cover on Tailings Dam No. 1

The soil cover on top is nearly horizontal, resulting in water accumulating in ponds on the top surface. Water in the ponds seeps through the soil cover and infiltrates into the saline wastes below. Some water also finds its way through the circumferential structure and emerges as saline streams in the outer slope. Some water is seeping through the entire waste and into the underlying alluvial stratum. This flow of water is causing karstification of the waste, resulting in fissures, sinkholes, underground streams and small caverns. As a result, more water is infiltrated through the waste and less is flowing off as surface water. The dam's structural stability is considered to be good under normal loading conditions. However, under high groundwater pressure and/or earthquake loading, the stability might be significantly reduced. The western part of the dam is affected by subsidence caused by the underlying Novo-Holyn mine. Future significant subsidence may cause cracking of the retaining structure and may result in a severe spill of the stored wastes through the crack.

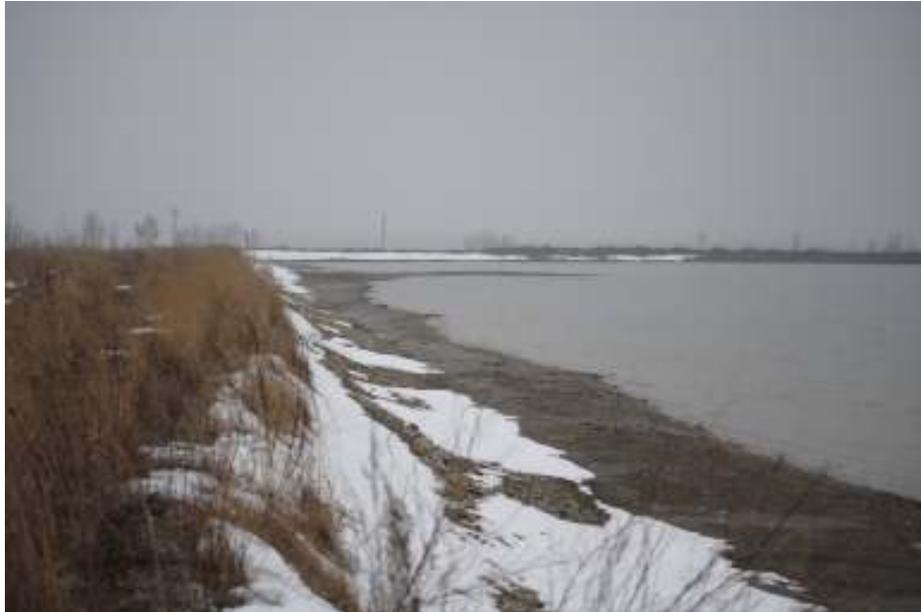
Figure 5: North side of Tailings Dam No. 2

Tailings Dam No. 2 is filled with solids and brine, as seen in Figure 5. The liquid level is controlled by pumping brine away from the dam. The dam has a polyethylene membrane sealing at the bottom, and up to five to seven metres on the slope of the starter dam. The dam is currently filling up by precipitation. If the level is allowed to rise and no action is taken, the dam will eventually overflow. As the dam is filled with brine, equilibrium will be reached between the seepage water and the salt in the waste. It has been observed that brine is seeping through the dam in places, especially at the eastern and western sides. The dam's structural stability can be considered as good under normal loading conditions. However, under high groundwater pressure and/or earthquake loading, the stability might be significantly reduced. Precipitation collected along the slopes has caused surface erosion. The western part of the dam is furthermore affected by subsidence caused by underlying the Novo-Holin mine. Future significant subsidence may cause cracking of the retaining structure and may result in a severe spill through the crack.

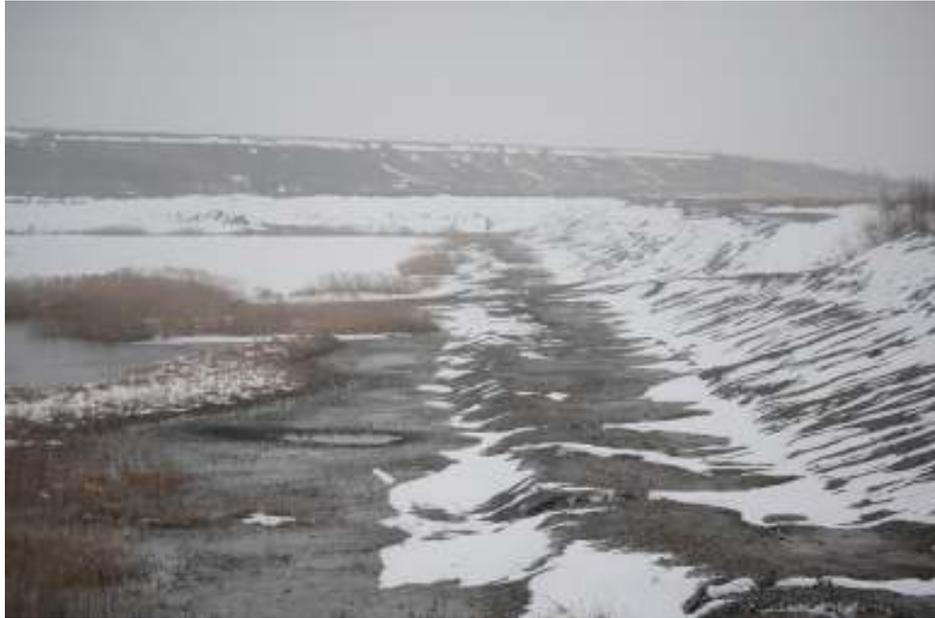
Tailings Dam No. 3 (see Figure 6) is situated between Tailings Dam No. 1 and No. 2. The dam is enclosing a former sludge pond. The dam's construction is partly finished as only the starter dam has been completed. The dam contains brine but no tailings.

Figure 6: Start dam for Tailings Dam No. 3 (west side)

The dam is filling up by precipitation. If the water level is allowed to rise and no action is taken, the dam will eventually overflow. Since the dam is filled with brine, equilibrium will be reached between the seepage and the salt in the waste. No seepage has been observed through the dam. The structural stability of the dam can be considered as good. However, the dam is under high groundwater pressure and/or earthquake loading, and therefore its stability might be significantly reduced. The western part of the dam is affected by subsidence caused by the underlying Novo-Holin Mine. Future significant subsidence may cause cracking of the retaining structure and severe spill through the crack.

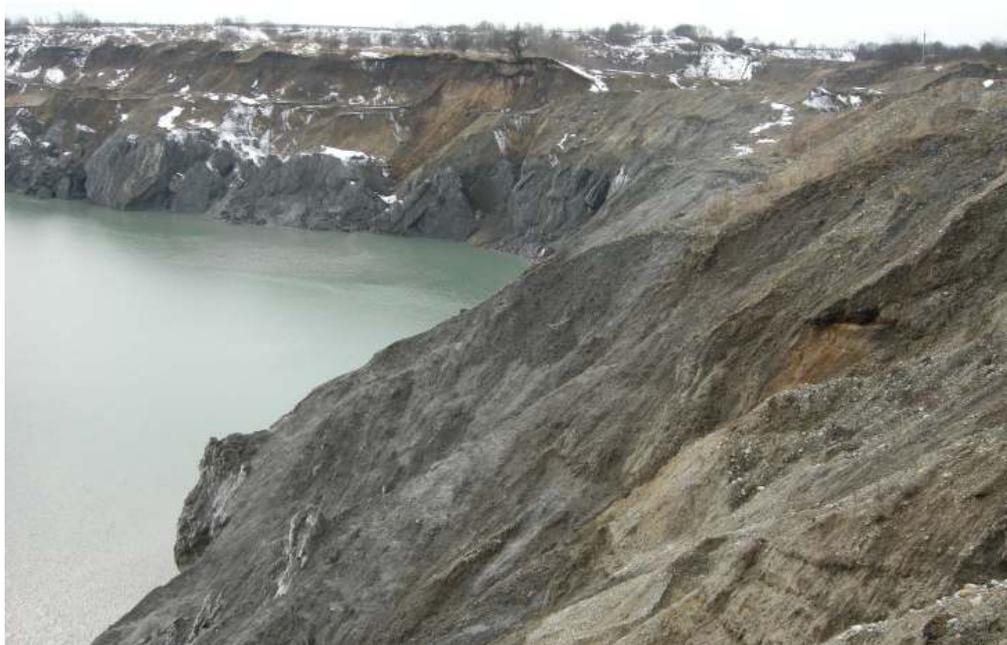
Figure 7: Dombrovski Open-Cast Mine (north-western corner)

The salt deposits that were mined in the Dombrovski Open-Cast Mine (Figure 7) were a prime source for the Oriana Potash Fertilizer Plant. Mining continued until the plant was shut down in October 2001. At present it remains the only mine that that could physically be reopened for production. The mine was initially opened in 1967. Since then, an estimated $14.7 \times 10^6 \text{ m}^3$ of potassium ore has been excavated, while an estimated deposit 32×10^6 tons of ore remains. The Dombrovski Open-Cast Mine has filled up with brine, as seen in Figure 8, having an estimated volume 12 to $15 \times 10^6 \text{ m}^3$.

Without a functional drainage system, the steep slopes have become highly unstable. The upper slope has been subjected to numerous small- and medium-scale slides, especially on the western and northern sides. The southern and eastern sides have been excavated with more gentle slopes. The slides occur mainly in the overburden, which consists of loess at the top and sand/gravel alluvium below. The result is a continuous lateral expansion of the mine pit caused by the loose character of the two top layers and the steep excavated cuts. Without a proper functioning drainage system, the slopes may become as flat as 1:3 (vertical:horizontal). This implies that the pit at places may expand laterally as much as 20 to 50 metres before the slopes are stable. In addition to the loose top soil layers, the cap rock and salt below the overburden are subjected to karstification, further contributing to the instability of the slopes.

The ongoing erosion and instability of the slopes are most severe in the northern sector. At certain locations, slides have already severely affected the perimeter drain and the edge of the pit is now close to some adjacent *dachas*. Moreover, with more slides the edge of the mine pit will approach the Sivka River that runs along the northern section of the Dombrovski Open-Cast Mine. At the same time, water from the Sivka River is already seeping through the alluvial aquifer into the pit. This seepage may cause further suffusion and eventually a ravine may cut retrogressively back into the Sivka River. Such a breakthrough would lead to a rapid filling of the pit, allowing the brine to reach the aquifer. As a result, the salt plume to the south of the pit will expand rapidly. Without corrective action, a breakthrough of the Sivka River cannot be avoided.

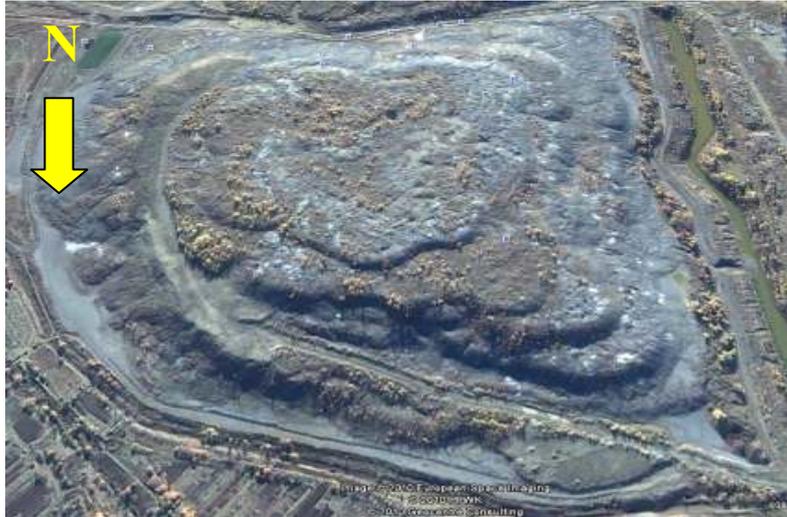
The Mine Waste Dump No. 1 (see Figure 9) has a round to square shape and the approximate dimensions of 0.75x0.75 km². With its top at 340 to 345 m in elevation, the dump rises 40 to 50 m above the surrounding landscape. The dump has not been rehabilitated, but some natural revegetation has occurred, as seen in the photo. Overall, the dump's slopes are steep. This, together with the lack of cover and vegetation, has led to severe erosion. On the dump's north, west and east sides, erosion has led to extensive spreading of sediments, which has filled the surrounding drains. The accumulation of sediments has led to surges of sediments out on the flats on the east side of the dump. On the west side it has led to gullies and erosion, breaking through the embankment between the outer and inner perimeter drain.

Figure 9: Mine Waste Dump No. 1

The general lack of rehabilitation, sediment control structures and maintenance, together with the unstable slopes of Mine Waste Dump No. 1, have led to erosion, filling up of drains and uncontrolled run-off (containing brines) into surrounding waterways and into the Dombrovski Open-Cast Mine. The waste dumps are also a major, if not the major source of brine polluting the groundwater aquifer in the direction of the River Limnitsya.

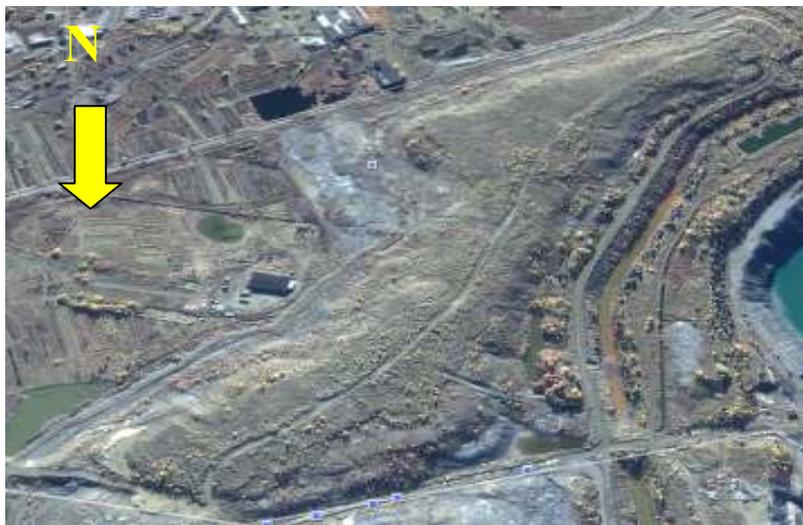
The Mine Waste Dump No. 4 (see Figure 10) has an elongated shape, stretching 1.2 km, and is 0.2 to 0.5 km wide. The top of the dump, which is 320 to 325 m in elevation, is relatively flat and to a large extent has been rehabilitated with cover material and vegetation. The dump rises 20 to 25 m over the surrounding landscape. On the east slope of the dump, erosion processes are active, which has led to the spreading of brines and fine material (silt and clay) into the surrounding drain. As seen in the photo, the drainage on the east side is covered by sediments.

Figure 10: Mine Waste Dump No. 4

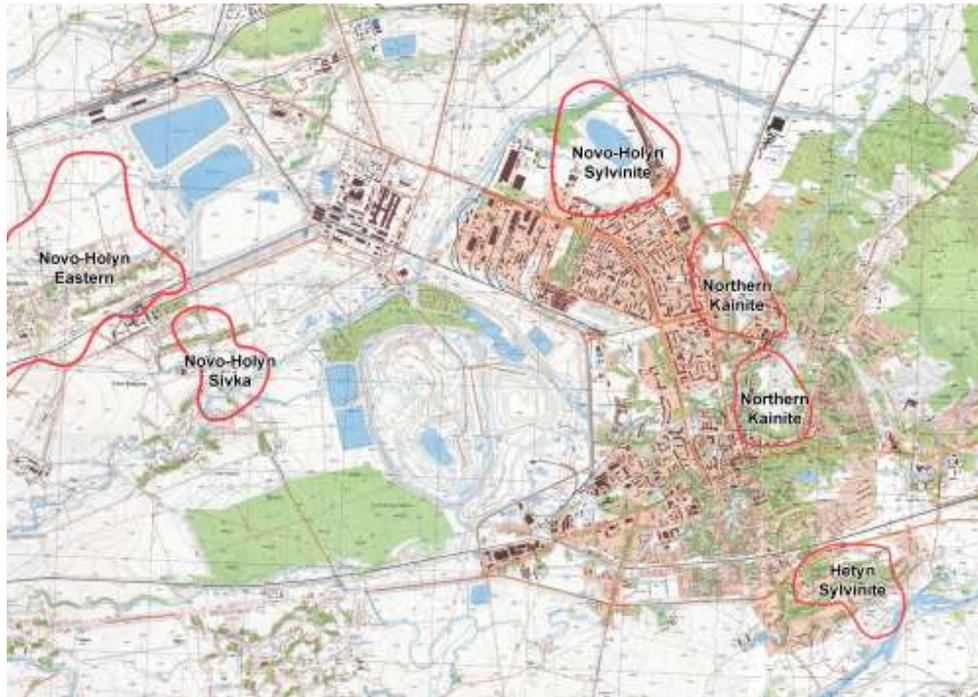
Figure 11: Areas of subsidence at the mine fields

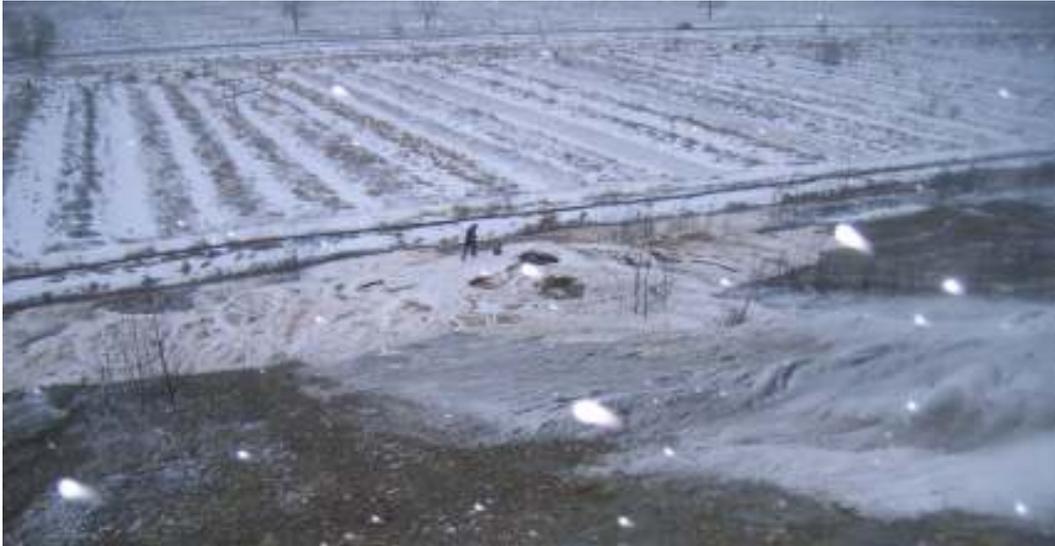
Figure 12: Salt fan at the embankment of the south-east side of Tailings Dam No. 1

The conditions of seepage from the surface are accelerated by extensive erosion of waste dumps and the fronts of the dam embankments. Only the vegetated parts with low inclination on Tailings Dam No. 1 and Waste Dump No. 4 are not subject to erosion. On Mine Waste Dump No. 1 and along the embankment of Tailings Dam No. 1, erosion gullies several metres in width and depth can be observed (see Figure 13, showing surface discharge or brines on the east side of Waste Dump No. 1, flowing to the open-mine pit). Lack of vegetation and steep slopes have contributed to the formation of gullies and increased the potential for internal erosion within the dump mass. The erosion increases instability of the waste dump and dam embankments by creating preferential paths for water undercutting some slopes and generally washing material away.

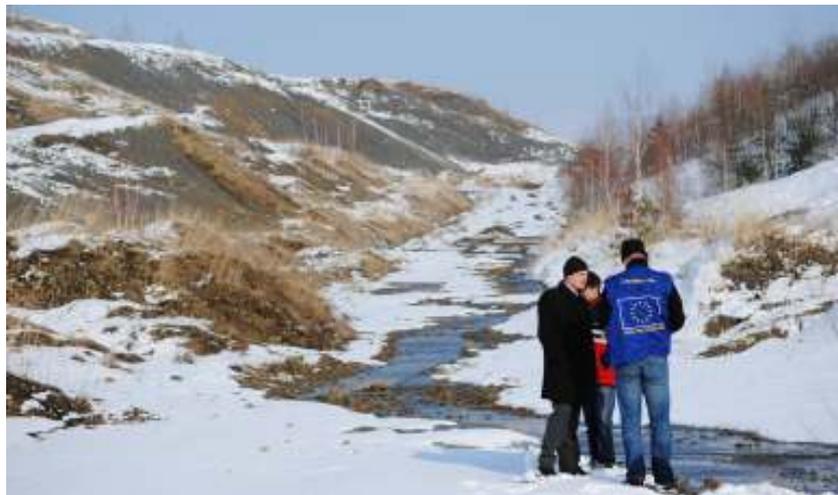
Figure 13: Surface discharge or brines on the east side of Waste Dump No. 1

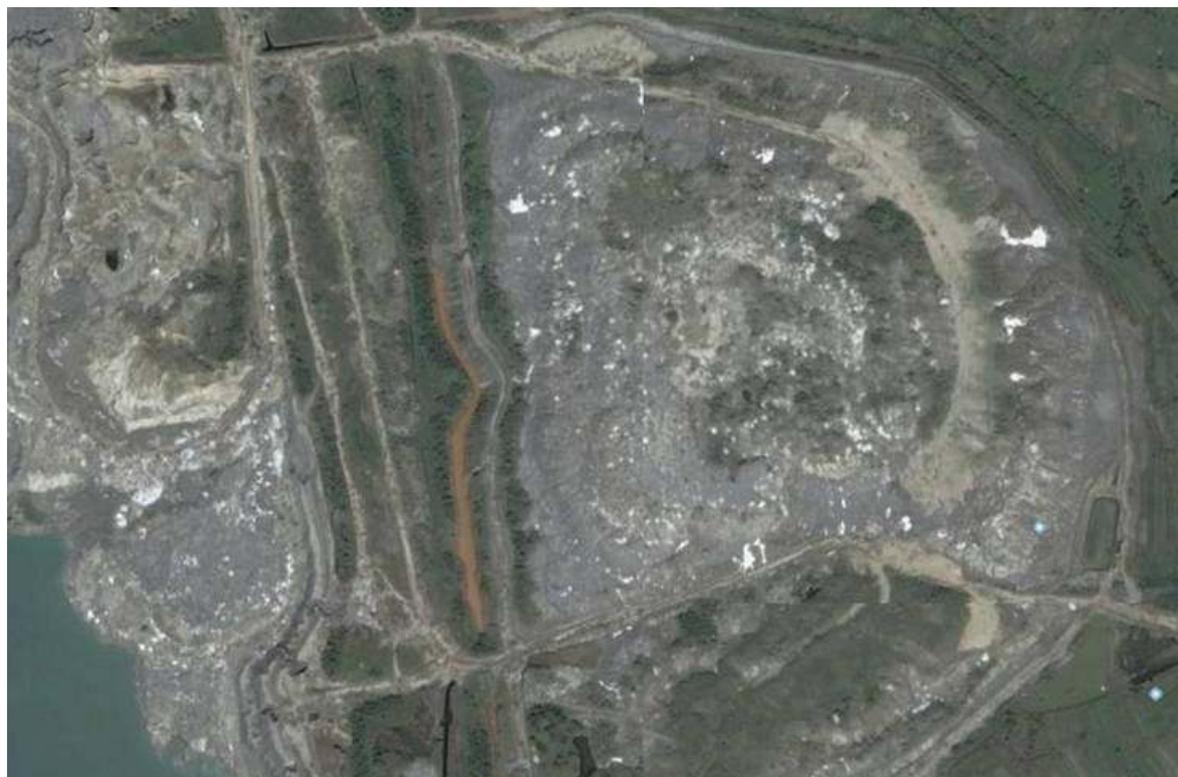
Figure 14: Mine Waste Dump No. 1 and dumps closer to the mine pit

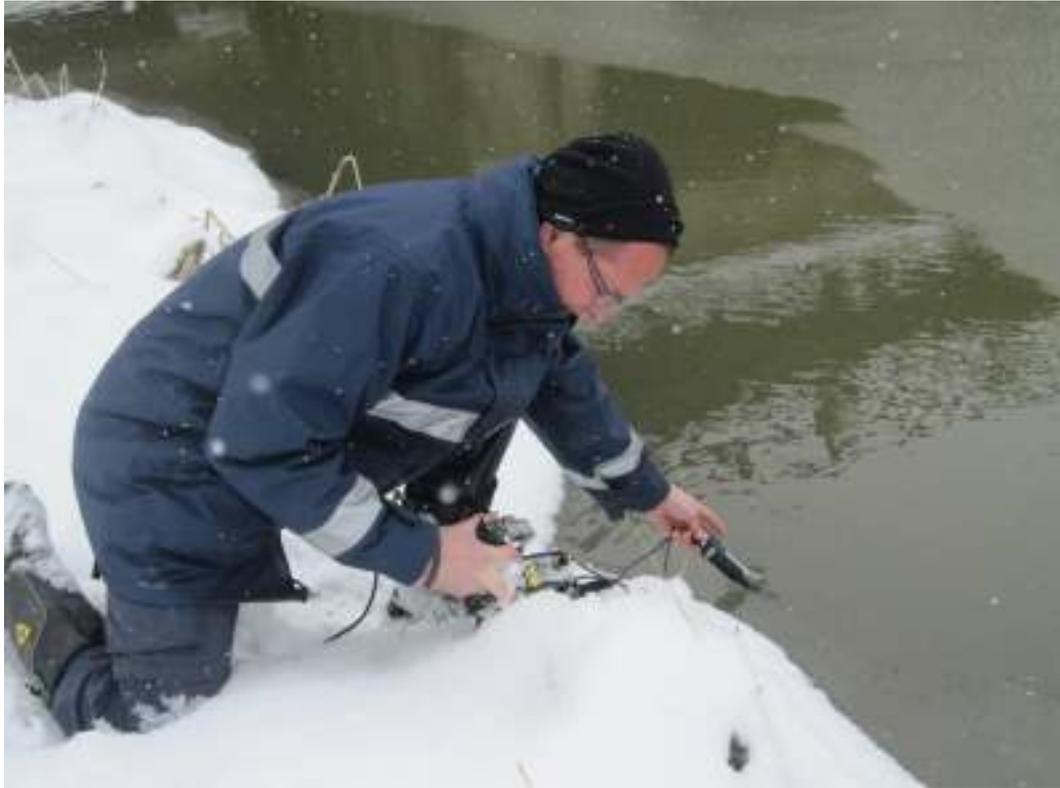
Figure 21: Pollution investigations near Mine Waste Dump Sites No. 1 and 4

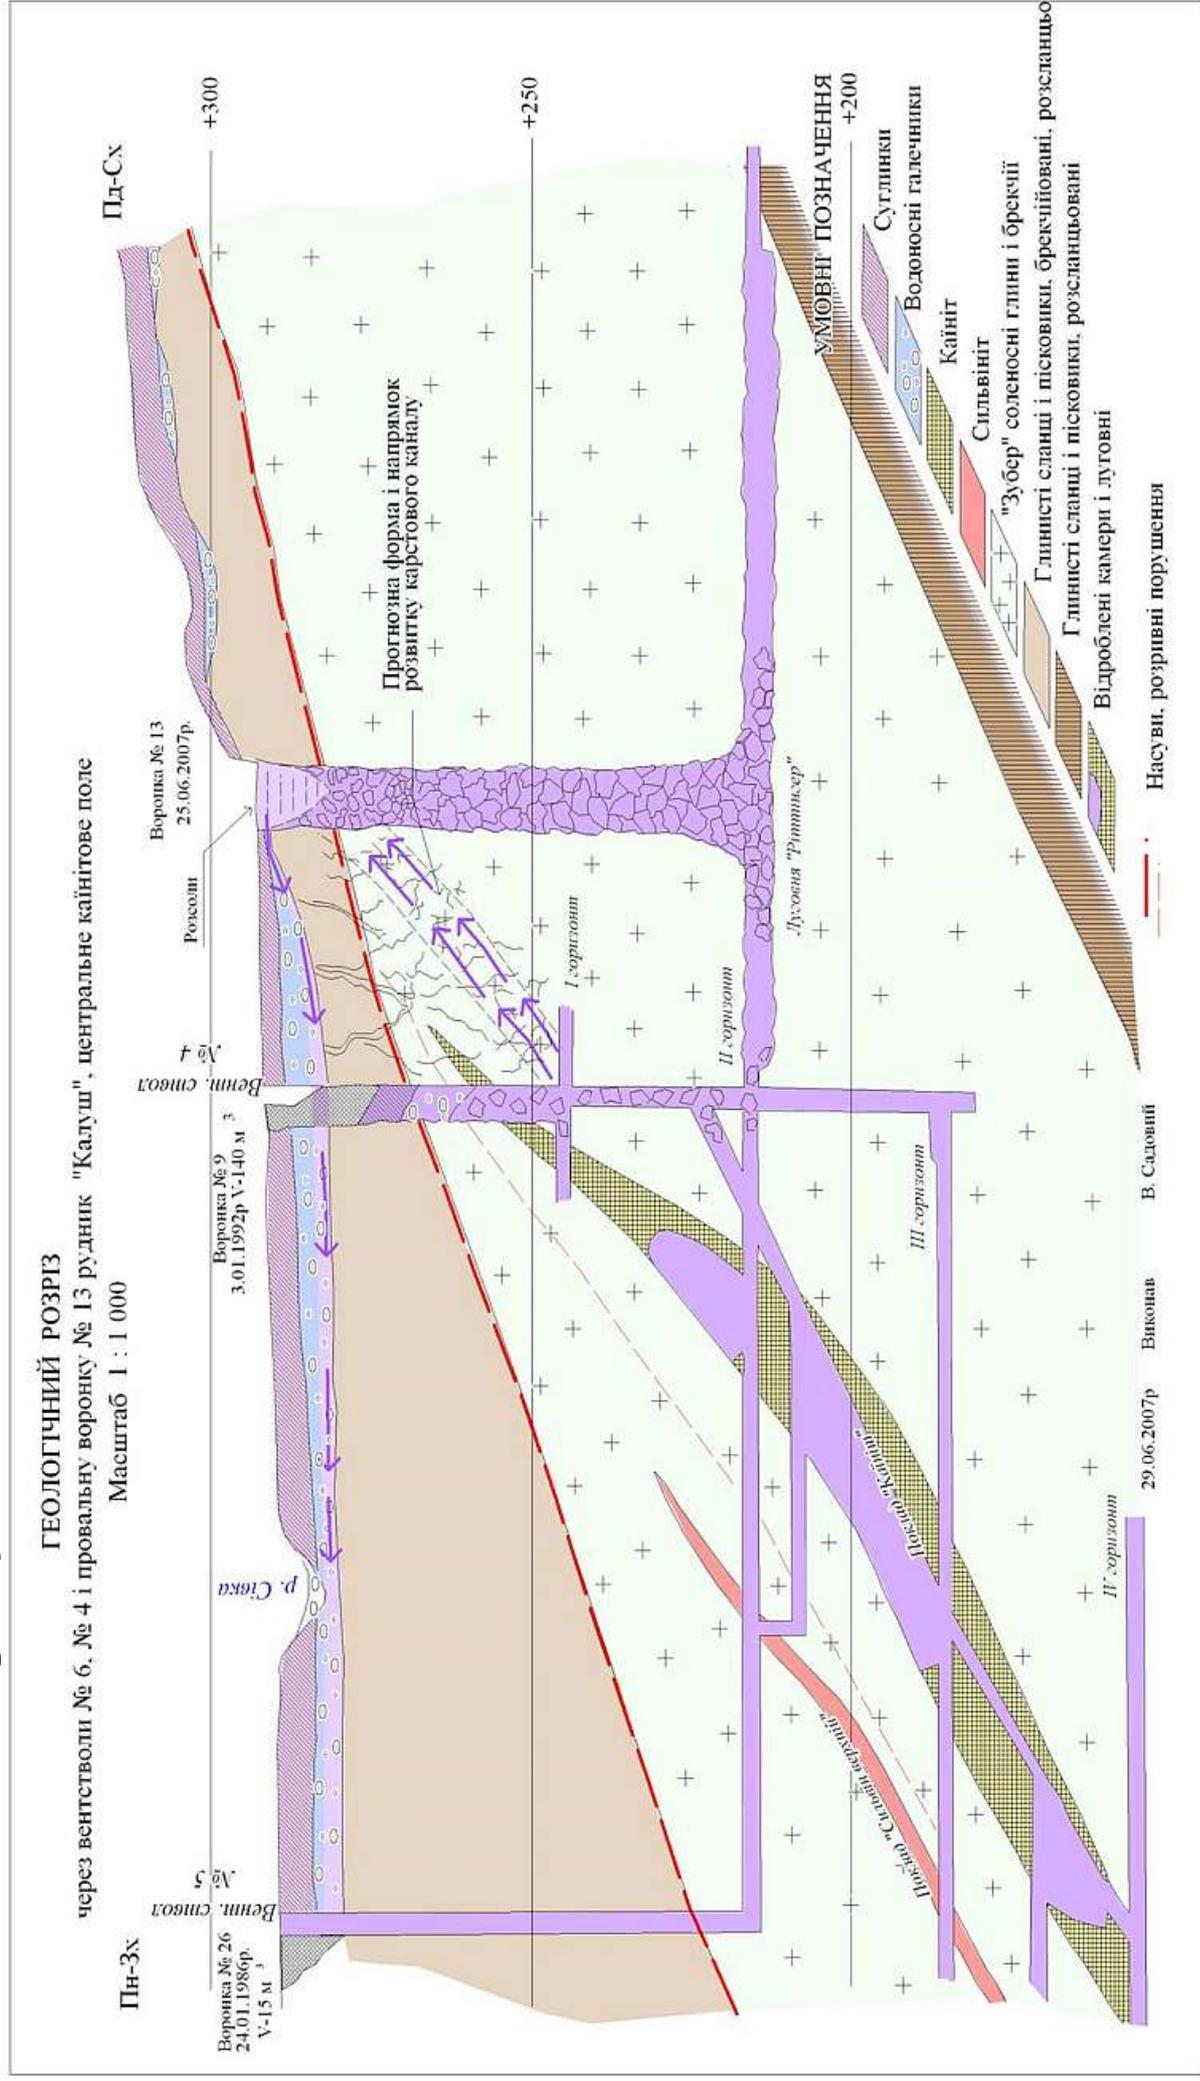
Annex VII: Geological profile of the Kalush Mine, Central Kainite field

Geological profile through the shafts No. 6, No. 4 and sinkhole No. 13 of the Kalush Mine, Central Kainite field. The arrows show the flow of salinized groundwater from the shafts to the water-bearing strata and the River Sivka. The pathways of the groundwater flow are due to fracturing and karstification around the shafts and sinkholes.
