Oil Spill in Estancia
Iloilo Province, Western Visayas, Philippines
Resulting from Typhoon Haiyan (Yolanda)
8 November 2013

Joint Assessment Report

30 November 2013

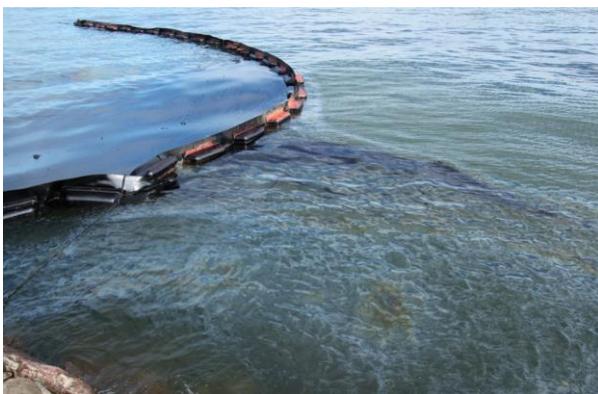
Some containment booms had been installed to contain the oil on the sea surface, but as of 21 November, these booms were insufficient to contain the amount of free phase oil present. Also, twisting was observed in several cases, which lead to leaking. On 22 November some additional booms from two other power barges were installed south of the already installed containment.

Figure 1: Leaking oil due to insufficiently installed booms, 21 November (Photo: Dennis Bruhn, UNDAC)

- All efforts must be taken to stop the leaking from the source (barge).
- Determine the remaining volume of bunker residing in each tank of the power barge and arrange for a method of transfer and storage of the remaining product.

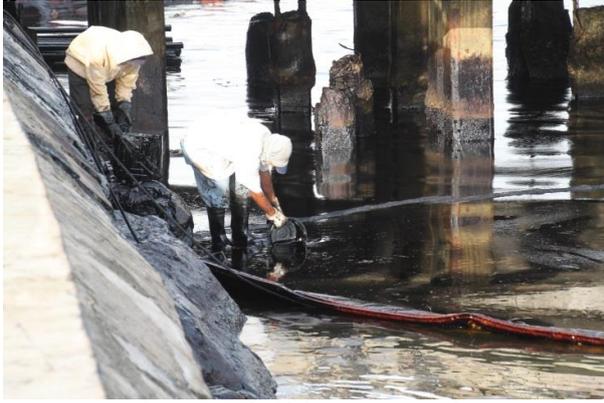
A specialist recovery, cleaning and salvage operator has been contracted to manage the situation (Kuan Yu Global Technologies Inc.) and staff from this company were observed to have arrived on-site on the 23rd November 2013, but were not available for interviews. Manual recovery of oil from the water inside the booms has been organised by NAPOCOR and their salvage contractors. According to the manager it is difficult to get sufficient booms capacity. Contaminated debris from the shoreline is being gathered and crudely bagged.

Figure 2 Manual recovery of oil (Photo: Dennis Bruhn, UNDAC)

- Of most concern is the manual recovery of oil from open water which should be stopped immediately.
- People who are working on the clean-up of an oil spill should be given appropriate training and personal protective equipment such as disposable nitrile gloves (to be worn under work gloves), protective suits, rubber boots and goggles. Respiratory protection with a P100 particulate filtering face piece respirator should be provided if there is a risk of inhalation of aerosolized oil mist e.g. through the use of pressure hoses¹⁴.

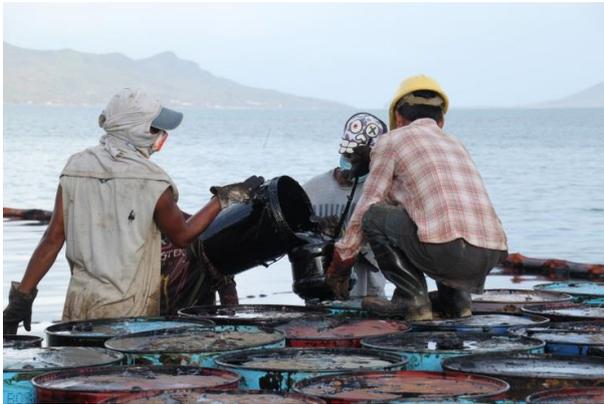
Figure 3 Manual recovery of free phase oil (Photo: Dennis Bruhn, UNDAC)

On 22 November clean-up of free phase oil on the water table was on-going. The work was being carried out by hand without use of sufficient Personal Protective Equipment (PPE) posing a significant health risk to the workers. No attempts are being made to empty the affected tanks or seal the leaks. No specialist control or recovery equipment is present at the site (apart from floating booms). There is a basic level of security around the port area in which the vessel is moored and its immediate shoreline (200-300 metres); the contamination of water and shoreline outside of this area is not as severe, but present, and these areas are readily accessible to the public.

The greatest immediate concern has to be with the manual recovery of oil from the open water that is currently taking place. The amounts of oil that can be recovered by these means is minimal, the hazard avoided is consequently of little benefit, and the risks involved to the workforce is considerable.

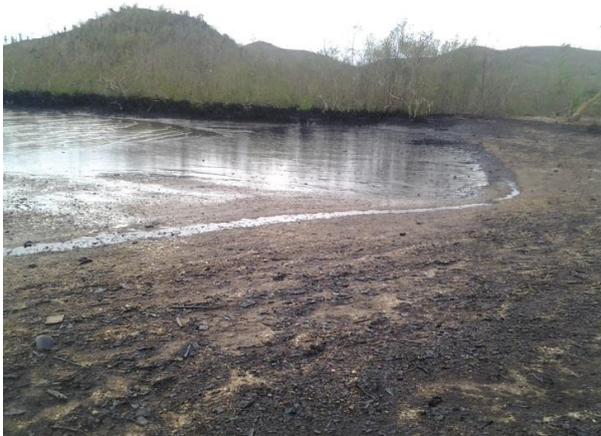
On 22 November the joint team assessed the bay in Embarcadero, Batad, which showed clear signs of severe free phase oil contamination of the bay and mangroves.

Figure 4 Oil contamination in Embarcadero, Batad
(Photo: Dennis Bruhn, UNDAC)

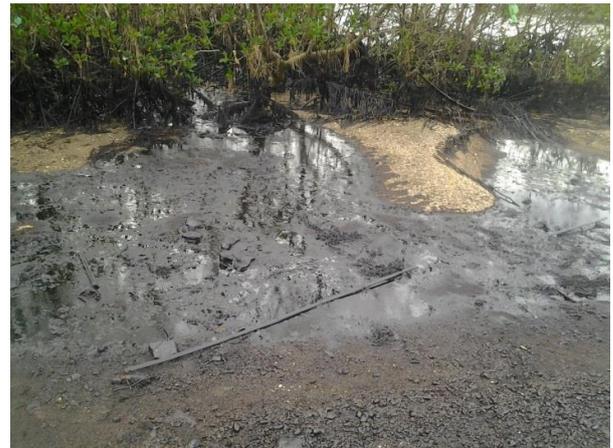
Figure 5 Oil contamination in Embarcadero, Batad
(Photo: Dennis Bruhn, UNDAC)

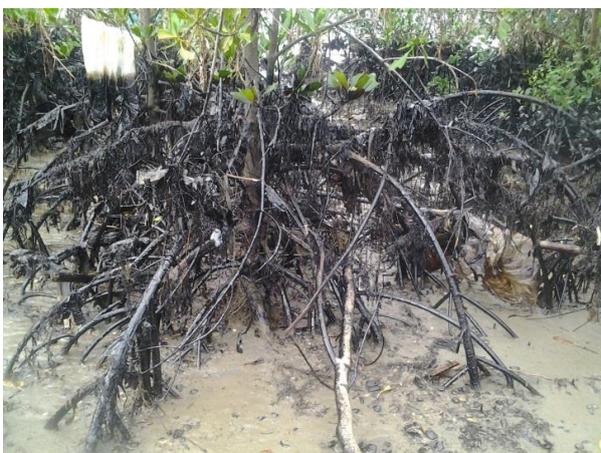
The assessment showed a widespread oil contamination of the mangroves along the coast and riversides. According to the local fisherman the area covered with free phase oil increased during the night of 21 November.

Figure 6 Contaminated mangroves
(Photo: Dennis Bruhn, UNDAC)

During high tide the oil will spread and infiltrate the root system of the mangroves. Not only will this process destroy the existing mangroves but will also be a source of continuous contamination of the waters in the future. In turn, this will affect the livelihood of the people depending on fishing in these waters. In addition, the presence of free phase oil and wash-up of oil on the shore may pose a health risk to people in the area especially in case of direct contact.

- Prioritise the assessment results according to environmental sensitivity and resources at risk.
- Begin efforts to try and flush bunker oil from the roots of impacted mangroves. Do not use chemicals. The use of chemical agents can further damage the root system of the mangroves.

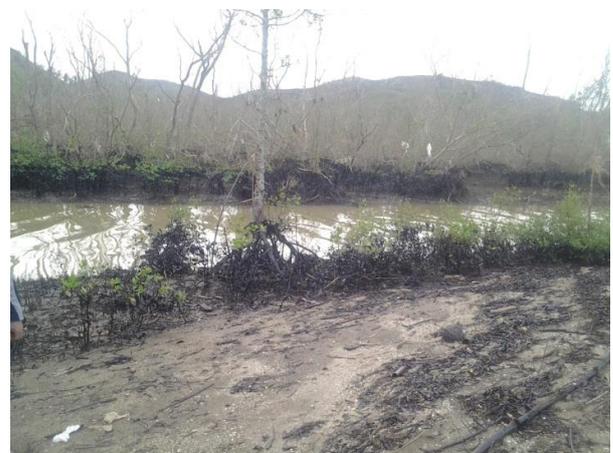
Figure 7 Oil contamination along riversides
(Photo: Dennis Bruhn, UNDAC)
