Lead Pollution and Poisoning Crisis

Environmental Emergency Response Mission

Zamfara State, Nigeria

September/October 2010

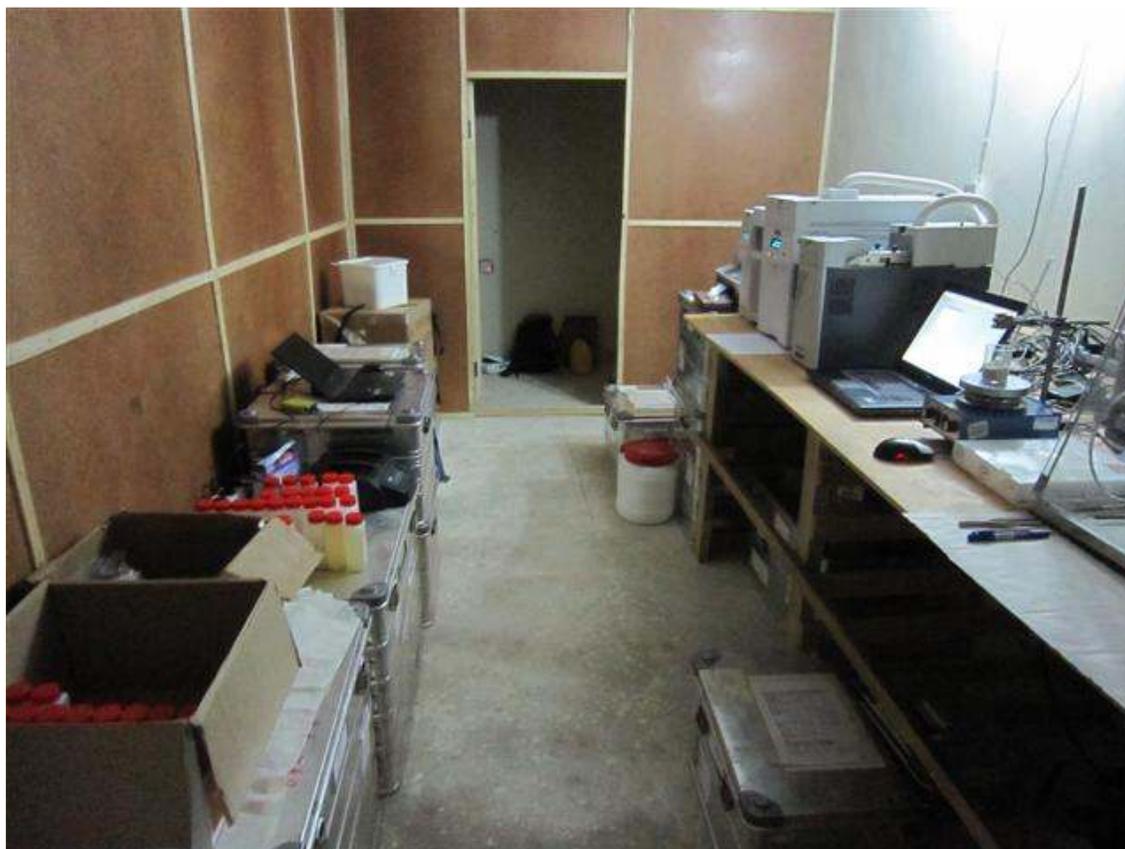
Figure II: The mission was supported by the Government of the Netherlands which provided four technical experts and equipment from the Environmental Assessment Module (EAM), a mobile laboratory designed and assembled specifically for international deployment. The above photo displays part of the EAM at the team's base in Anka village.

The mission was supported by the Government of the Netherlands with four technical experts and equipment from the Environmental Assessment Module (EAM), a mobile laboratory designed and assembled specifically for international deployment. Mapping support was provided by UNOSAT, which is the Operational Satellite Applications Programme of the United Nations Institute for Training and Research (UNITAR).

The **Environmental Assessment Module (EAM)** is a fully equipped mobile laboratory that can be deployed together with a small flexible team of experts quickly after a disaster involving hazardous substances in countries that lack the specialist knowledge or capacity needed to deal with environmental disasters. The module is equipped with technology for taking samples, performing environmental measurements and analyses and for communication and navigation purposes. With the equipment and personnel expertise, the EAM team can identify a large number of chemical substances in polluted material, and advise on the nature of the pollution, and the threat it poses. The EAM is an initiative of the Government of the Netherlands, in particular the Ministry of Foreign Affairs (MinBuza) and the Ministry of Infrastructure and the Environment (IenM). The aim of this initiative is to support international humanitarian missions, with a focus on health and the environment. The EAM is accommodated by the Dutch National Institute for Public Health and the Environment (RIVM).

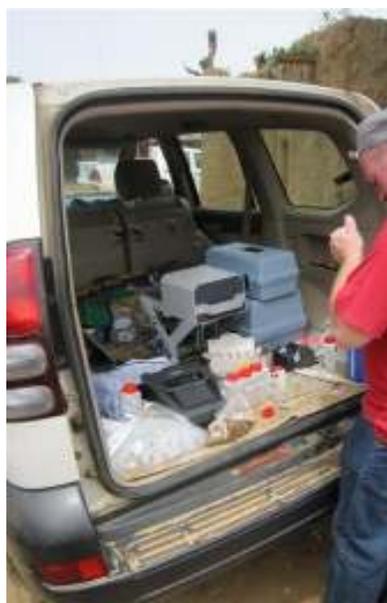
Figure III: The Gas Chromatography-Mass Spectrometry apparatus (GC-MS) used for the detection of lead in water.

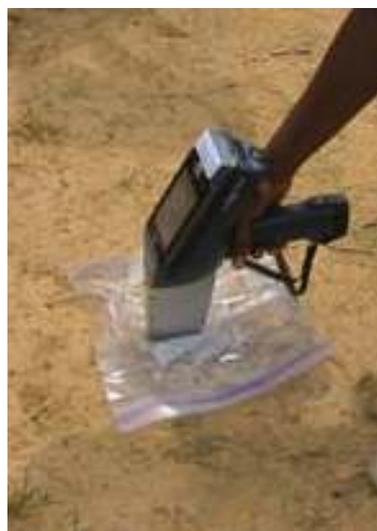
Figure IV: The X-Ray Fluorescence analyser (XRF) used as a lead screening device. The XRF gave an indication of the lead content in top soil and wet sediment.

The sediment samples could not be analysed with the lead water testing kit or Gas Chromatography-Mass Spectrometry apparatus (GC-MS), and were measured with a hand-held X-Ray Fluorescence (XRF) analyser instead. In addition, the lead concentration of the top soil (maximum 5 cm) was also measured with this hand-held XRF analyser at several sample locations (e.g. near wells). These XRF measurements of the soil were performed in collaboration with Blacksmith/TerraGraphics. The XRF analyser is a screening device and gives only an indication of the lead content in top soil and wet sediment. There are no WHO guidelines for lead concentration in soil and sediment. However, during prior screening of the soil with a hand-held XRF analyser, Blacksmith/TerraGraphics used the United States Environmental Protection Agency (US EPA) guidelines of 400 ppm in soil (dry) to indicate a potential health risk. In this report, the US EPA guideline will also be used to indicate the potential health risk of lead in soil and sediment. Please note that sediment samples were not dried before testing.

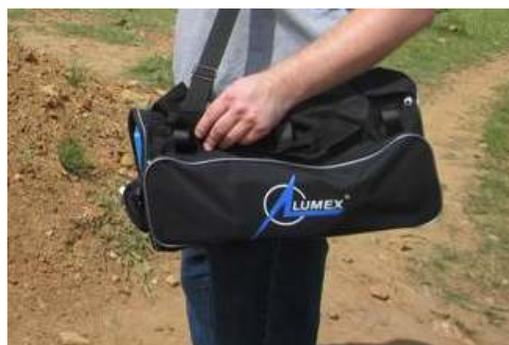
Figure V: The mercury analyser used to measure the presence of mercury in the air.

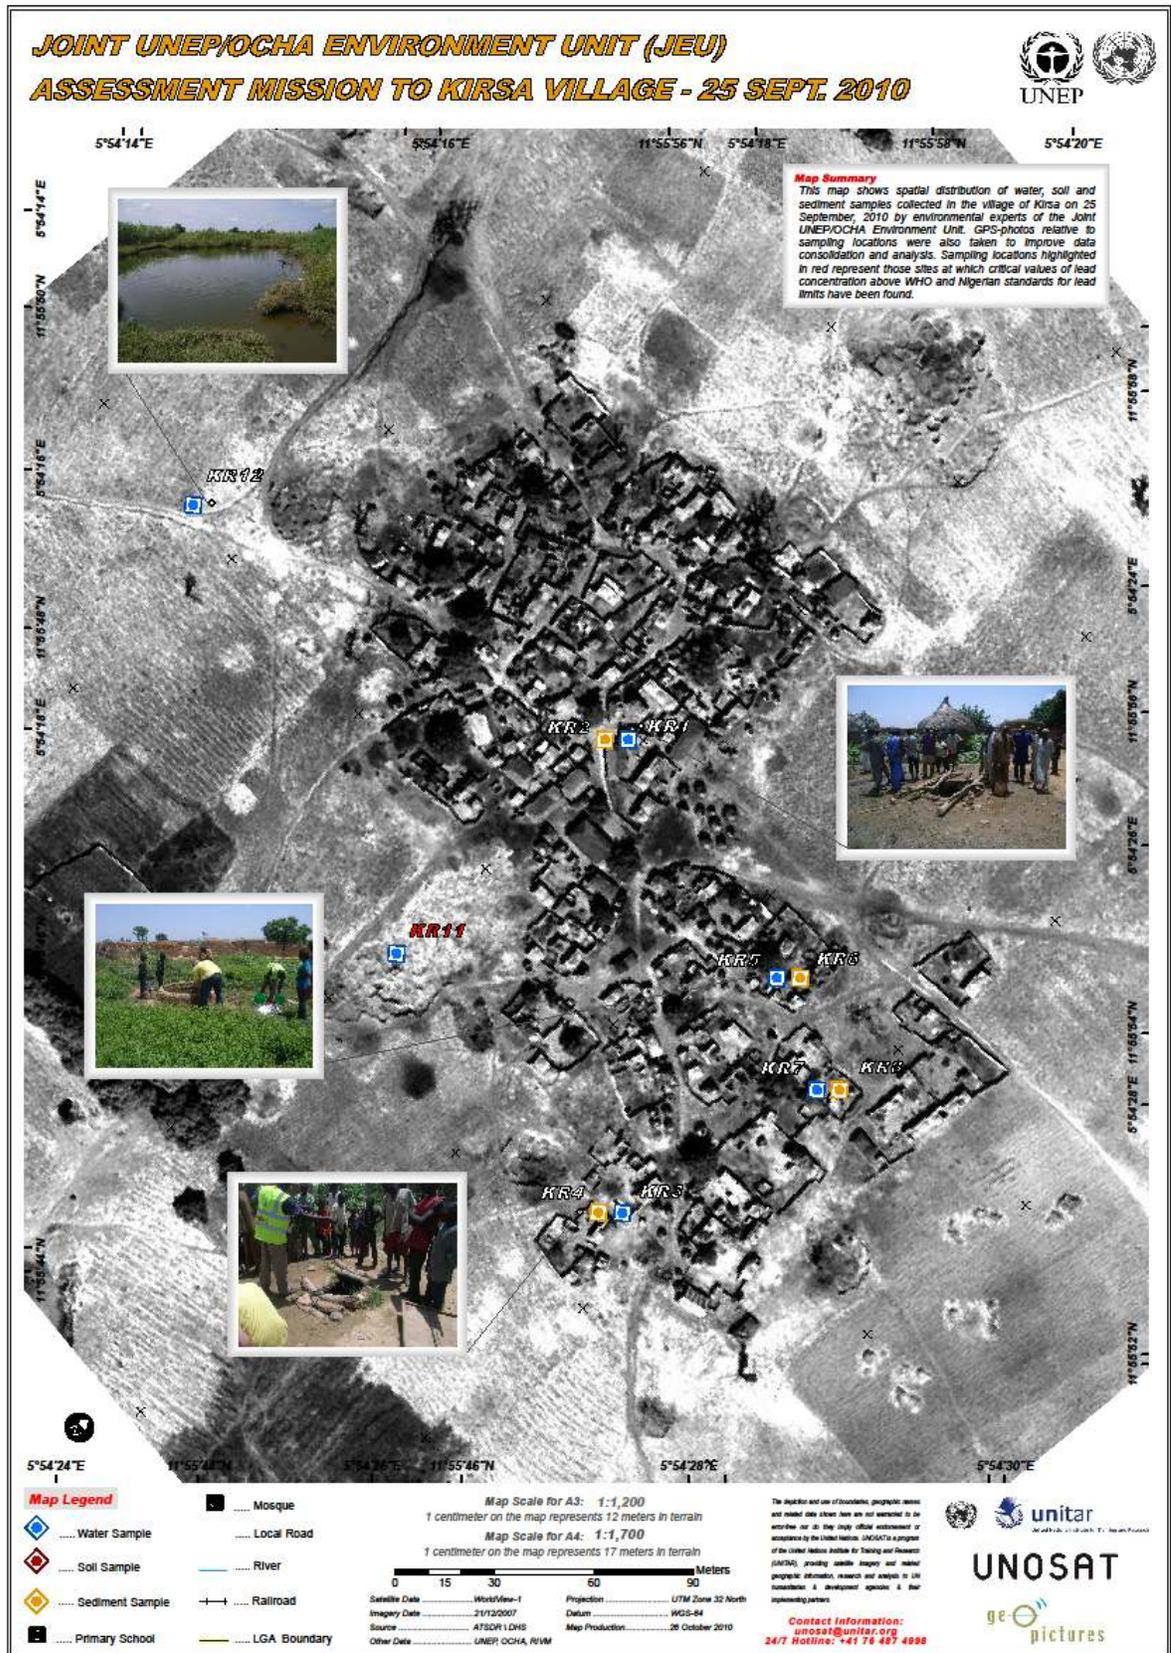
Map III: Kirsa village

Note: The Sample ID coordinates differ on Map III from the table and text below (e.g. KIR001 is cited on the map as KR1).

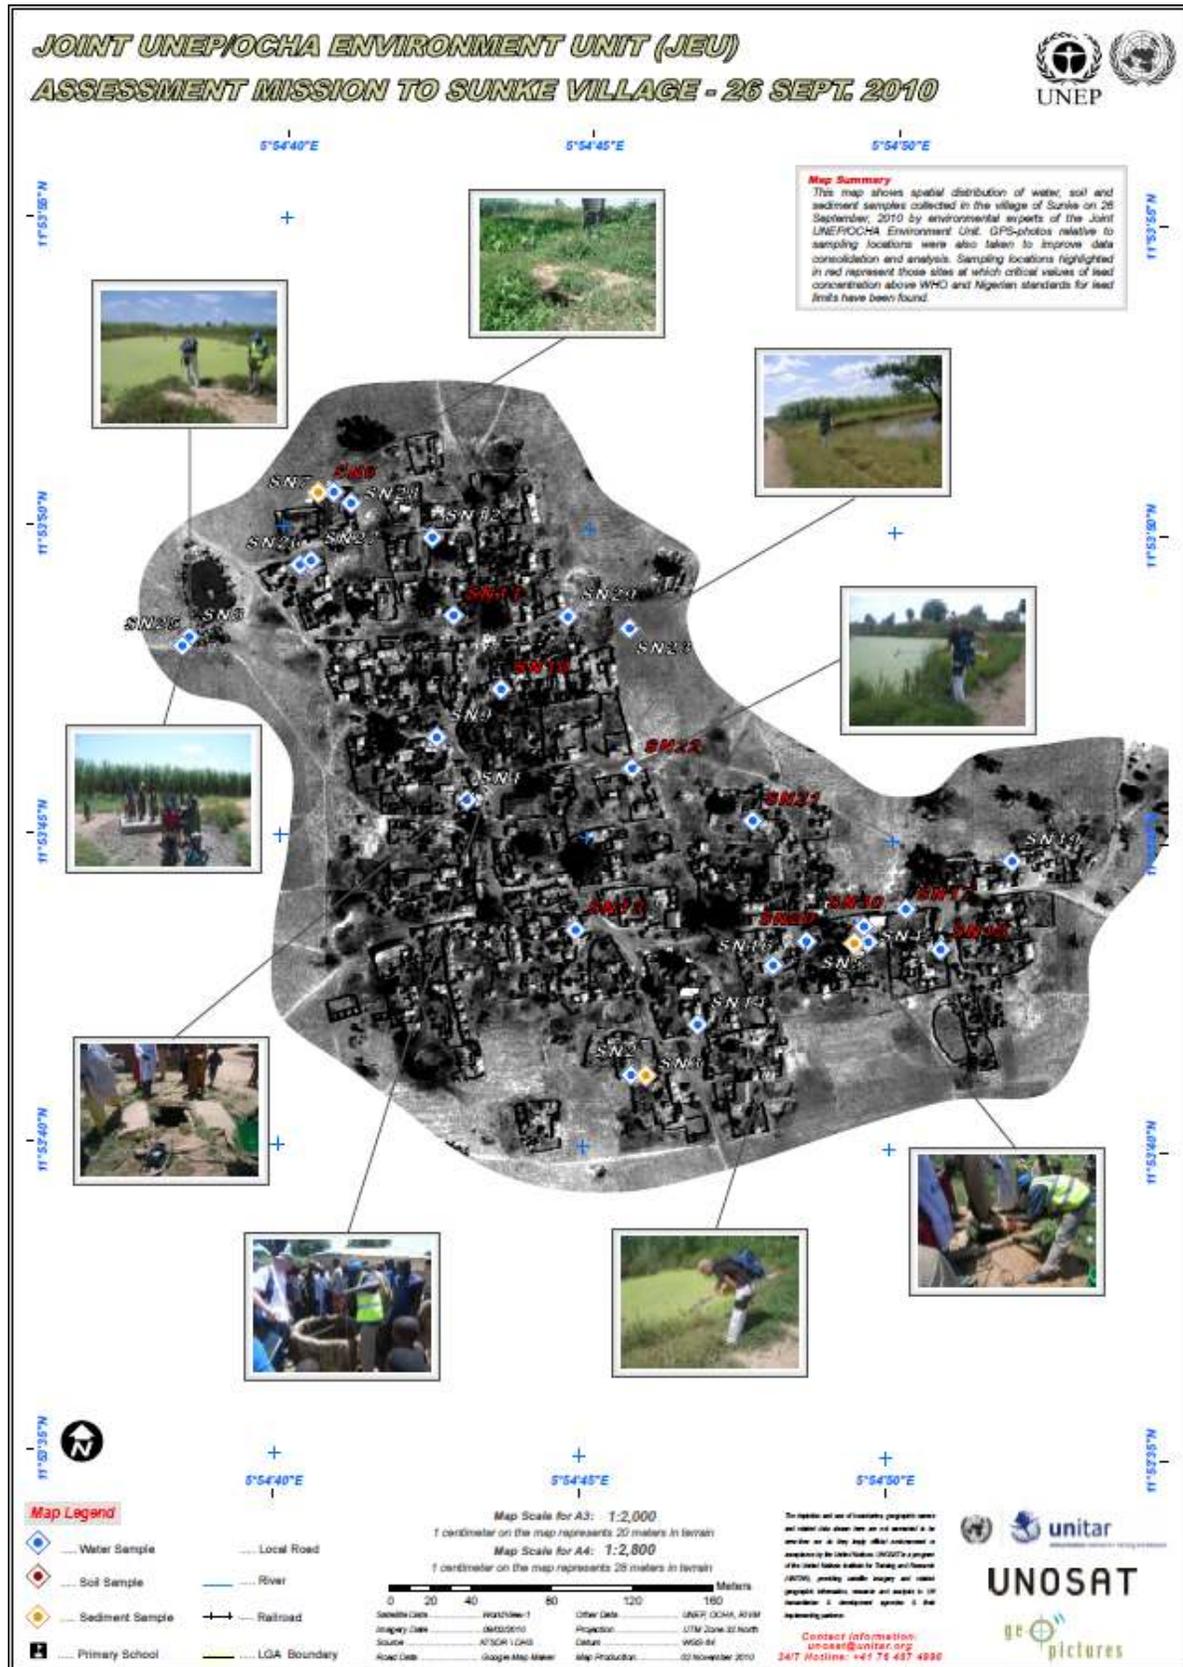
Map IV: Sunke village

Note: The Sample ID coordinates differ on Map IV from the table and text below (e.g. SUN001 is cited on the map as SN1).

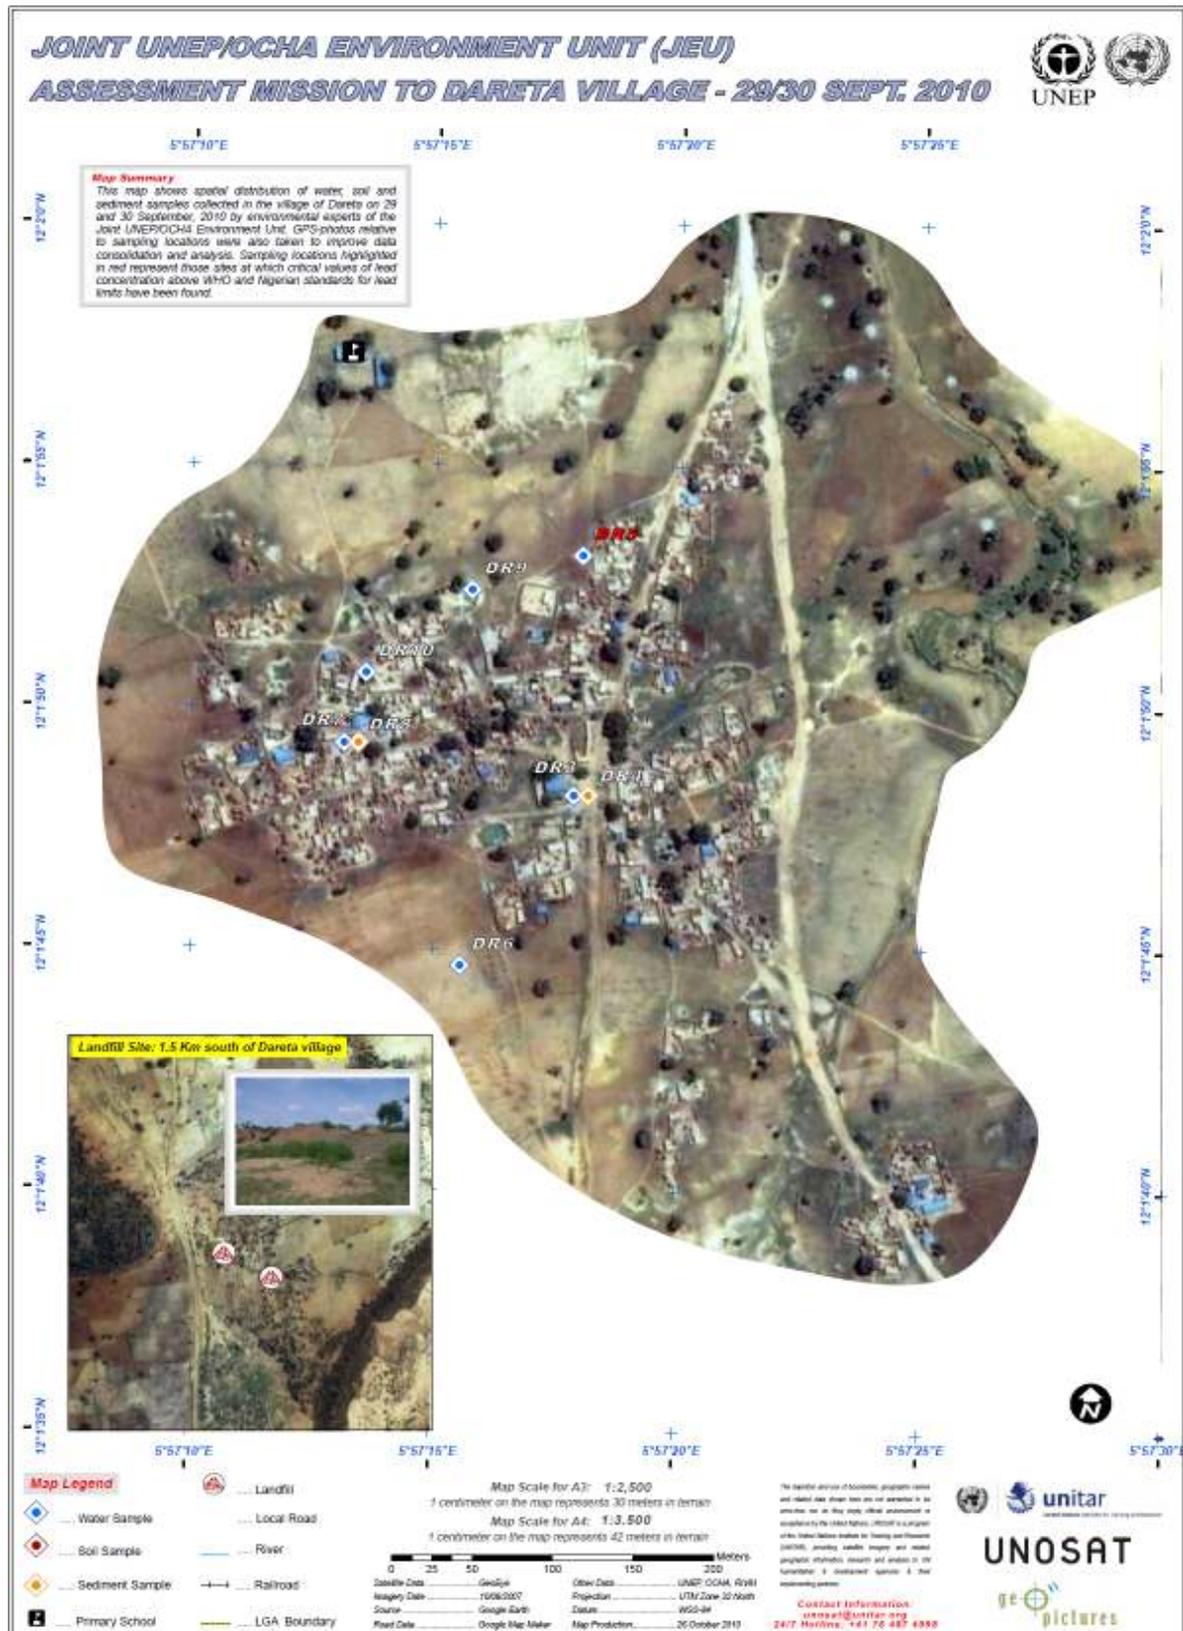
Map V: Daretta village

Note: The Sample ID coordinates differ on Map V from the table and text below (e.g. DAR001 is cited on the map as DR1).

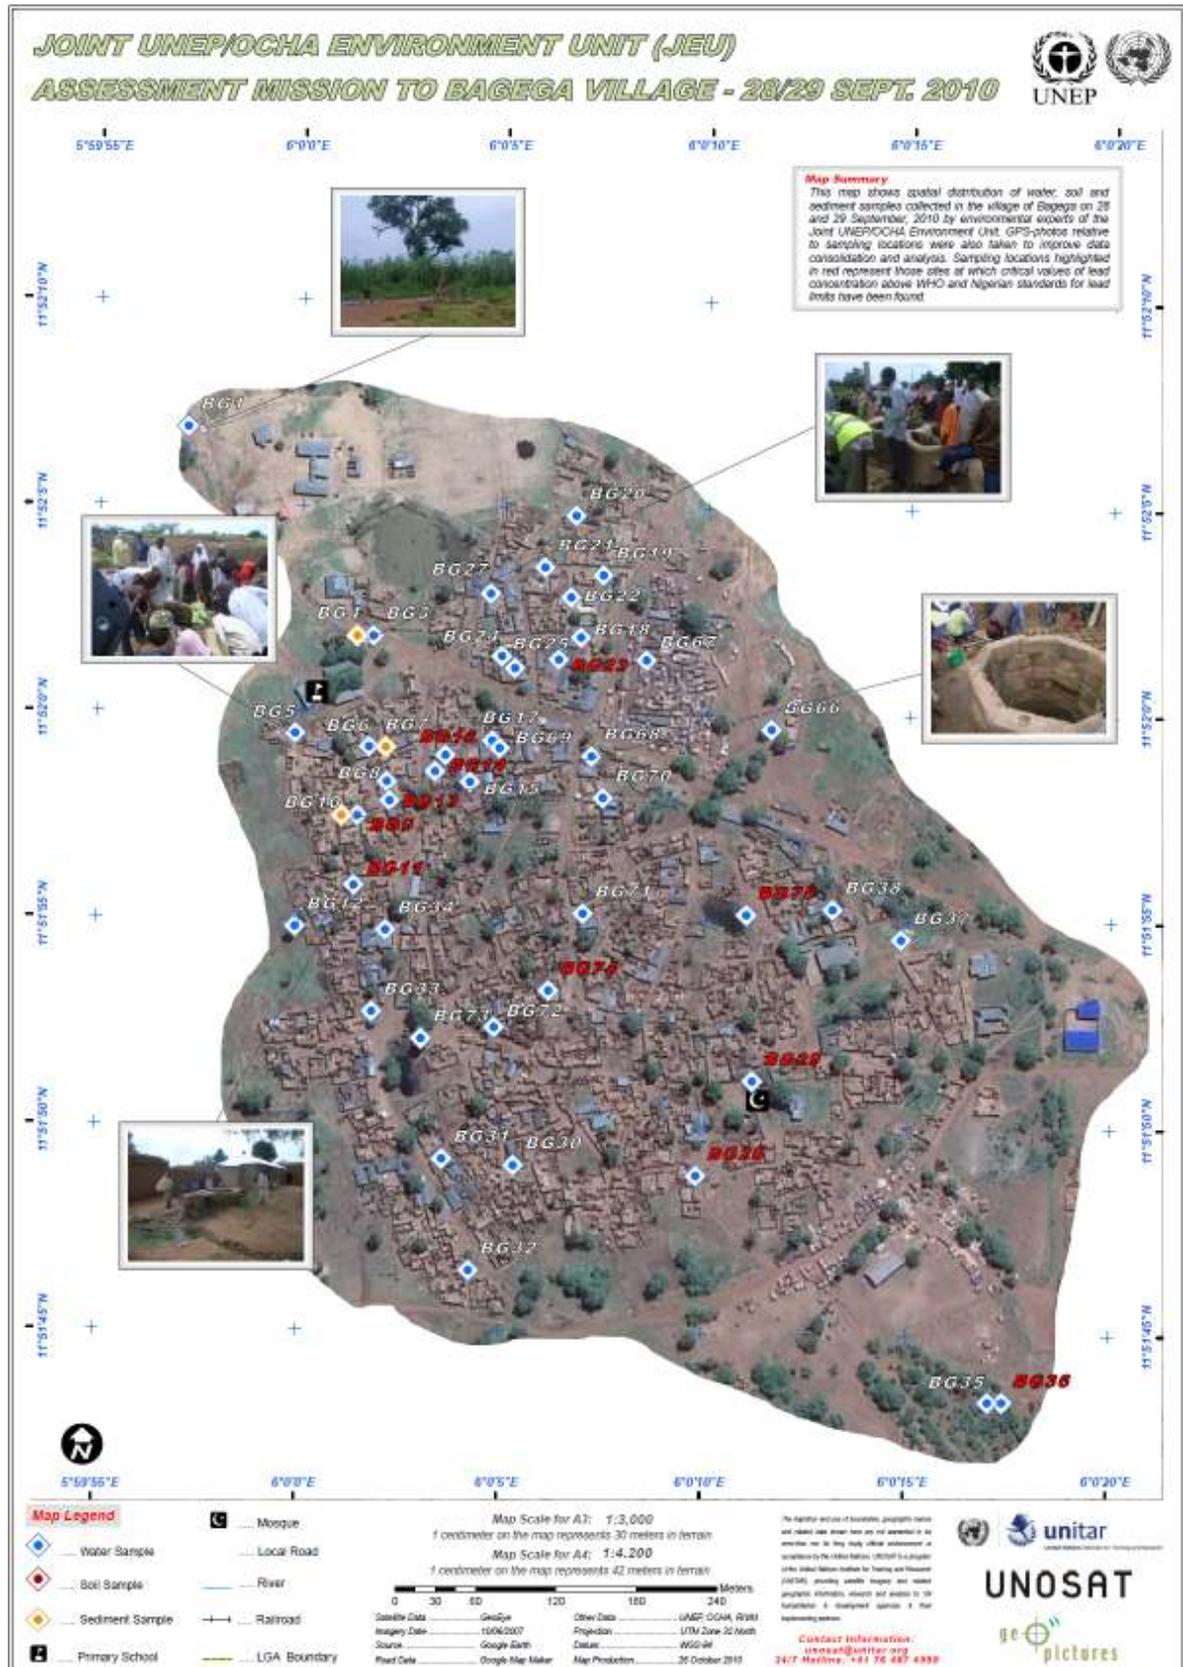
Map VI: Bagega village

Note: The Sample ID coordinates differ on Map VI from the table and text below (e.g. BAG001 is cited on the map as BG1).

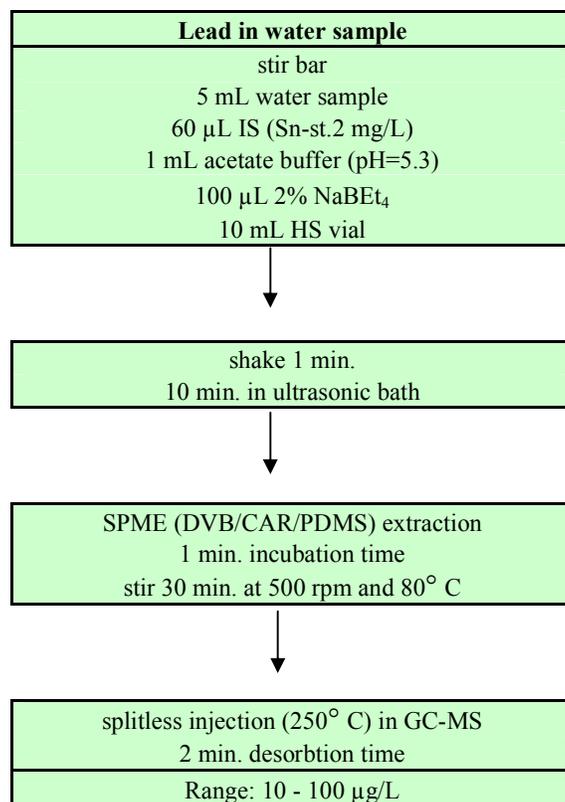
Figure VII: Schematic representation of lead detection in water with the GC-MS method.

Analyses were performed by adding a 4 millilitre (mL) water sample in a 10 mL headspace vial with a Teflon-coated stir bar (5 mm), 60 microlitre (µL) internal standard (2 mg/L tin solution), 1 mL acetate buffer (pH = 5.3). The sample vial was vigorously shaken and placed in an ultrasonic bath for 10 minutes. The vial was placed in a sand bath (100 mL glass beaker

with 50 mL quartz sand placed on a hot plate/stirrer) at 80 °C and stirring rate of 500 revolutions per minute (1 minute incubation time at 80° C). Headspace extraction with solid phase microextraction (SPME) (divinylbenzene/carboxen/polydimethylsiloxane (DVB/CAR/PDMS)) was performed for 15 minutes (see following schematic representation).

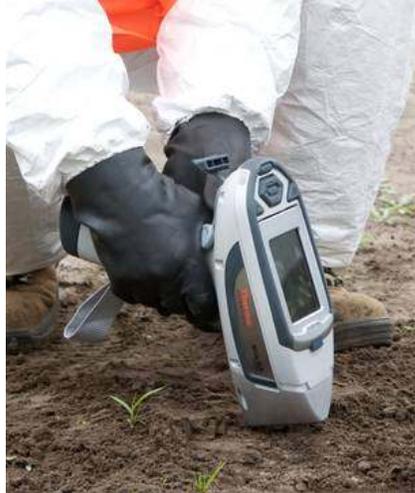
Figure VIII: Lead measurements were taken on location with the X-Ray Fluorescence analyser (XRF). The apparatus gives direct readings without taking samples.

The lowest detection limit in (dry) soil for lead is 50 ppm (= 50 mg lead/kg soil). When measuring with the instrument on the ground without any sample preparations, the measured sample might be wet. This might affect the lowest detection limit. Therefore, in this report, results below 100 ppm (100 mg lead/kg soil) are reported as < 100 mg/kg.
