# X-PRESS PEARL MARITIME DISASTER SRI LANKA

REPORT OF THE UN ENVIRONMENTAL ADVISORY MISSION

JULY 2021

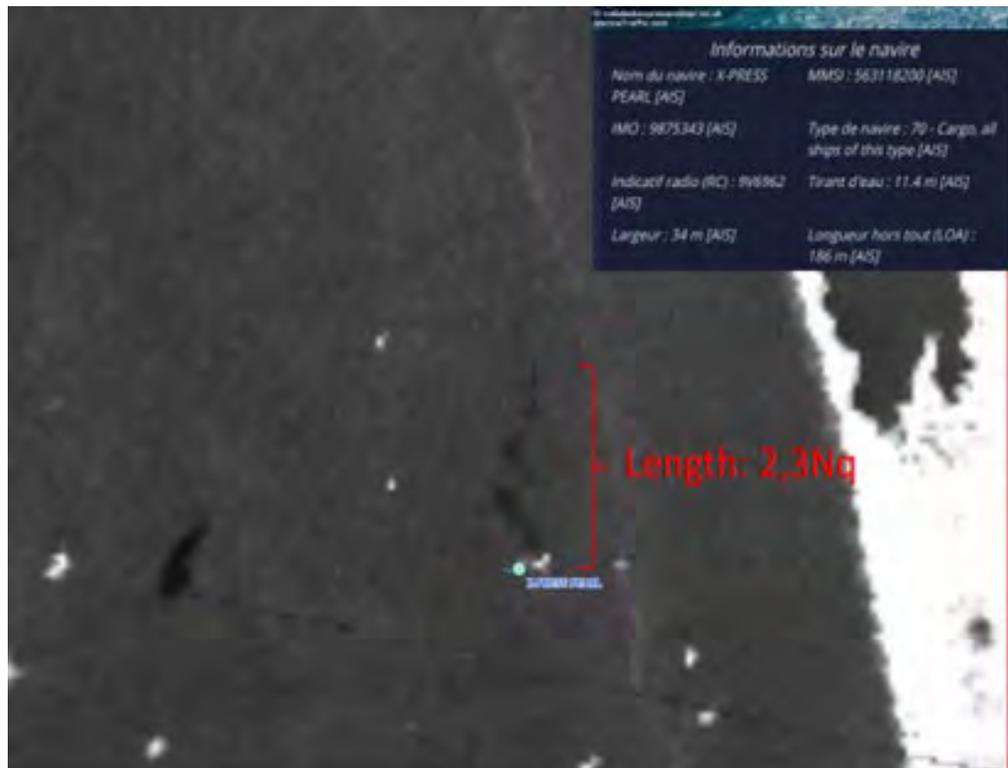
Figure 2.2: Sentinel 1 satellite image (2021-06-14 / 00H24 UTC) processed by CLS and highlighting extent of spill.

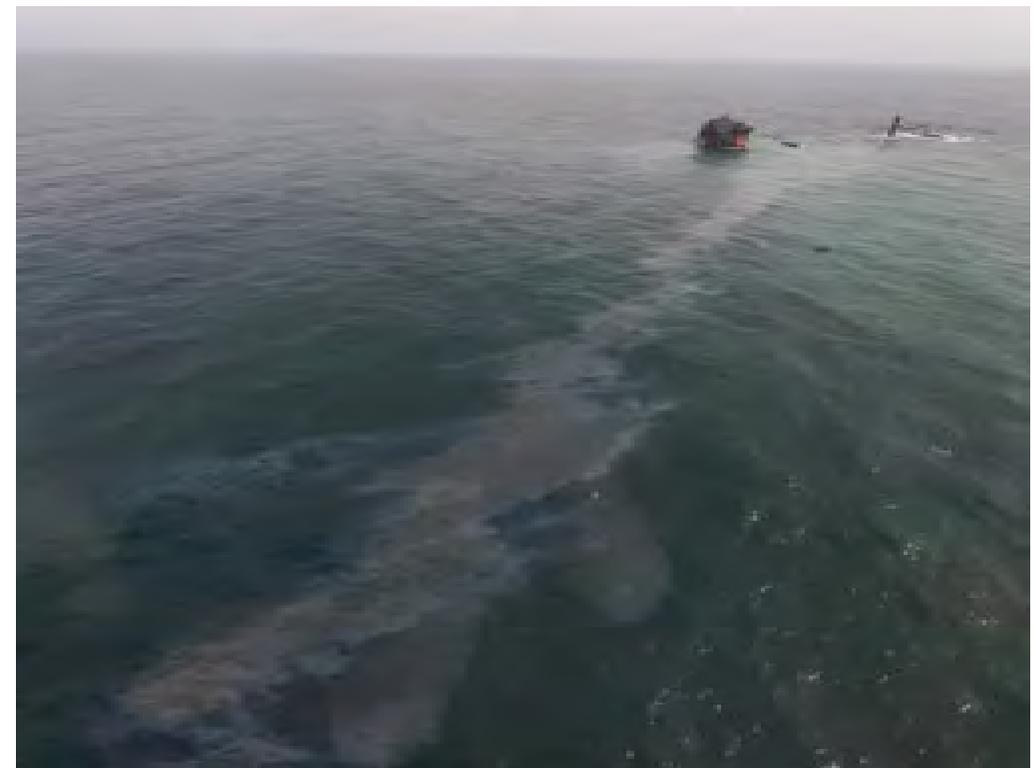
- A continuous release of oil is flowing from the ship for nearly one month (8 June – 4 July);
- Based on the Bonn Agreement Oil Appearance Code (BAOAC), the oil observed from the aerial survey on 20 June is classified as 'discontinuous true colour' (code 4) of 50-200 µm thickness, and in some segments 'continuous true oil colour' of over 200 µm thick (code 5). This situation should normally trigger deployment of oil spill response equipment;
- Furthermore a 'sheen' (code 1) of 0.04-0.3 µm thickness can be seen to be surrounding the main oil slick.

Figure 2.3: The slick originating from the wreck observed by helicopter (2021-06-20).

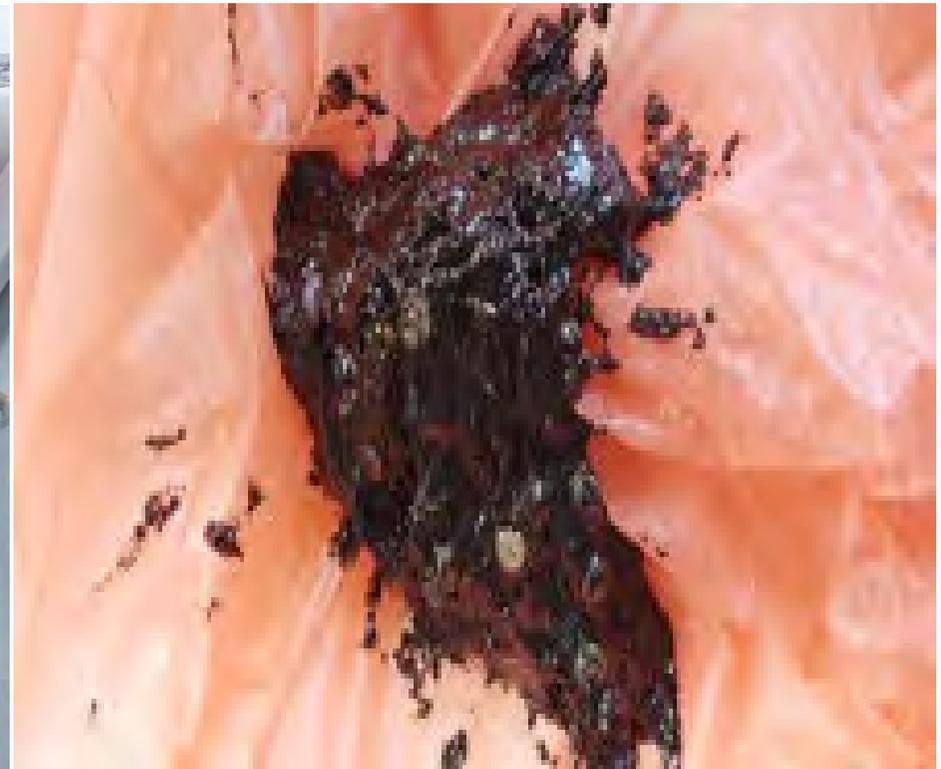
Figure 2.5: Sample of oil and pellets collected on 21 June 2021.

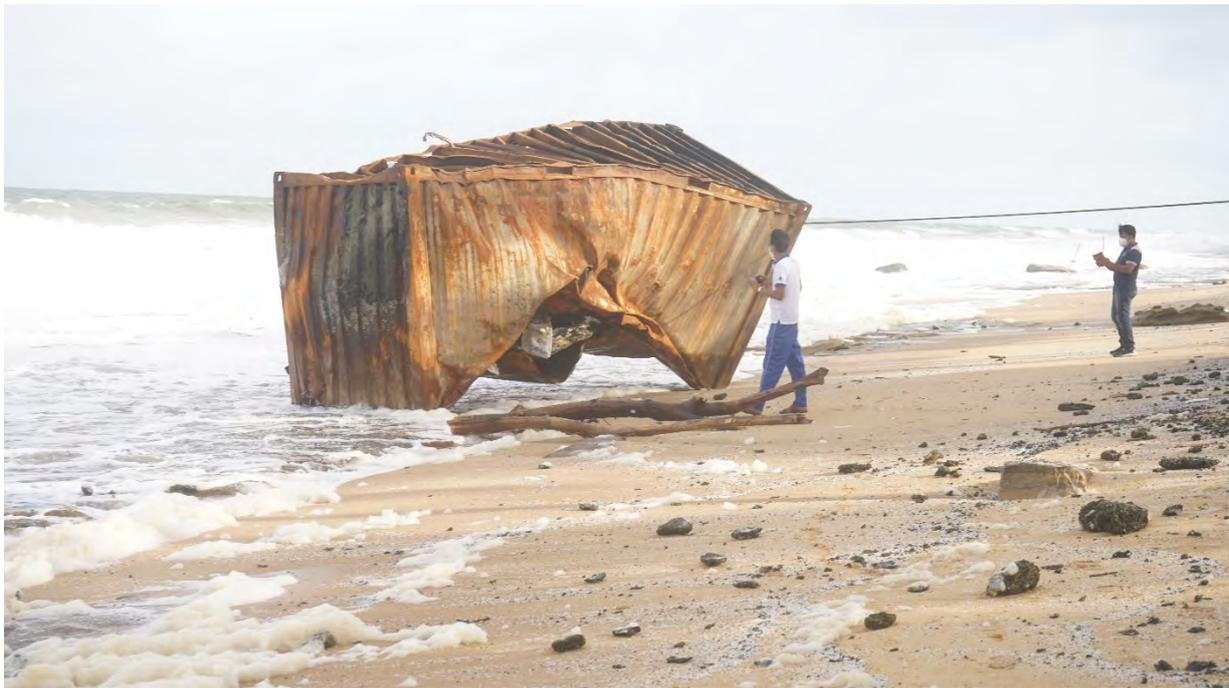
**Figure 2.7:** Damaged containers washed ashore (credit: MEPA)

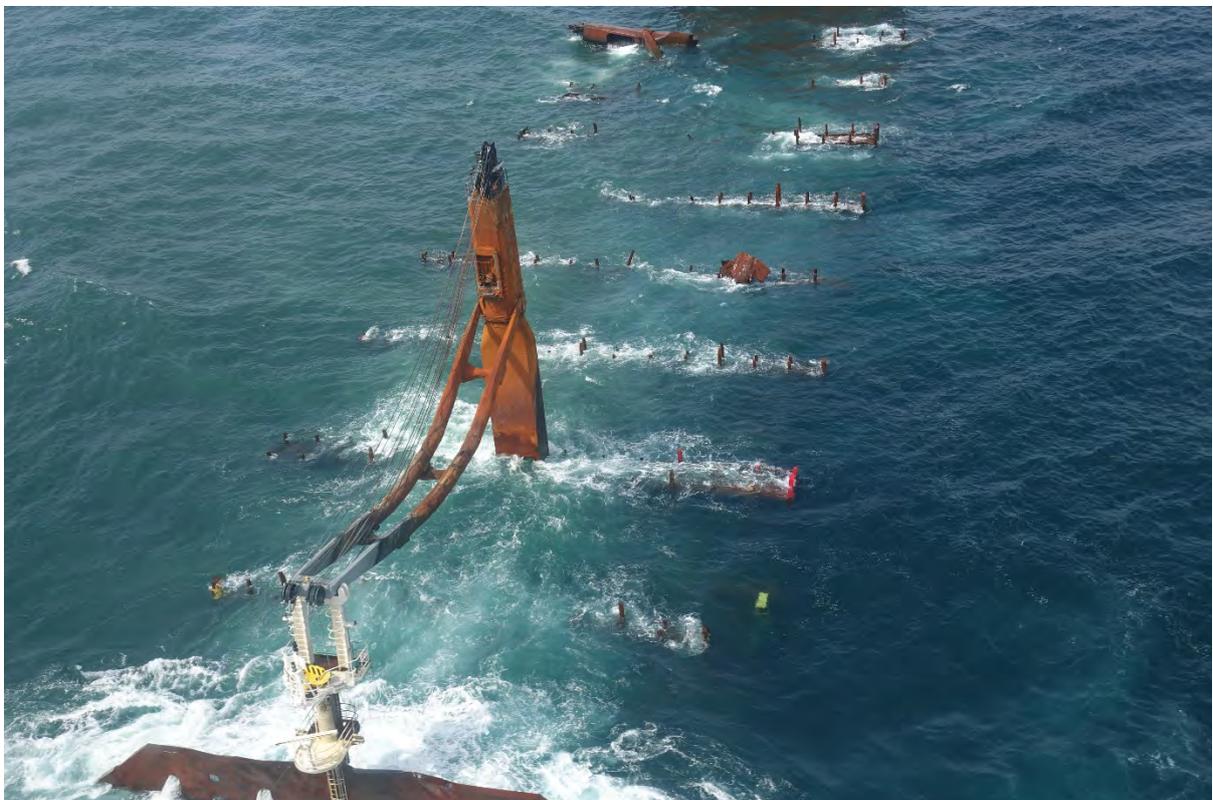
Figure 2.12: Current status of the wreck.

The multiple navigational, environmental and livelihood hazards from the wreck and lost containers highlight the need for their prompt removal. And while recognizing that the monsoon season may impede recovery of the wreck and lost containers, and that the safety of salvage personnel is of foremost priority, weather conditions are not an impediment to undertaking swift and detailed planning and initiating the tendering process for the wreck and container recovery, as indicated earlier.

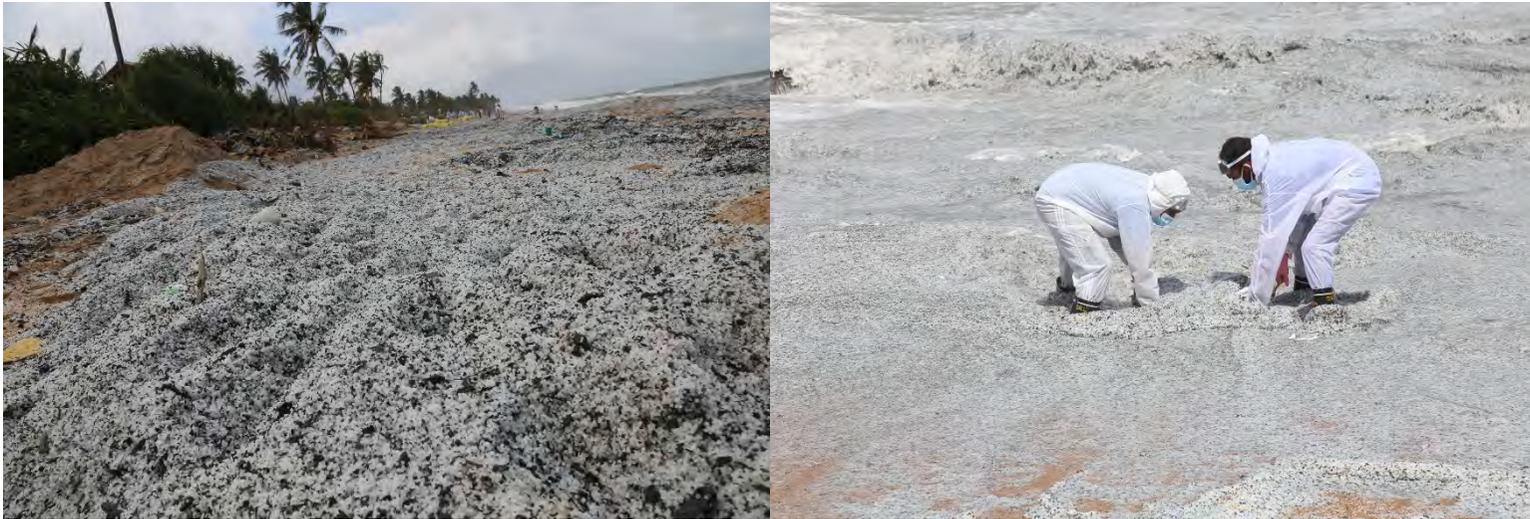
**Figure 2.13:** Massive arrival of plastic pollution on the west coast of Sri Lanka following the incident (credit: MEPA).

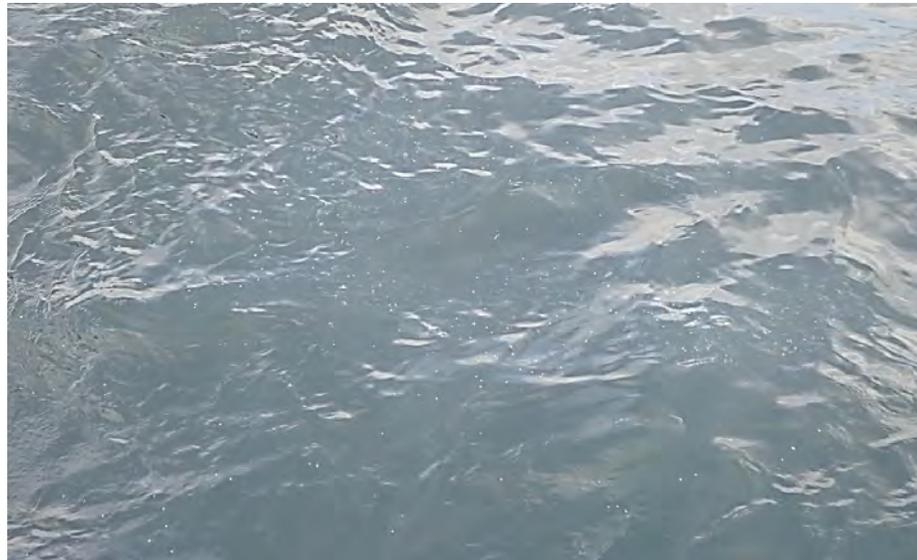
**Figure 2.14:** Plastic pellets floating in the oil slick near the wreck, boat survey on 20 June.

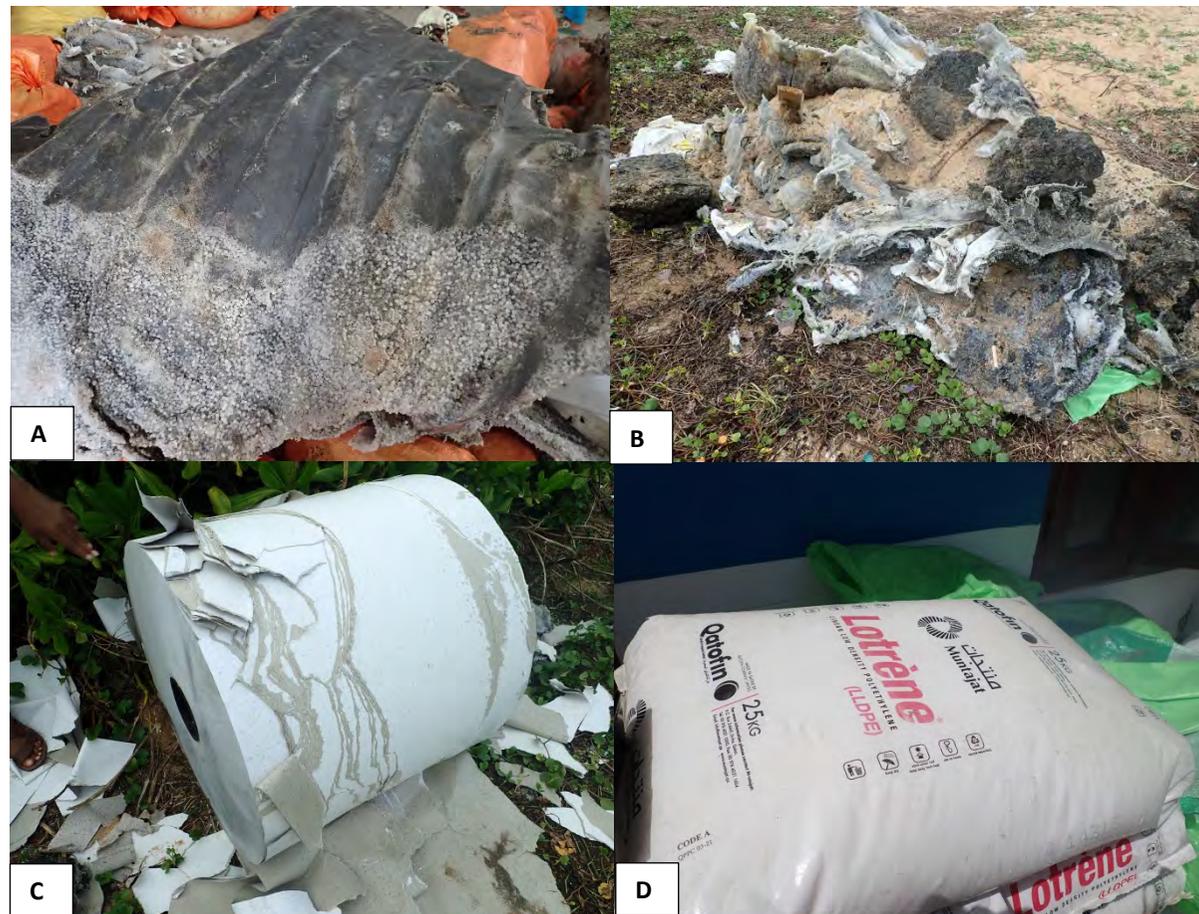
**Figure 2.15:** Large items collected on the coastline in Sarakkuwa and Dungalpitiya, Gampaha district. A and B: pieces of burnt plastic pellet bags; C: cardboard roll and D: Intact plastic pellet bag.

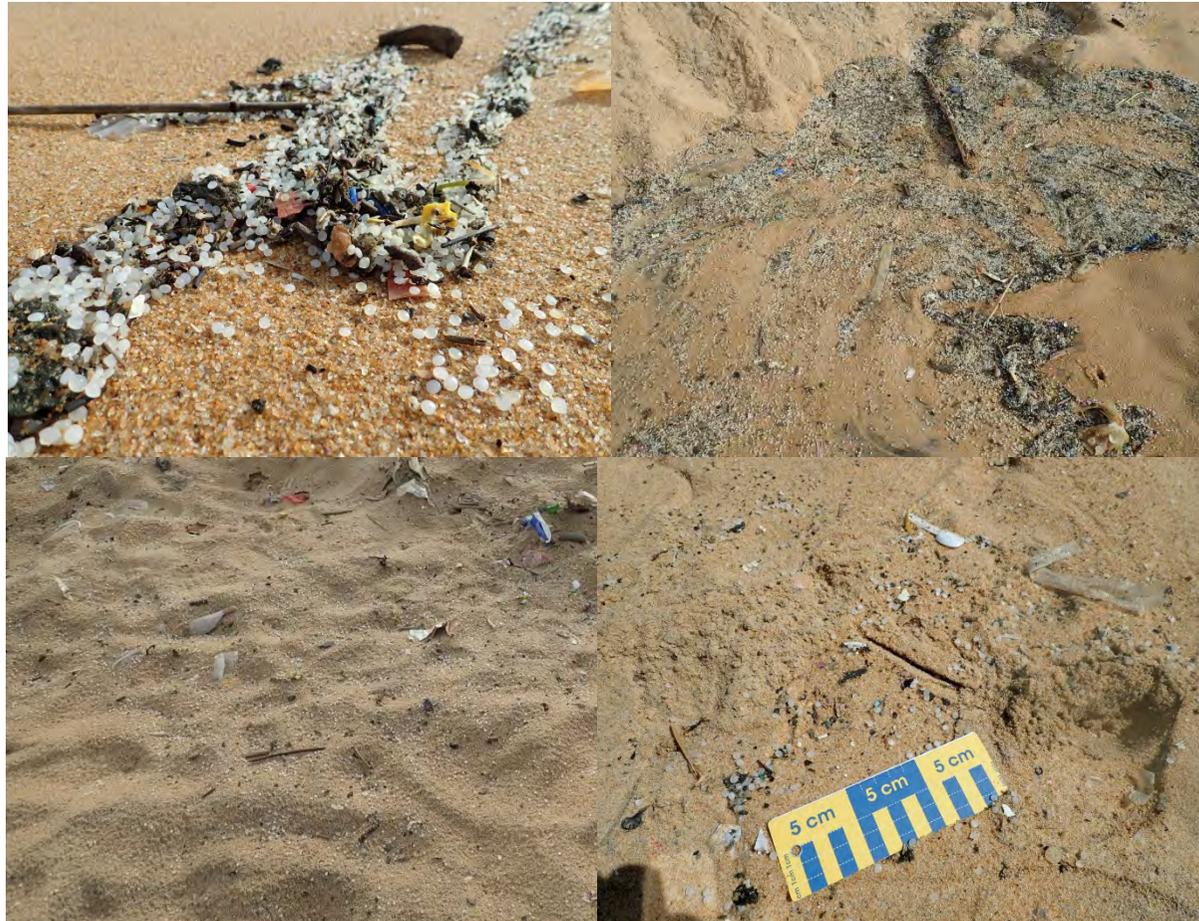
**Figure 2.16:** Pellets and small burnt plastic pieces deposited in recent strandlines or mixed in the first layer of sand in Sarakkuwa beach, Gampaha district.

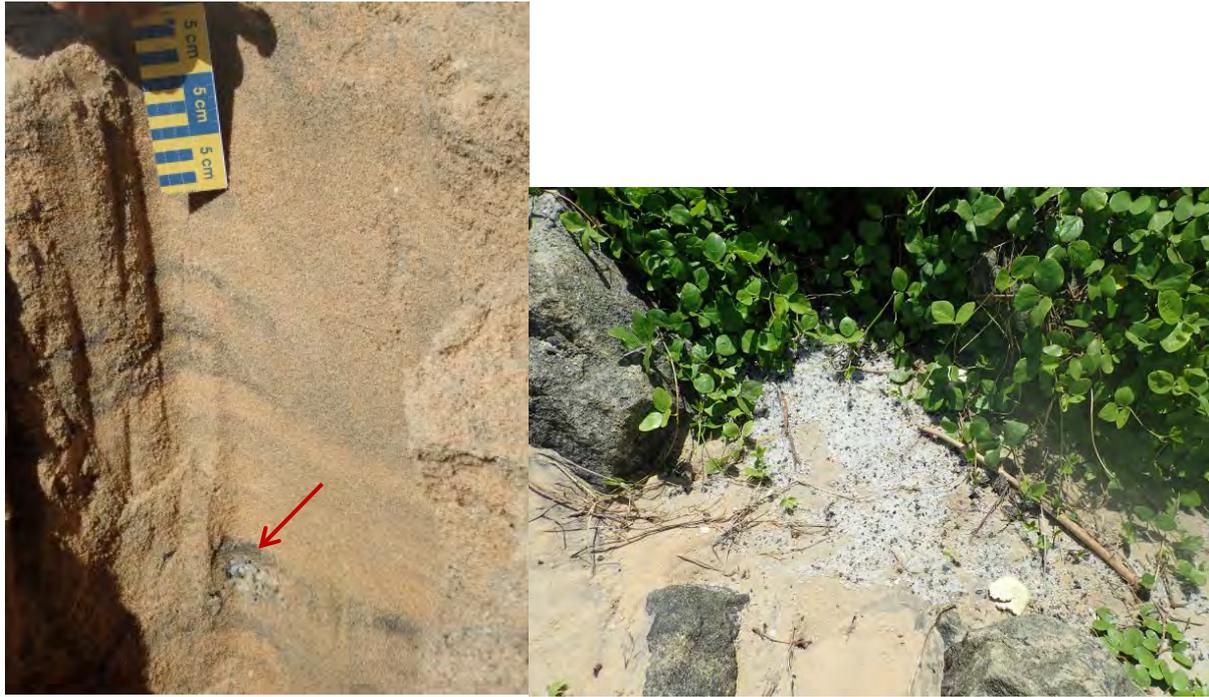
Although mainly deposited on the sand surface, the small plastics easily mix with sand due to tidal changes, trampling by workers and heavy machinery during clean-up operations. Buried plastic pollution is also caused by high wave energy and sand movement, most notably in Sarakkuwa beach; where the UN team observed layers of plastic pollution embedded in several dozen centimetres of sand. On the backshore, pellets were found mixed with coastal vegetation making their recovery more complicated (Figure 2.17).

**Figure 2.17:** Left: buried pollution in Sarakkuwa beach;  
right: pollution in the vegetation, Dungalpitiya Gampaha district.

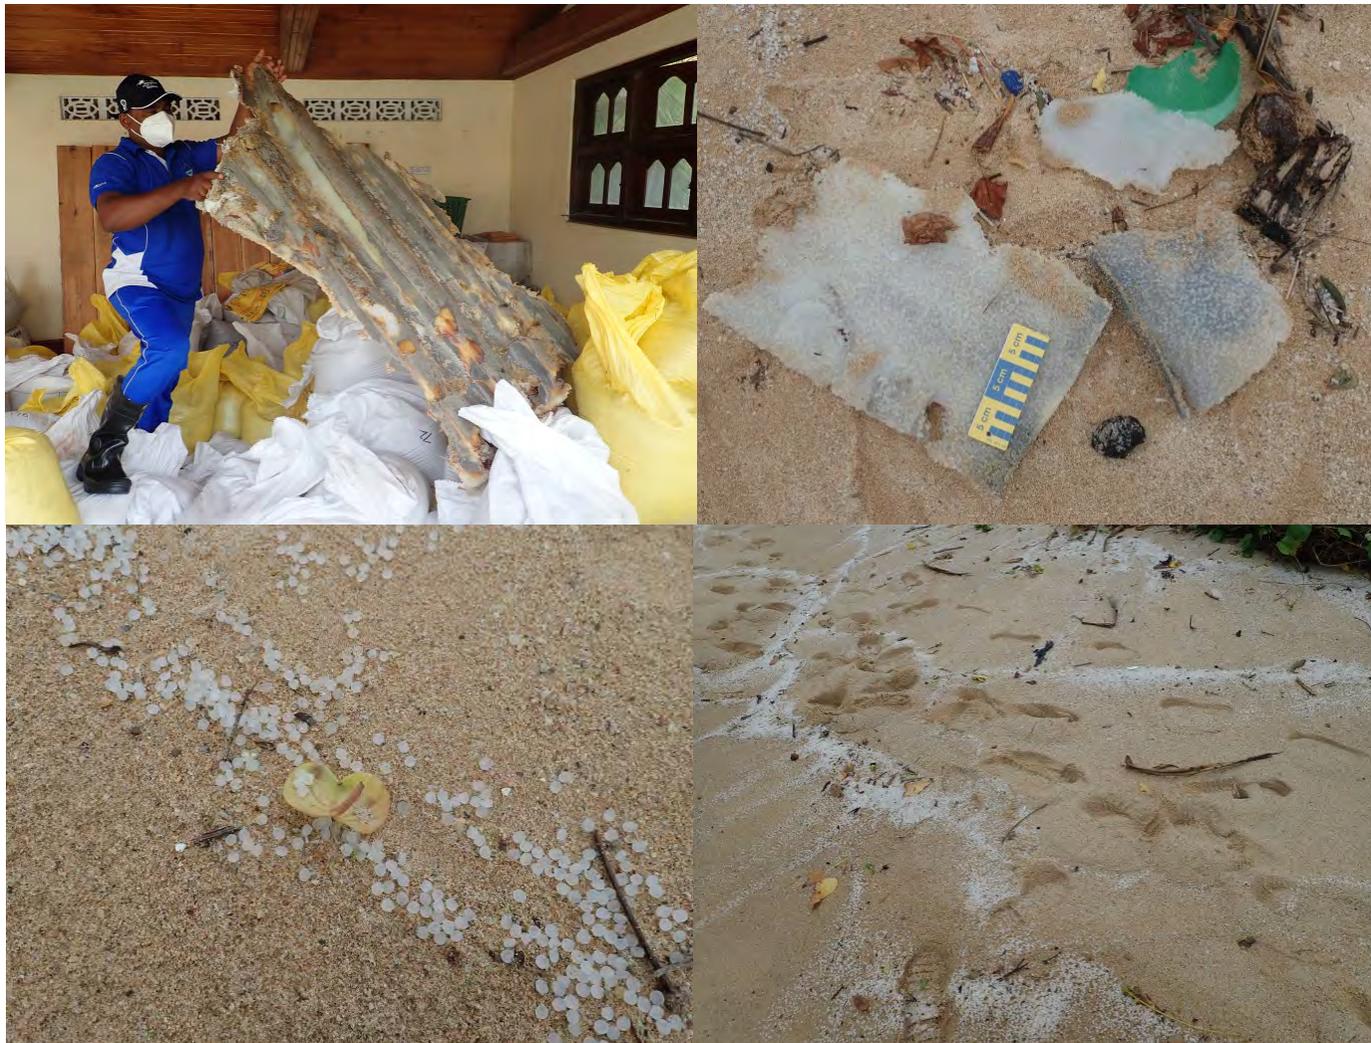
Along the southern coast, the larger debris has been collected and remaining pollution is constituted of virgin LDPE pellets and fragments of melted pellet bags. Though exposed to massive pellet arrivals, the situation along the southern shorelines is relatively less challenging due to the limited diversity of pollutants and absence of burnt plastic pieces.

Figure 2.18: Melted pellet bags and LDPE pellet on the Matara coastline.

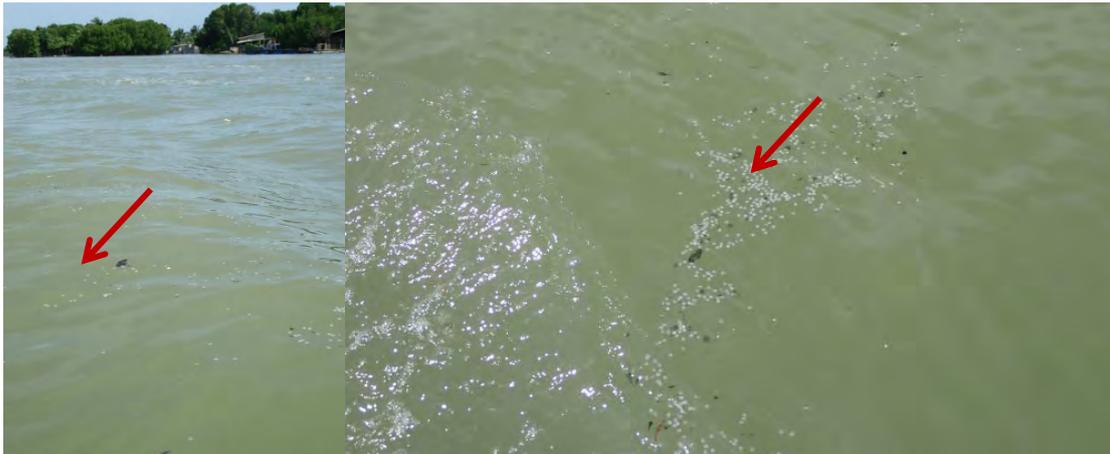
The inlets of the Negombo Lagoon – a major fishing ground situated near the most impacted sites – were partially protected by the deployment of booms along the two entrance channels. It is estimated that the booms may have prevented up to 80% of the plastic pollution from entering the lagoon. These booms had been removed by the time of the UN team's visit. Though clean-up campaigns have been conducted, the UN team was able to observe patches of pellets and burnt plastic fragments during a boat survey in the lagoon on 24 June. Recovery of floating plastic pollution in the lagoon inlet (e.g. using small meshed nets) should be considered before it disseminates deeper in the lagoon or enter mangrove stands. Chronic pollution of lagoon water may also make the microplastics a long-term hazard as pollutants adsorb on them and enter the food chain.

Figure 2.19: Floating pollution in inlets connecting Negombo lagoon with the ocean; pellets and burnt plastic fragments, Gampaha district.

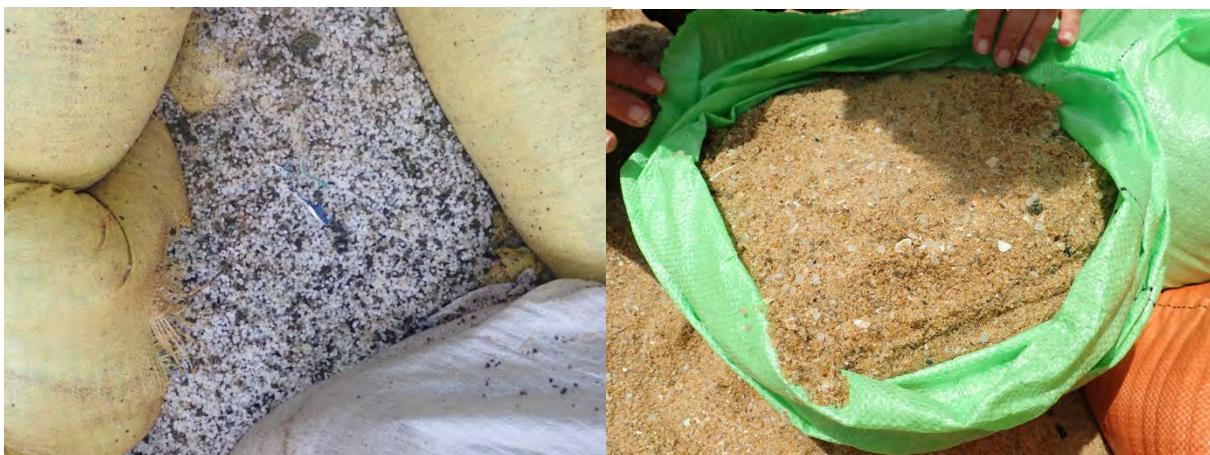
Figure 2.20: Evolution of bag content on Sarakkuwa beach, Gampaha district. On the left, content of bags at the beginning of the clean-up campaign, and on the right after several weeks.

A phased approach is being applied to plastic pellet recovery. Bulk arrivals of nurdles mixed with other debris was initially hauled manually using large baskets and heavy equipment. As the clean-up progressed and reached an advanced stage, the quantity of nurdles collected decreased while that of sand increased, especially when shovels are used to scoop up the pellets. It was observed that a substantial number of bags contain a large proportion of sand, which in some cases can reach up to 80 percent. Additional treatment will be required to separate the sand from the pellets.

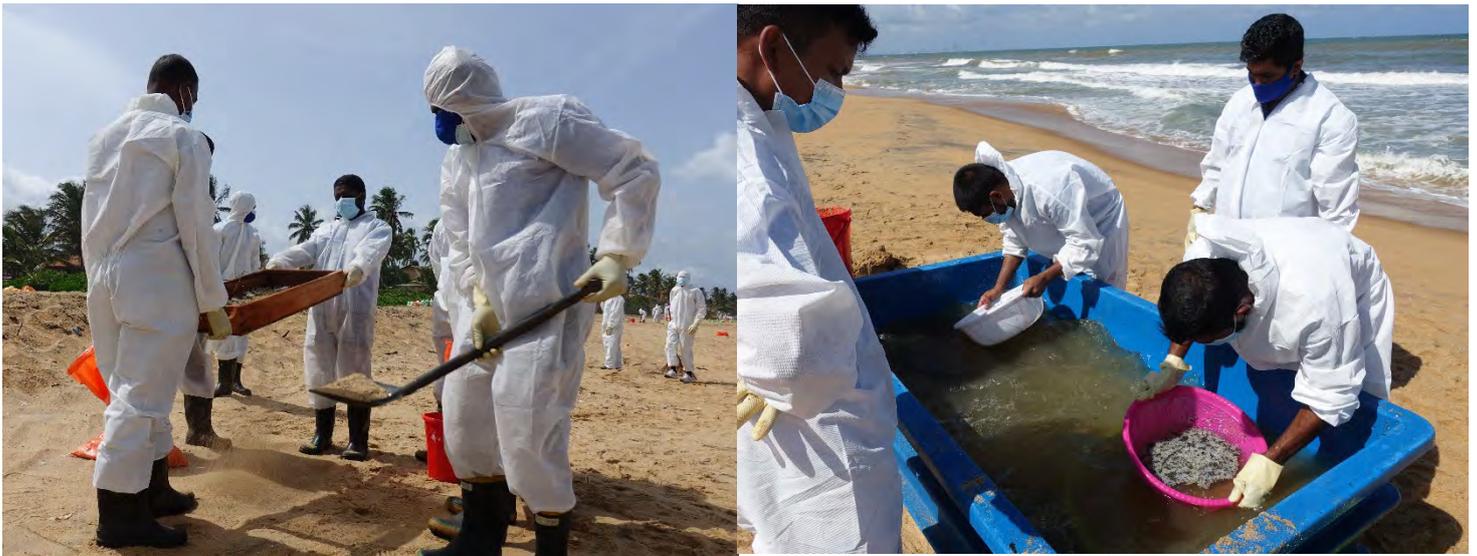
**Figure 2.21:** Left: Manual sieving, Right: flotation in seawater. Sarakkuwa beach, Gampaha district.

Flotation appears to be the more effective option, reduces the volume of sand collected, and offers the possibility of separating and recovering small burnt fragments. Guidance on scaling-up this density-based separation method is needed.

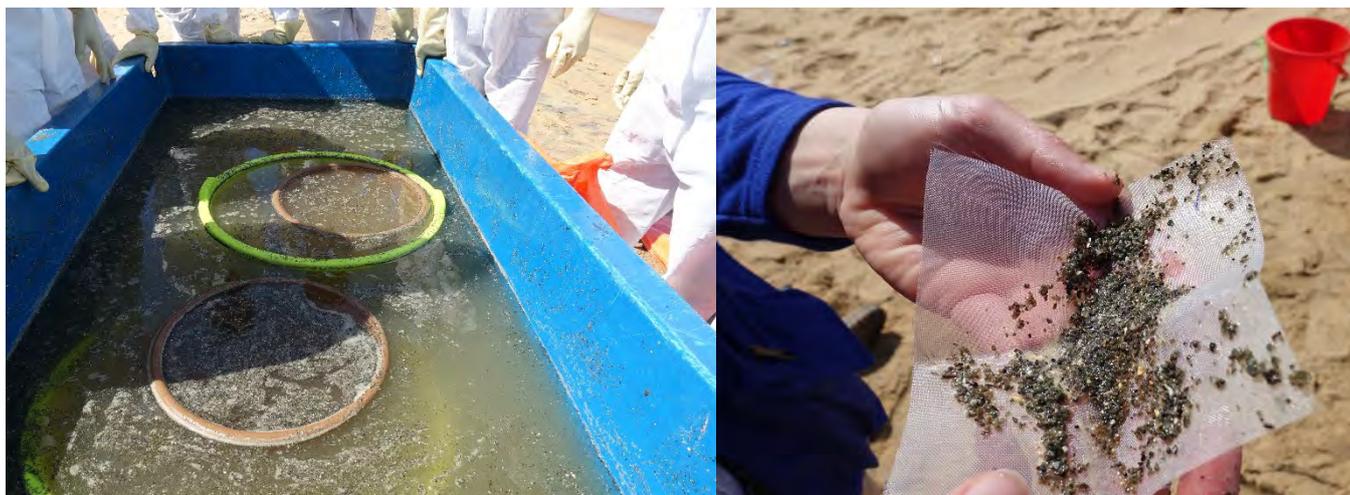
The burnt plastic fragments represent a challenge for the clean-up as they appear to be very brittle and easily breakdown into small irregular shaped particles; whereas pellets are solid, round and of standard size. Significantly, the degradation of the burnt fragments can be augmented by mechanical clean-up techniques. Moreover, the smaller particles with an irregular shape and a size inferior to pellets (3 mm) are generally not recoverable with techniques such as manual flotation or sieving due to large mesh size. Methods to recover these small burnt plastic flakes need to be developed. Furthermore, the extent of the remaining burnt plastic pollution in the sand is currently unknown and needs to be assessed.

**Figure 2.23:** Burnt plastic particles left after flotation that are too small to be recovered with existing sieves.

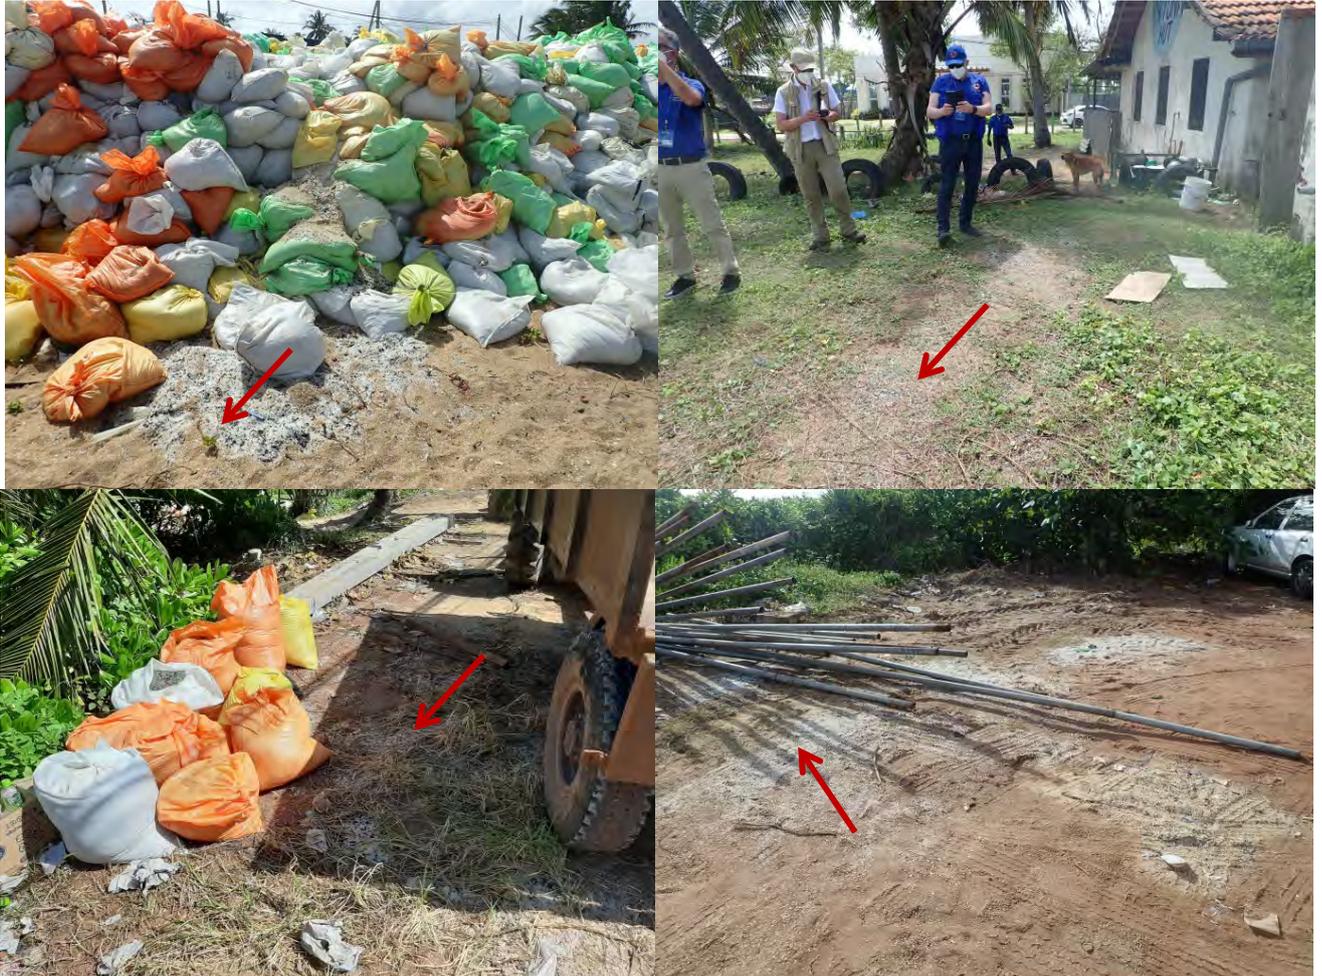
Inadvertent release of pellets during transport is another problem. Specifically, leakages during bag transport from the beach to the main road - where continuous traces of plastic pellets could be observed along footpaths and in the vegetation, including in private residences – is an issue of concern. Improvement of on-site storage and proofing of transport methods to avoid contamination is therefore needed.

**Figure 2.24:** Secondary pollution on the backshore of the beach, on paths used to transport bags and along the road, Sarakkuwa and Dungalpitiya beach, Gampaha district.

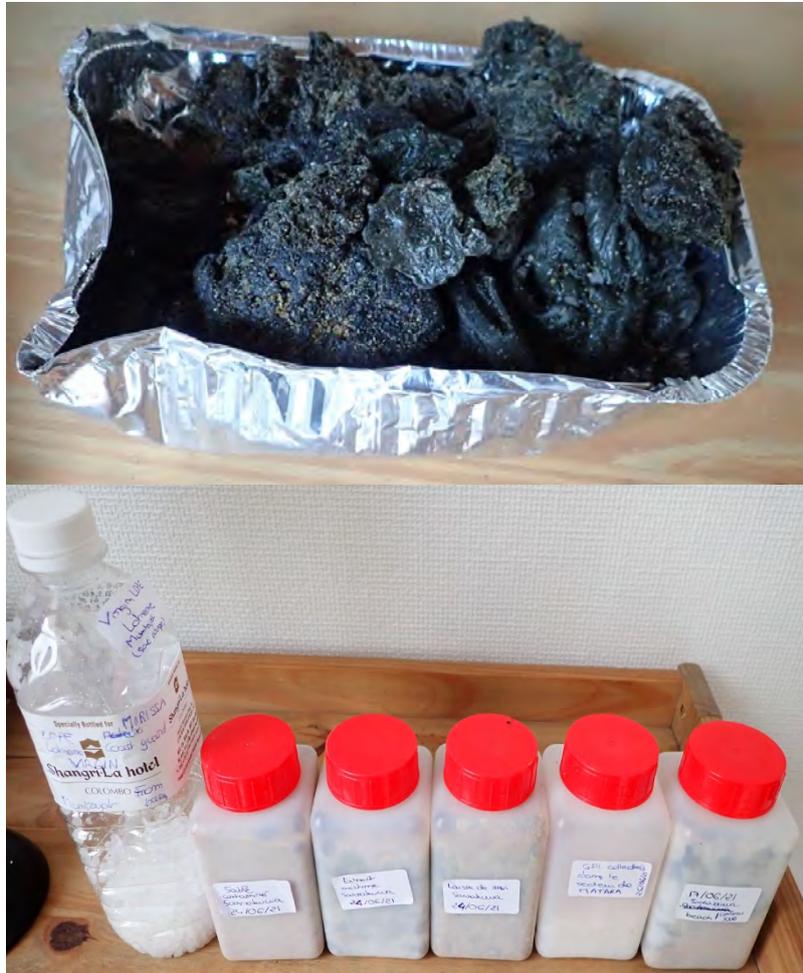
Figure 2.25: Burnt plastic pieces and pellet samples collected on different beaches.

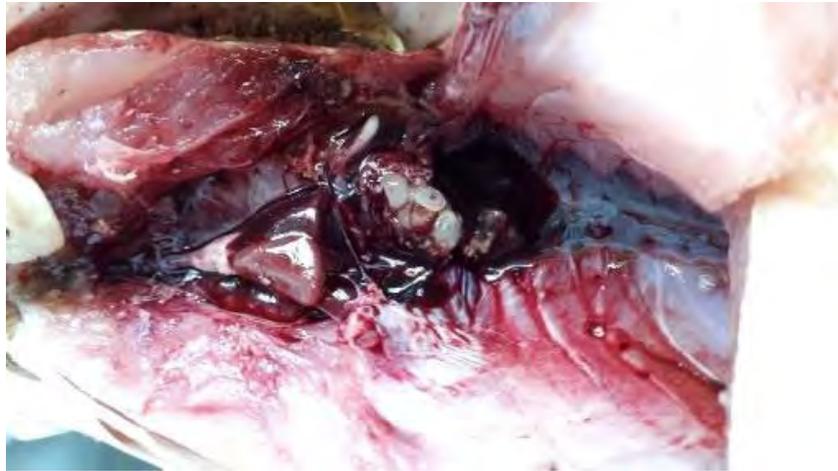
While there is a potential risk of fish accidentally feeding on pellets, there is limited evidence so far that this has occurred. Analysis of dead fish found ashore and live samples collected through experimental fishing by the National Aquatic Resource Agency (NARA) have so far found few specimens with pellets lodged around their gills.

Figure 2.28: Giant trevally (*Caranx ignobilis*) with plastic pellets in pharynx (credit: NARA).

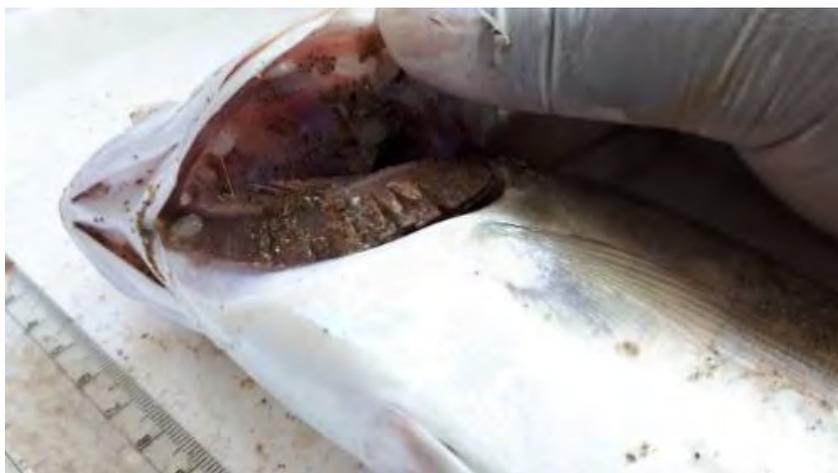
Figure 2.29: Gold silk sea bream (*Acanthopagrus berda*) with plastic pellets in opercle (credit: NARA).

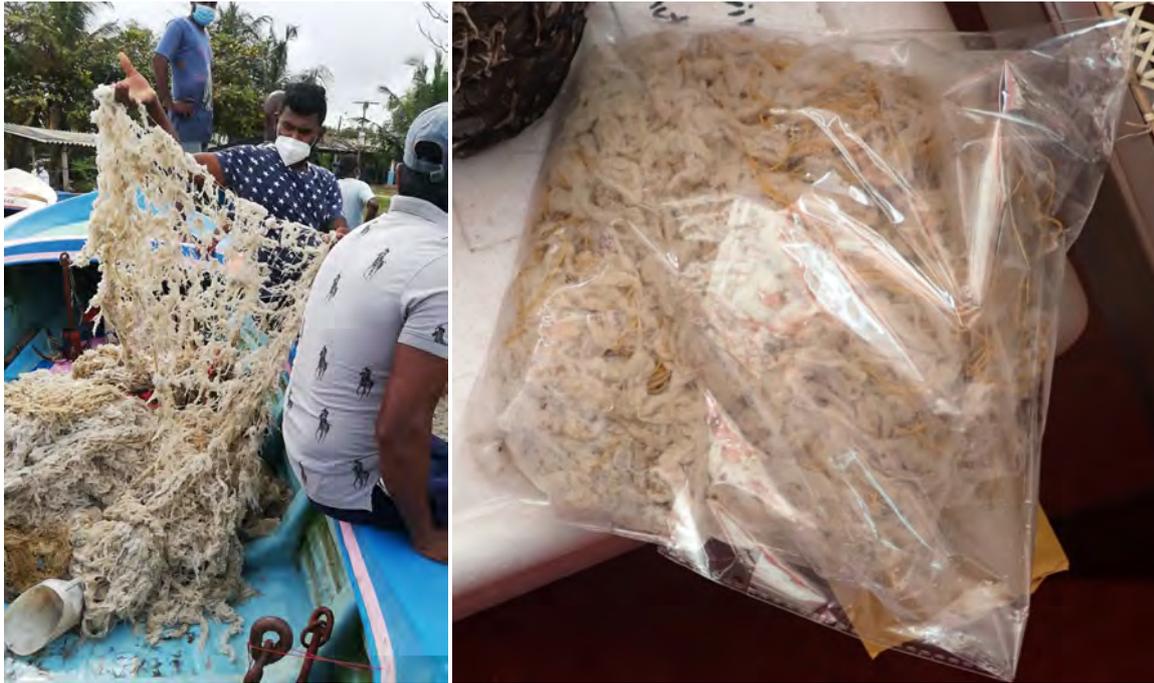
Figure 2.30: Nets entangled with synthetic fibres (left, credit: MEPA).

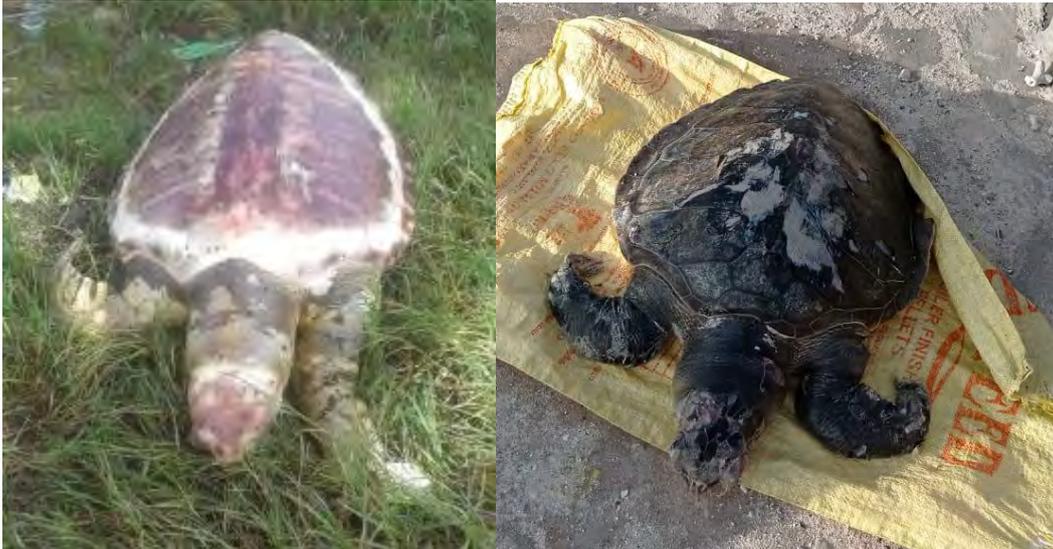
**Figure 2.31 (left):** Turtle with bleached shell suggesting potential burn (credit: Department of Wildlife Conservation).  
**Figure 2.32 (right):** Turtle with intact carapace (credit: NARA).

While the high mortality of turtles and marine mammals is a cause of concern, the UN team cautions on causal attribution to the incident without scientific evidence. Two qualifications are worth noting here: i) the deaths coincide with the start of the monsoon season which typically witness a high number of turtle stranding as carcasses are washed ashore by rough western currents; and ii) the increased reporting of turtle deaths may be due to a 'heightened awareness situation' and increased surveillance by both government institutions and the public.

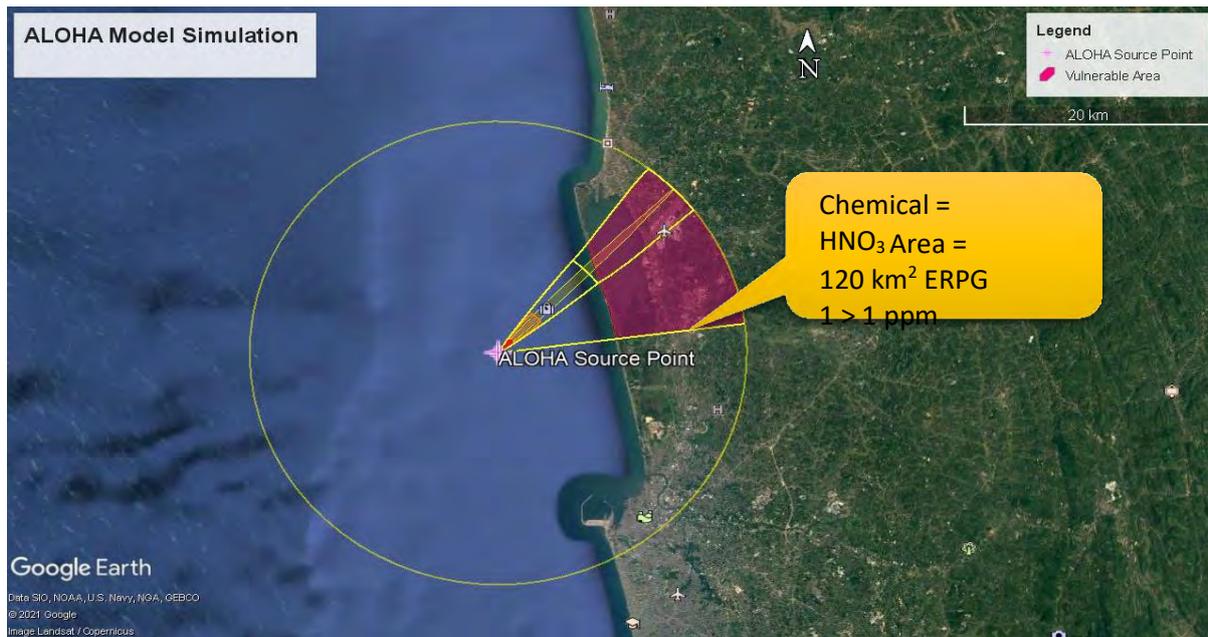
**Figure 2.39:** Identified vulnerable area for nitric acid according to simulation modelling (credit: NBRO).

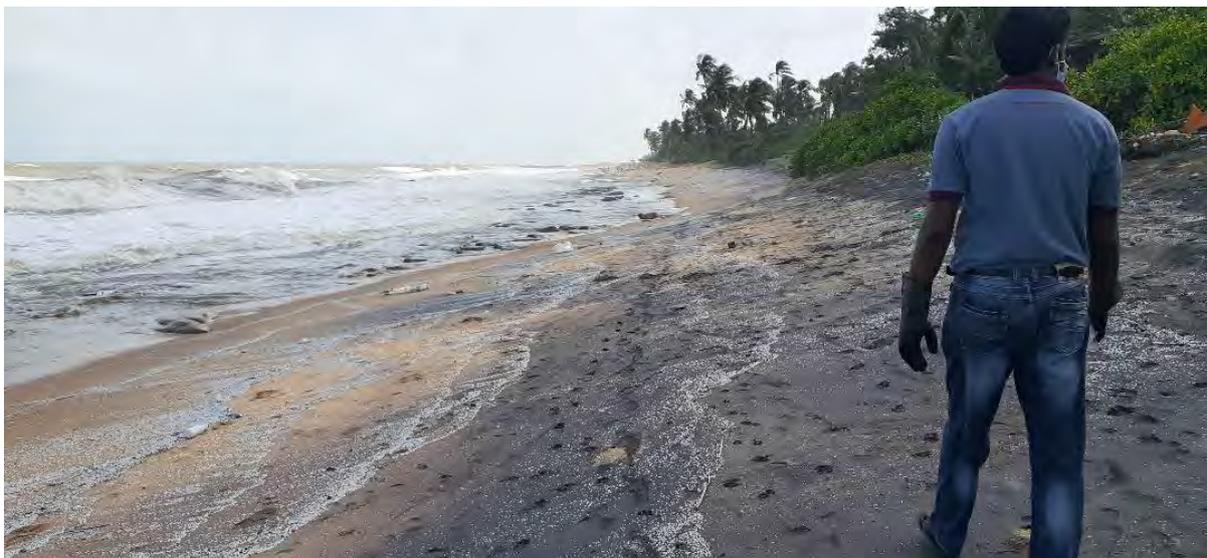
**Figure 2.40:** Depositor of fire residue on the shoreline (credit: NBRO).

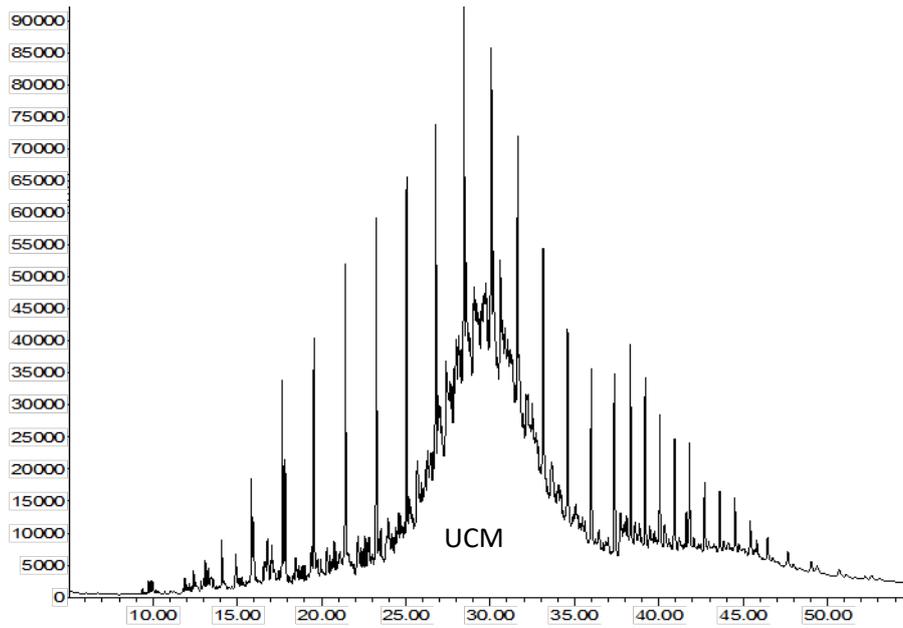
Figure 1: Chromatogram of oil sample taken on 20 June, which is typical of a heavy fuel oil.

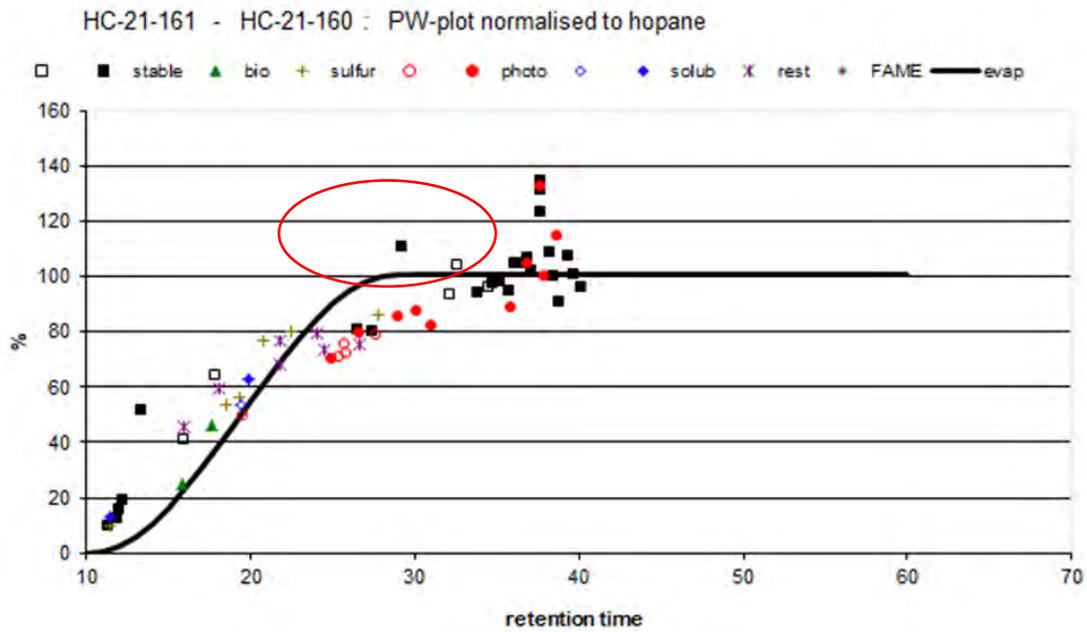
Figure 2: Full concordance for compounds in the red circle. The statistical treatment of analysis does not show significant difference between the two oil samples taken.
