Fuel Spill and Fire Rapid Environmental Emergency Assessment Mukuru-Sinai slum, Nairobi Kenya October 2011

JOINT
UNEP / OCHA
ENVIRONMENT UNIT

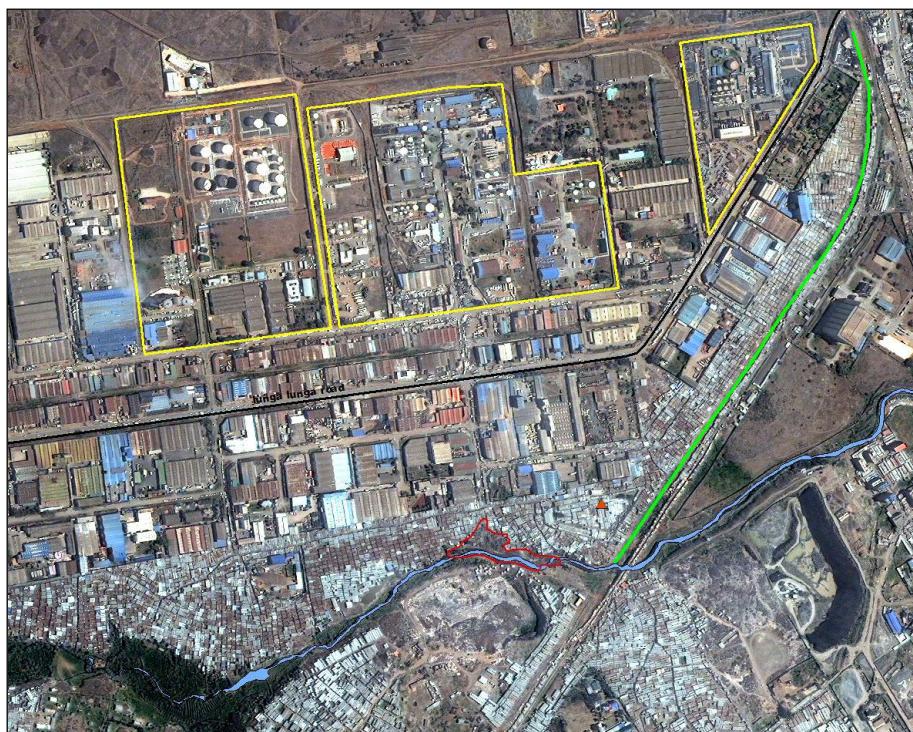
The satellite image on the left shows the industrial area of Lunga Lunga (in yellow) including a site of the Kenya Pipeline Company, the suspected pipeline (in green) and the affected area (in red adjacent to the Ngong River).

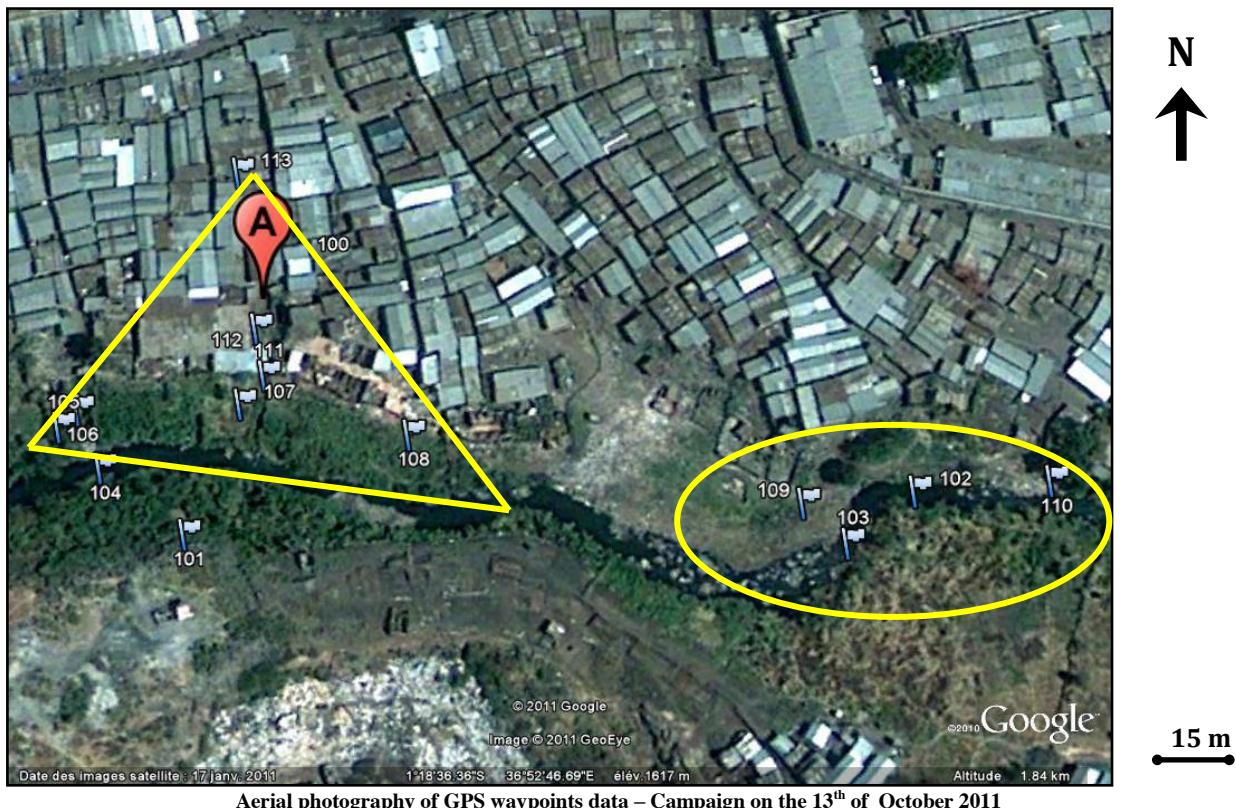
The aerial photography below shows the location of GPS data-collected waypoints on 13 October 2011, focused on the two main areas affected by the fire.
