Technical Scoping Mission

Kalush Area, Ukraine

March 2010

**A Joint United Nations – European Commission
Environmental Emergency Response Mission**

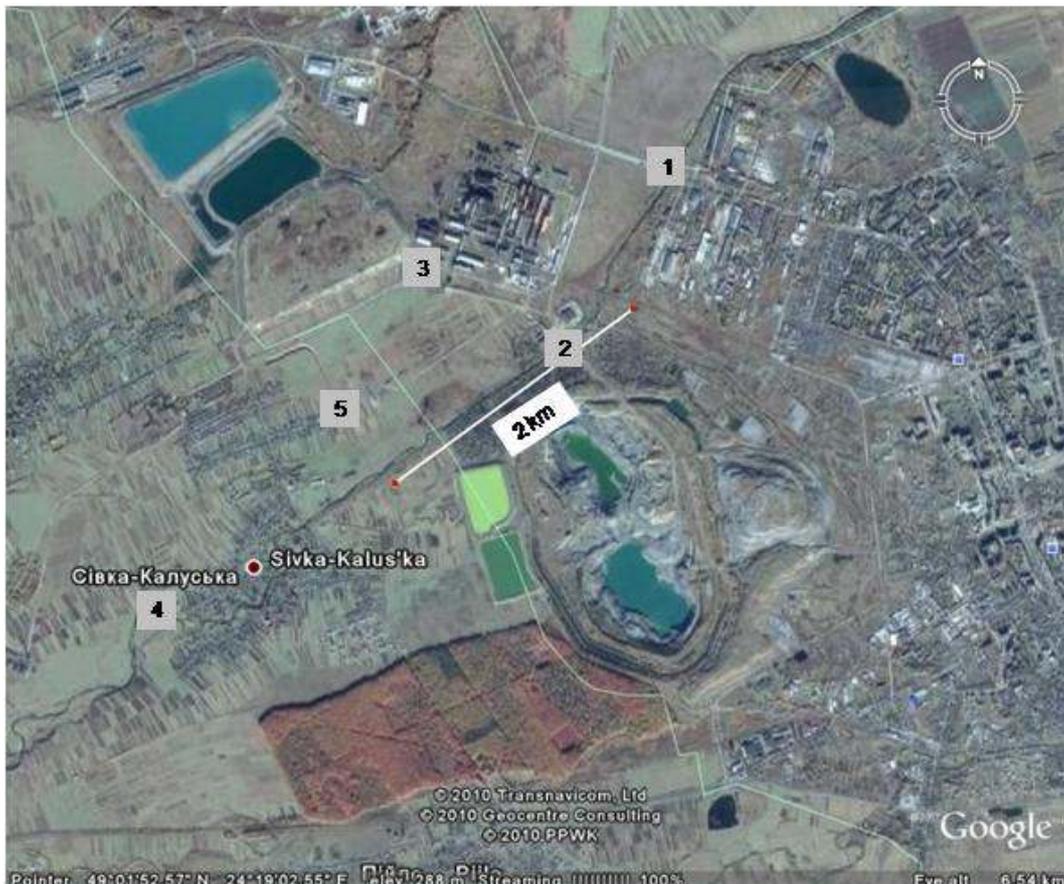
The UN/EC Technical Scoping Mission investigated the spreading of salts leaking from Tailings Dam No. 1 into surface waters and in particular into the Sivka River. On 7 March, the team took surface water samples near Tailings Dam No. 1, and upstream and downstream from the point where a small stream from Tailings Dam No. 1 enters the Sivka River. In Figure 4, the sampling points are shown. These samples were analysed for conductivity, acidity (pH) and concentrations of several elements and salts.

Figure 4: Sampling points in surface water around Tailings Dam No. 1.

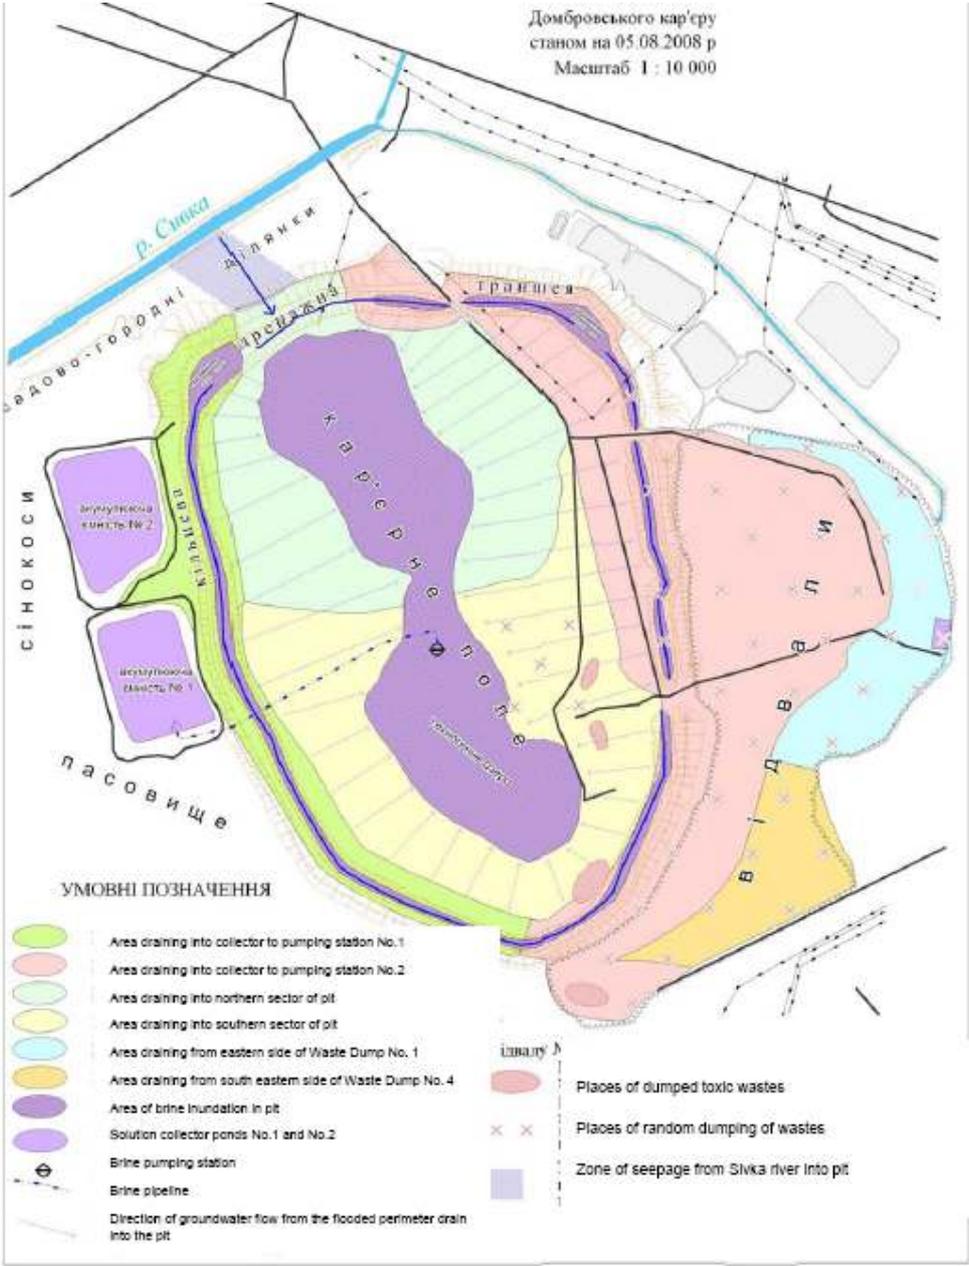
The salt deposits that were mined in the Dombrovski Open-Cast Mine (Figure 7) were a prime source for the Oriana Potash Fertilizer Plant. Mining continued until the plant was shut down in October 2001. At present it remains the only mine that that could physically be reopened for production. The mine was initially opened in 1967. Since then, an estimated $14.7 \times 10^6 \text{ m}^3$ of potassium ore has been excavated, while an estimated deposit 32×10^6 tons of ore remains. The Dombrovski Open-Cast Mine has filled up with brine, as seen in Figure 8, having an estimated volume 12 to $15 \times 10^6 \text{ m}^3$.

Figure 8: Plan of Dombrovski Open-Cast Mine

water and brine were stored in the solution-storage pond to the west of the pit (see also Figure 8). Since the termination of mining operations, the pit has been filling up with brine. Degradation of the drainage system has destroyed the separation of freshwater and salt water. As a result, the total catchment area that drains into the pit has gradually increased.

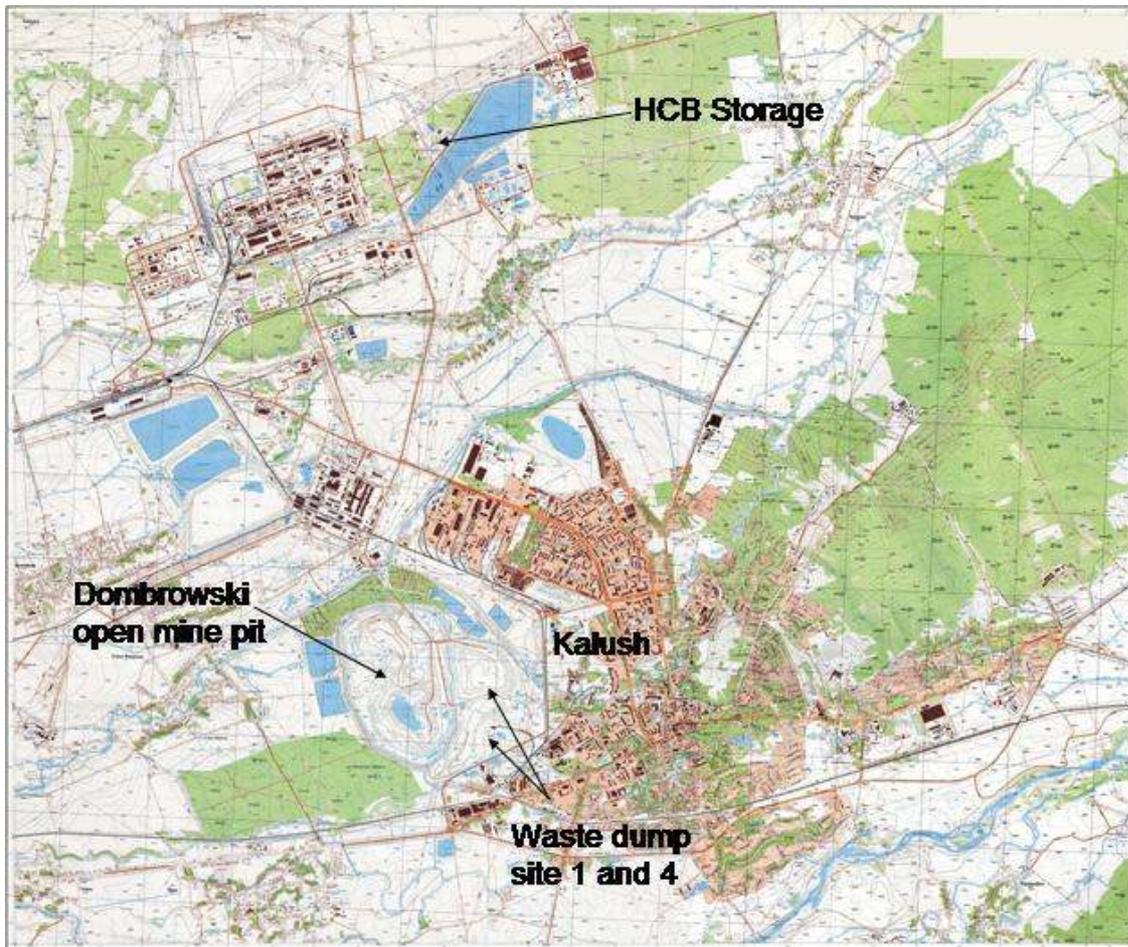
For the first three years of production of CTC and ETC in Kalush, no dedicated storage site existed yet and HCB waste was reportedly stored at several places in the Kalush Area. The only evidence that could be provided of such a storage site was of Mine Waste Dump No. 1 and/or No. 4, east of the Dombrovski Open-Mine Pit (see Figure 15). This "storage" would today be classified as uncontrolled dumping. The mission viewed photographs of scattered barrels near the open-cast mine, but could not determine their location or contents. The mission did not focus on locating these barrels because the dumpsite is large and the team did not have the equipment needed to locate them. Therefore, the condition of these barrels is

unknown. Barrels may have corroded, and if present, with HCB possibly having leaked into the areas of Mine Waste Dump No. 1 and/or 4.

Figure 15: Location of the HCB storage and waste dump sites.

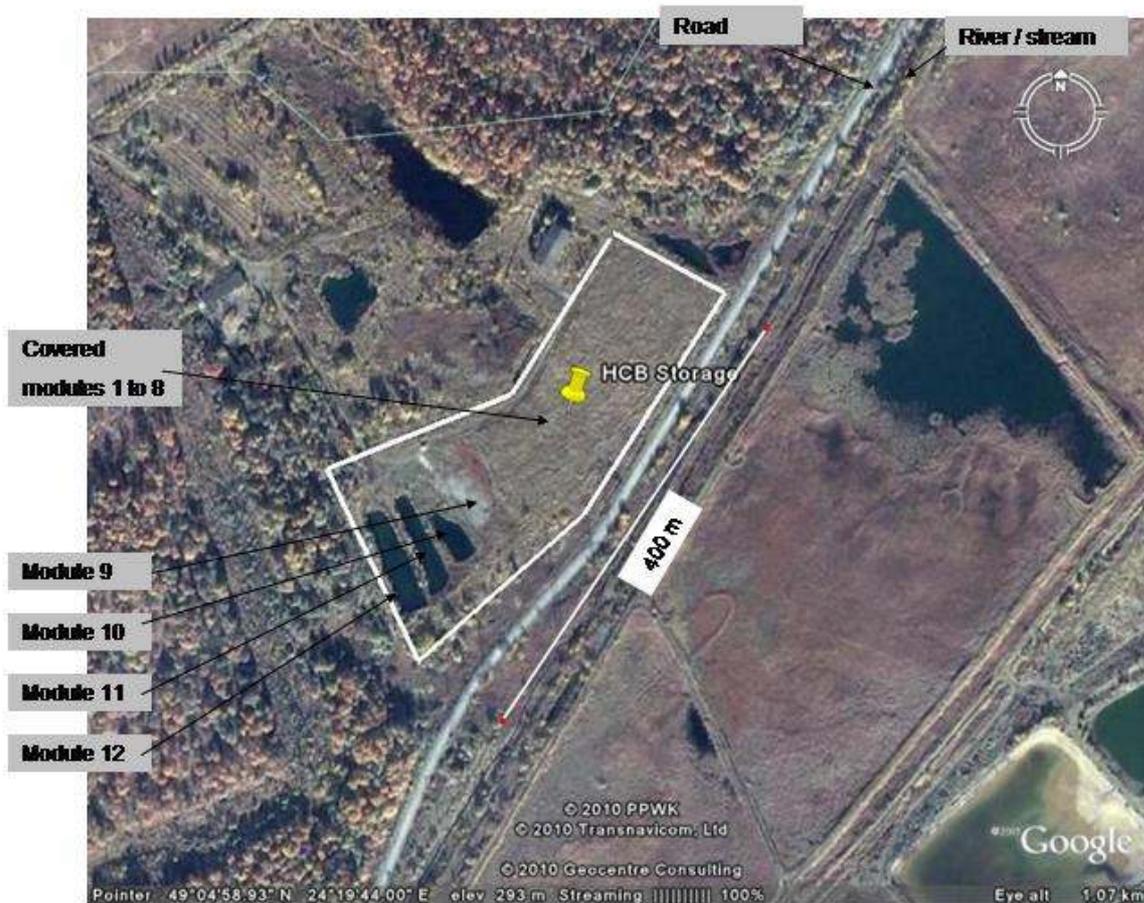
The HCB storage site (see Figure 15 for location; see Figure 16 for image) was fit for use three years after HCB production began and was used until 2000. At present, the barrels lie in water that has entered the storage site. These barrels will therefore be corroding or have corroded and it is likely that HCB is being released into the environment. Though the solubility of HCB in water is low, a certain amount of HCB in the water is expected when leakage has occurred.

The HCB storage site contains 12 modules (basins). Nine modules are filled, closed and covered, the ninth with a smaller layer of clay on top of it. One module (the tenth) is half-used, not completely covered and filled with water. The remaining two modules are not used.

Figure 16: Google Earth image of the HCB storage site.

The HCB storage site modules are basins consisting of a bottom layer of natural clay, followed by a polyethylene film (0.2 mm), rows of three 200-litre barrels on top of each other, filled with sand and stones, a polyethylene film again and 50 cm of clay. Information provided to the mission indicates that during the installation of the modules, water was not prevented from entering. This means that, the barrels may have been in water from the beginning.

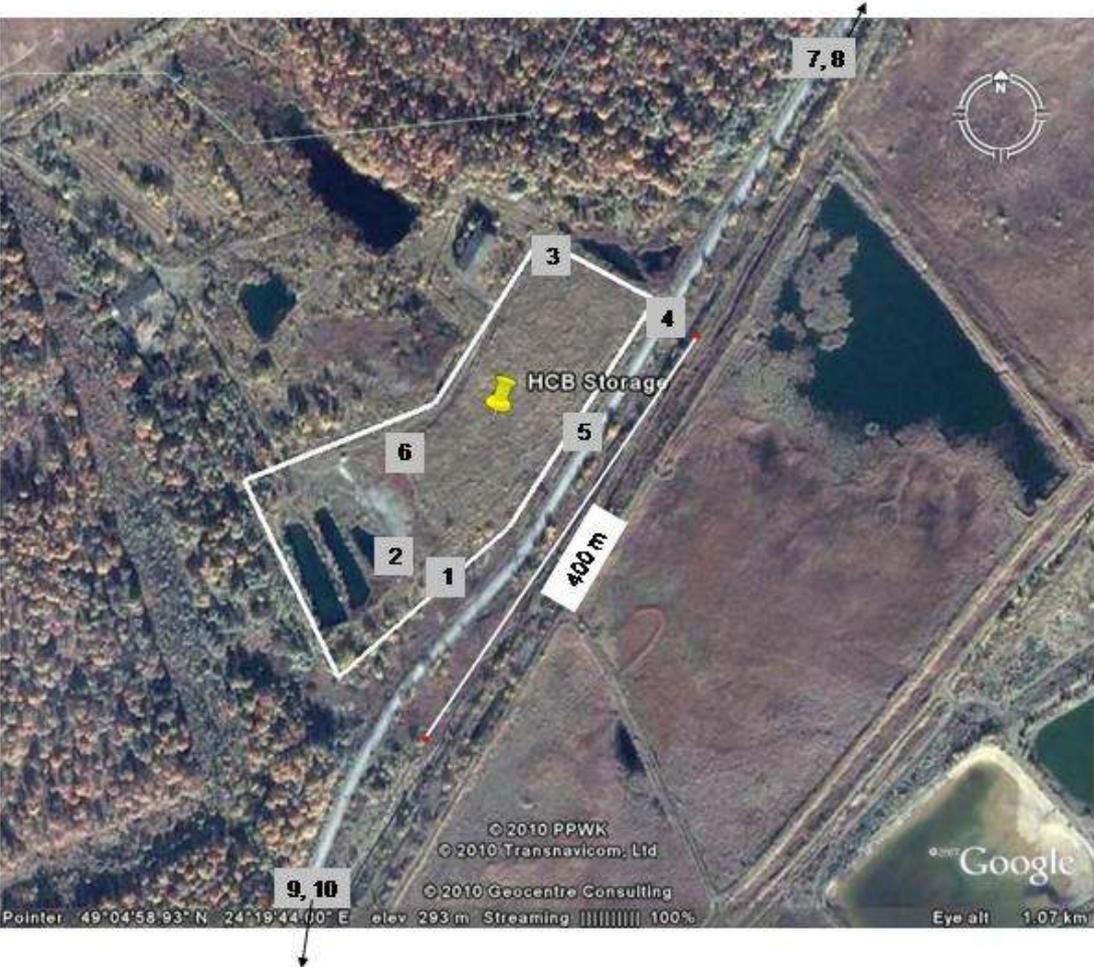
Figure 17 and Figure 18 show the sampling points. Points 1 to 6 are on or near the storage site. The other points are further upstream (sampling points 9 and 10) or downstream (points 7 and 8) from the storage site.

Figure 17: Location of sampling points near the HCB storage site.

Table 12 gives the measured concentrations of HCB. This table is an extract of Table A2.1 in Annex VIII, where results of other substances are also given. The detection limit for HCB was 0.3 ng/l, which is below the Ukraine standard for HCB concentrations in water of 1 ng/l. All samples contained HCB concentrations higher than the Ukraine water standard. This is remarkable for the samples taken upstream of the storage site (sampling points 9 and 10) and cannot be explained by spreading from the HCB storage site. It is advised to take additional reference samples at these points to verify the findings and clarify the concentrations by possible other upstream sources. Three samples taken at the storage site contain HCB concentrations higher than 100 ng/l. The highest concentration was 3,500 ng/l.

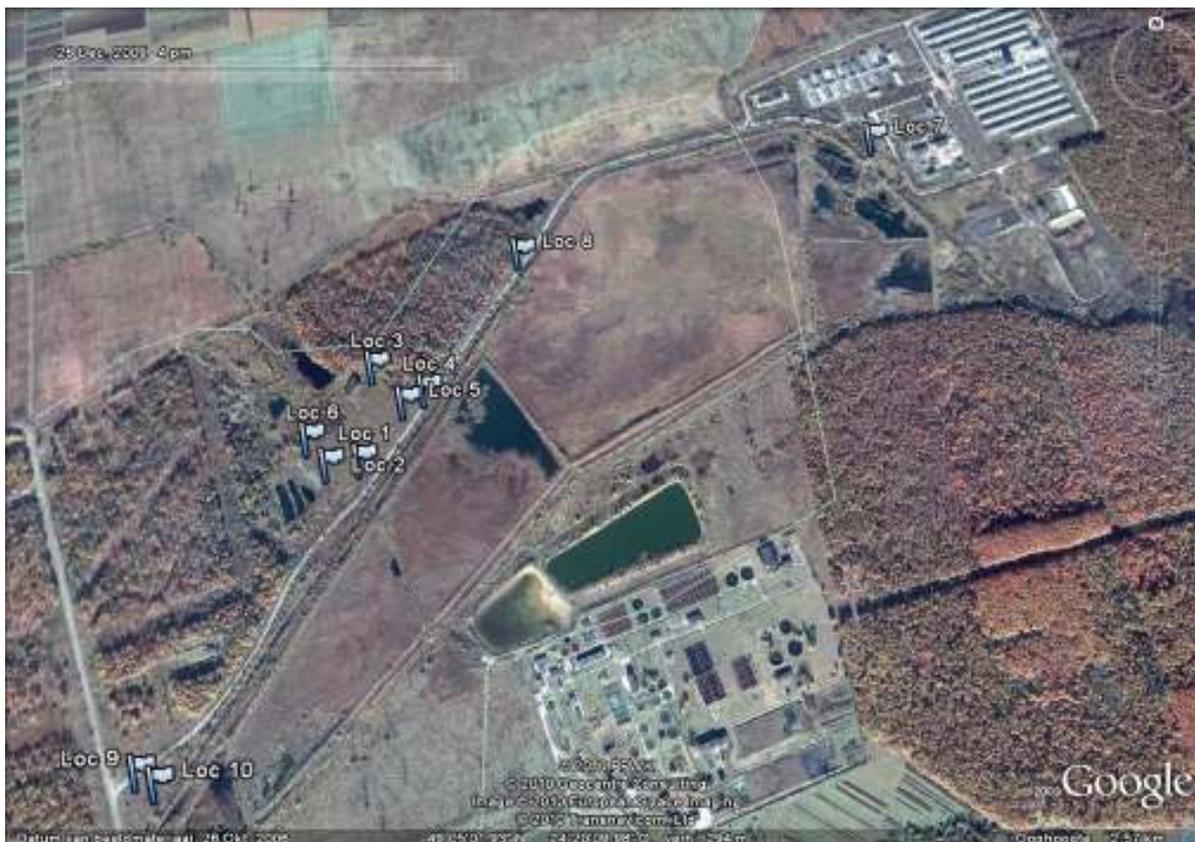
The samples were analysed at the Institute for Public Health and the Environment in the Netherlands for HCB and heavy metal concentrations. The mission noted that the monitoring pipes at the storage site were made of metal and were corroding. Thus, metal (iron) concentrations in the water samples were expected and could not be directly linked to corroding barrels in the storage.

Figure 18: Sampling points on or near the HCB storage site.

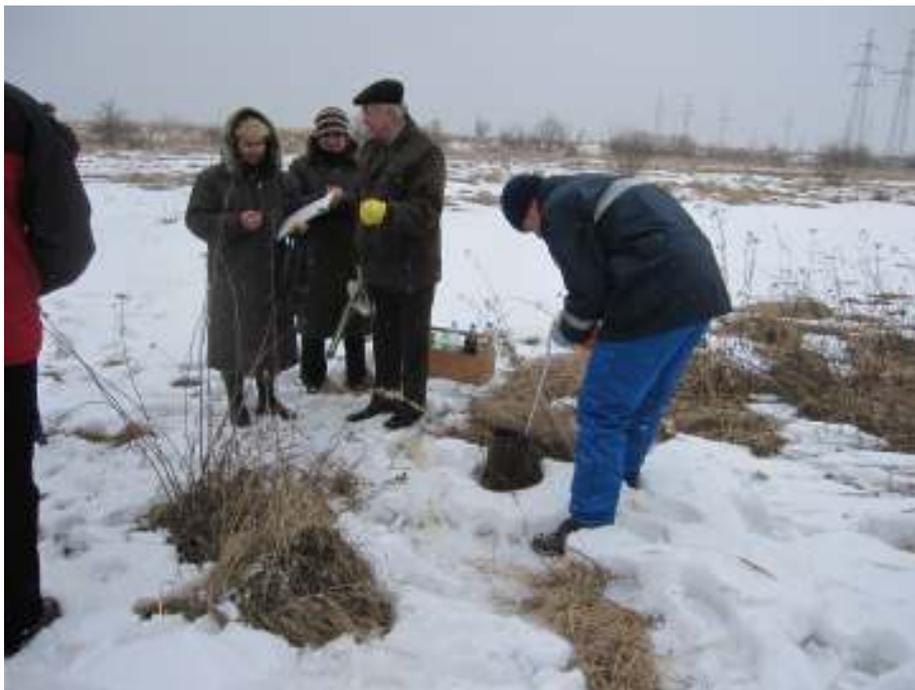
Figure 19: Sampling at the HCB storage site

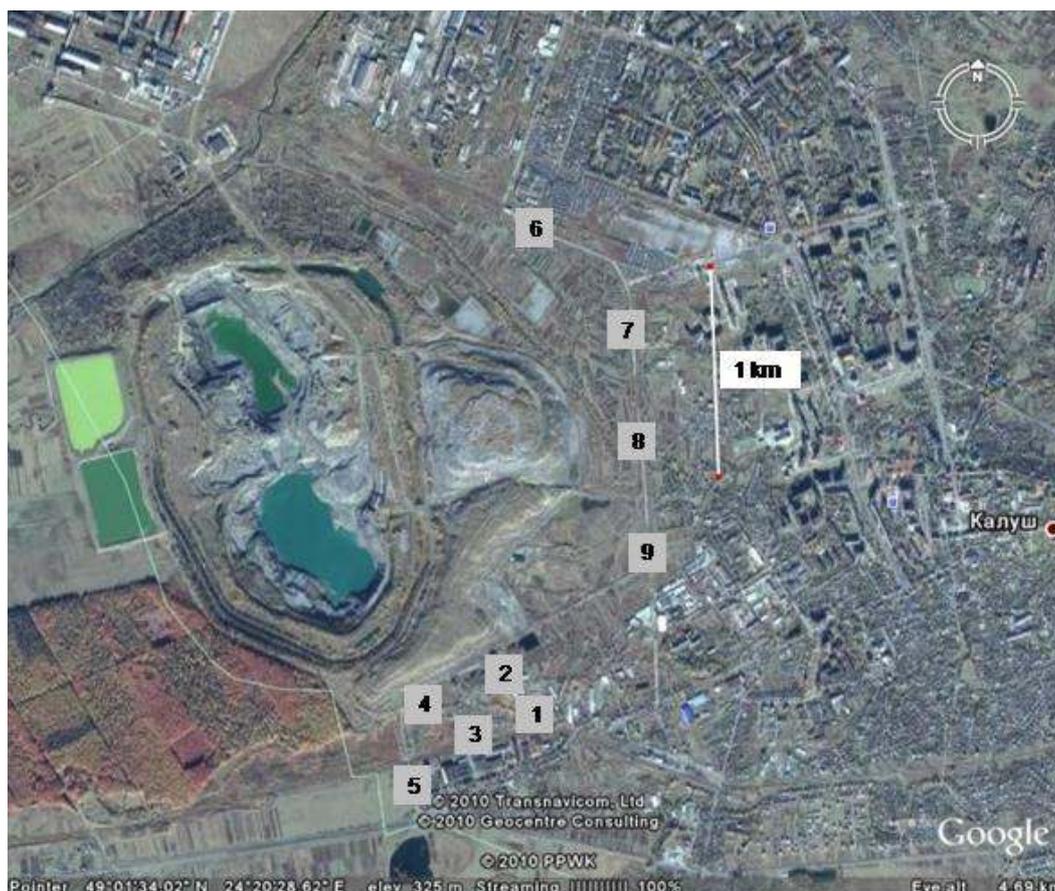
Downstream of Mine Waste Dump sites No. 1 and No. 4, samples of soil and groundwater were taken for analysis of HCB concentrations. The mission had limited time to perform a complete investigation of the spreading of HCB. As such, nine sample points of groundwater (if possible) and soil were taken from the upper layer (maximum depth: two metres), meaning that only the first groundwater layer was sampled. This sampling strategy means that only a screening of potential HCB spreading was conducted. It should therefore be noted that if HCB was not detected, one cannot conclude that no spreading has occurred and a more detailed investigation is advised.

In Figure 20, the sample points are shown. Samples of soil were taken at all points. However, it was not possible to take groundwater samples at all points as rocks made the ground impenetrable.

Sampling points 1 through 5 are close to some dachas. Sampling point 1 is just outside a back garden. Sampling points 6 through 9 are at a greater distance from houses, but some of these points are located in communal gardens where people are cultivating vegetables for private consumption.

Figure 20: Sampling points near Mine Waste Dump Sites no. 1 and no. 4.
